Submitted by
RJH Consultants, Inc.
9800 Mt. Pyramid Court, Suite 330
Englewood, Colorado 80112
303-225-4611
www.rjh-consultants.com

April 2010
Project 09121

ATLANTIC RIM
RESERVOIR

SITE VICINITY MAP

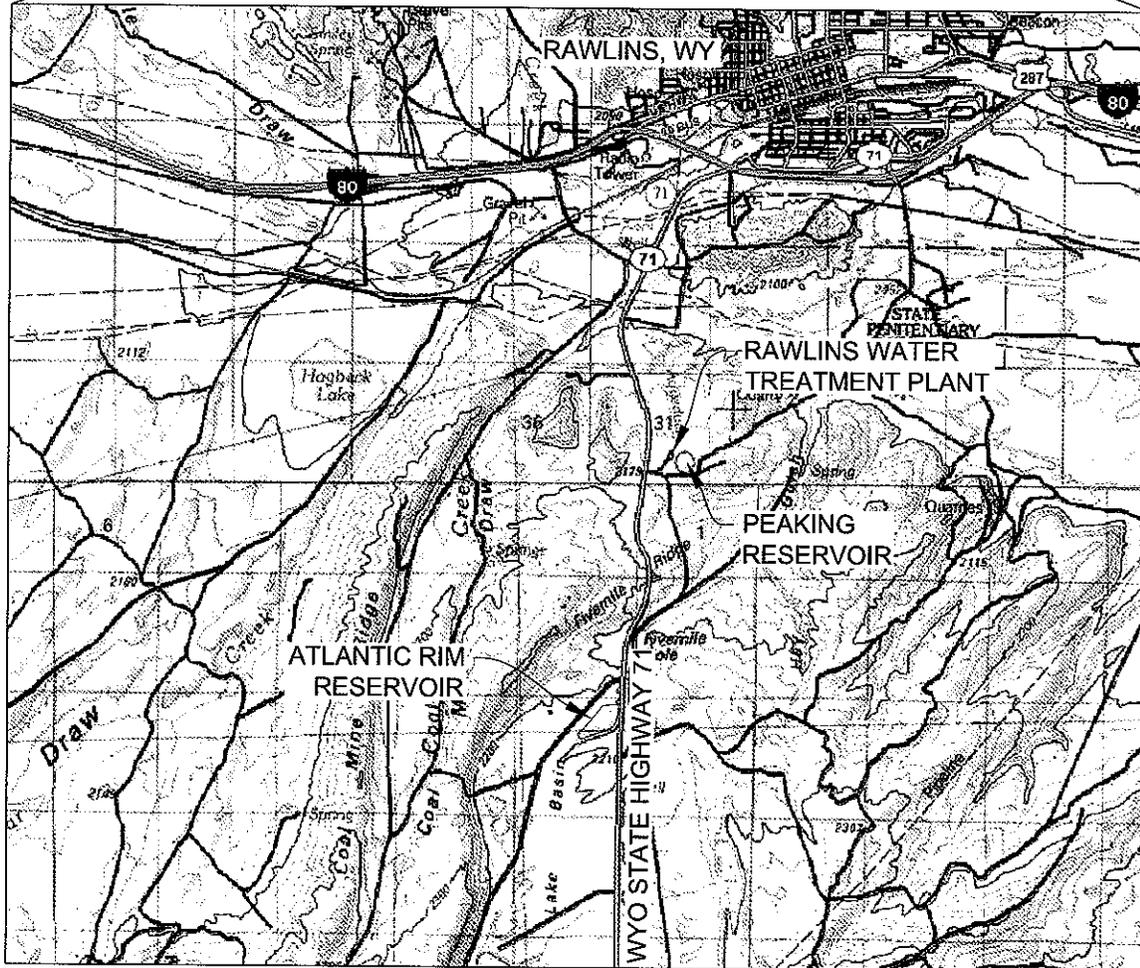
- NOTE:
1. PIPELINES AND ANCILLARY RESERVOIR COMPONENTS SHOWN IN GRAY ARE SHOWN IN THE APPROXIMATE LOCATIONS OF THOSE PROVIDED TO RJH BY WESTER-WETSTEIN AND ASSOCIATES, INC. ON A UNTITLED, UNDATED SITE PLAN. THE LOCATIONS OF THESE FEATURES ARE NOT SHOWN ON CONSTRUCTION DRAWINGS.
 2. DRAWING ILLUSTRATES STATIONING, GENERAL LOCATIONS OF FACILITIES, AND THE LIMIT OF CUT AND FILL SLOPES. ALL LOCATIONS ARE APPROXIMATE.

Figure 1.1	Site Vicinity Map
Figure 1.2	General Plan of Reservoir and Appurtenances

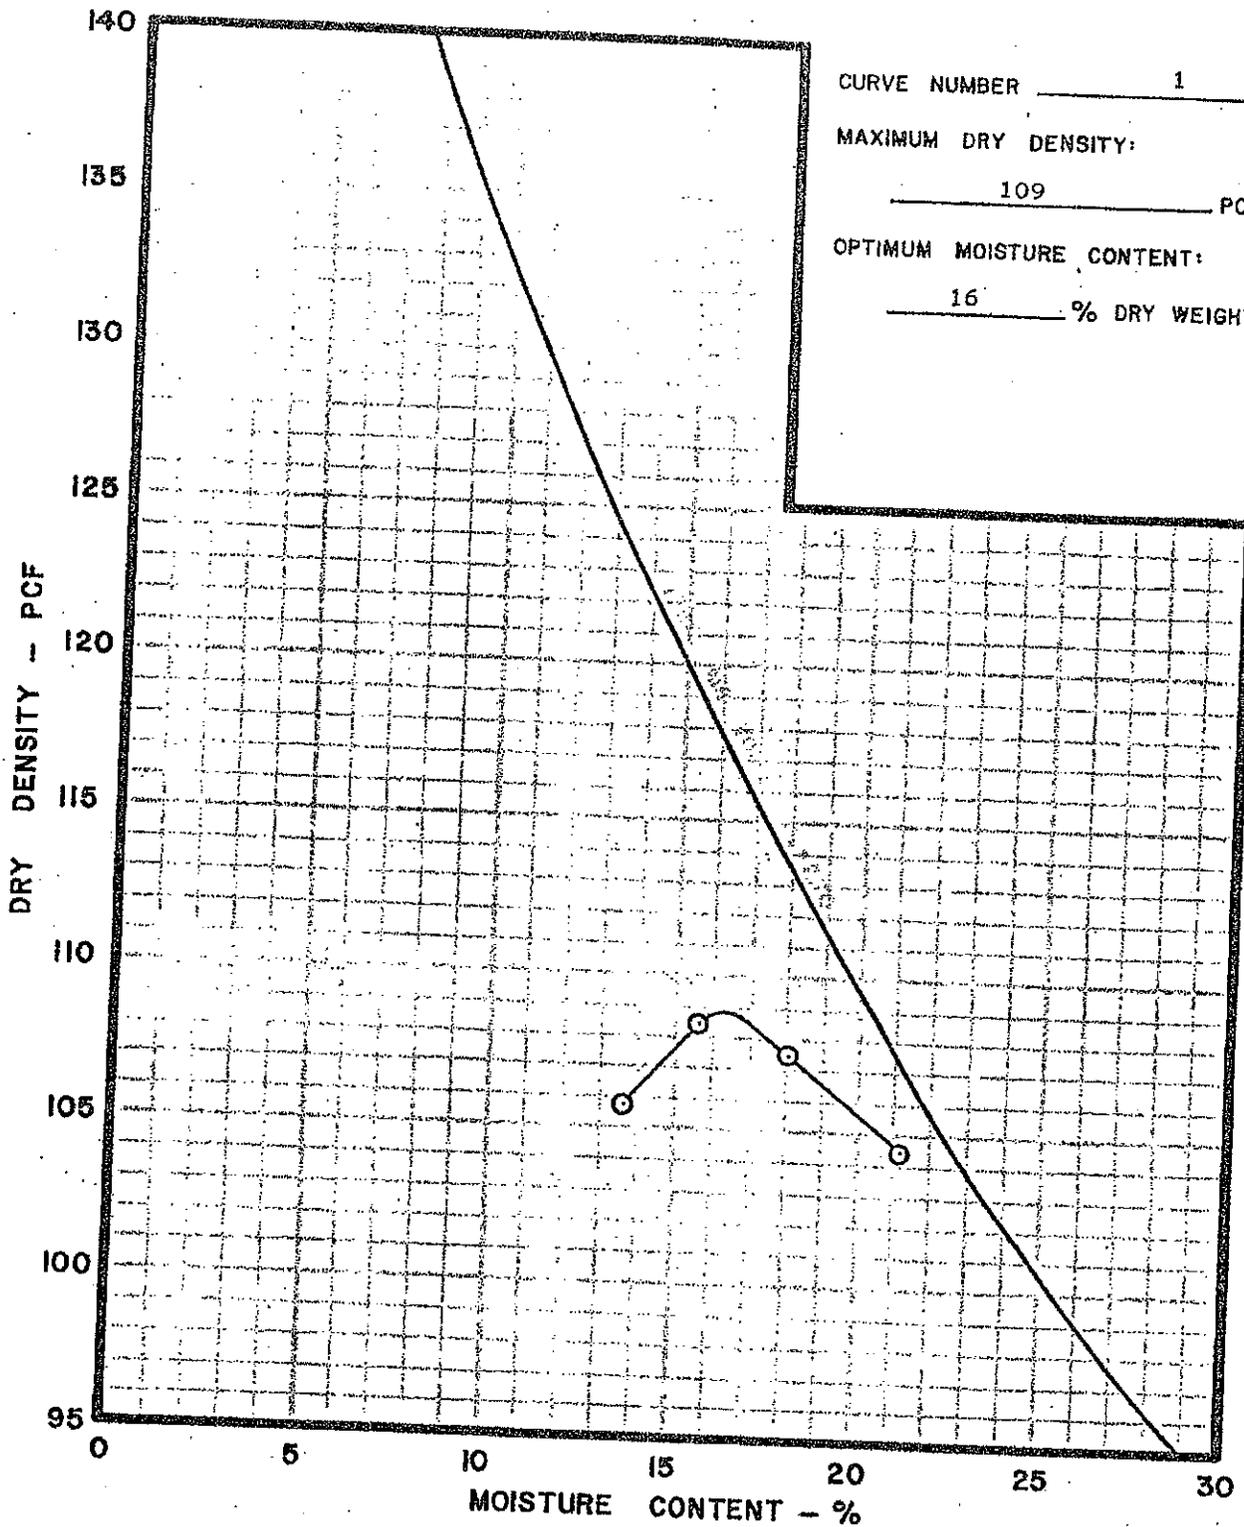
COMPACTION TEST RESULTS

SAMPLE DESCRIPTION CLAY, SLIGHTLY SANDY, HIGHLY CALCAREOUS, BROWN

LOCATION ATLANTIC RIM RESERVOIR

SILT & CLAY 89 %

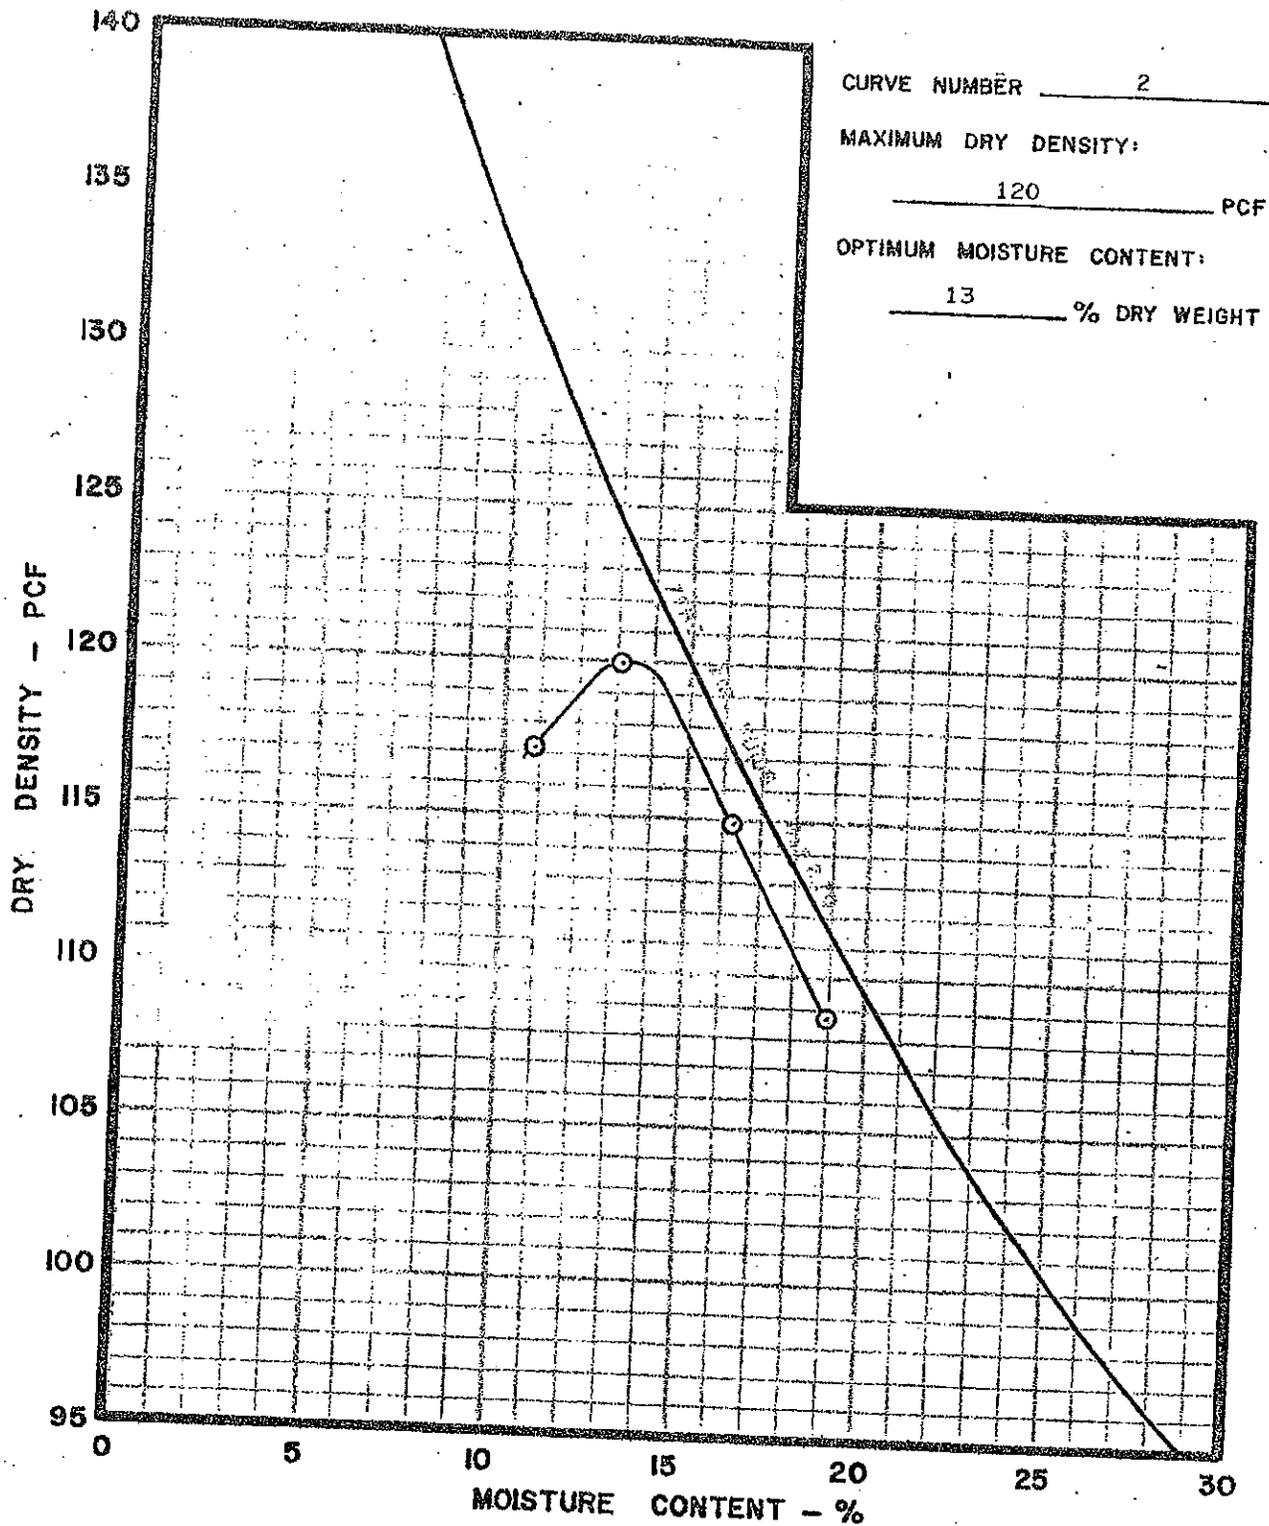
COMPACTION TEST RESULTS

SAMPLE DESCRIPTION CLAYSTONE, VERY SILTY, SLIGHTLY SANDY, GRAY, GREEN

LOCATION ATLANTIC RIM RESERVOIR

GRAVEL 0 % SAND 10 % SILT & CLAY 90 %

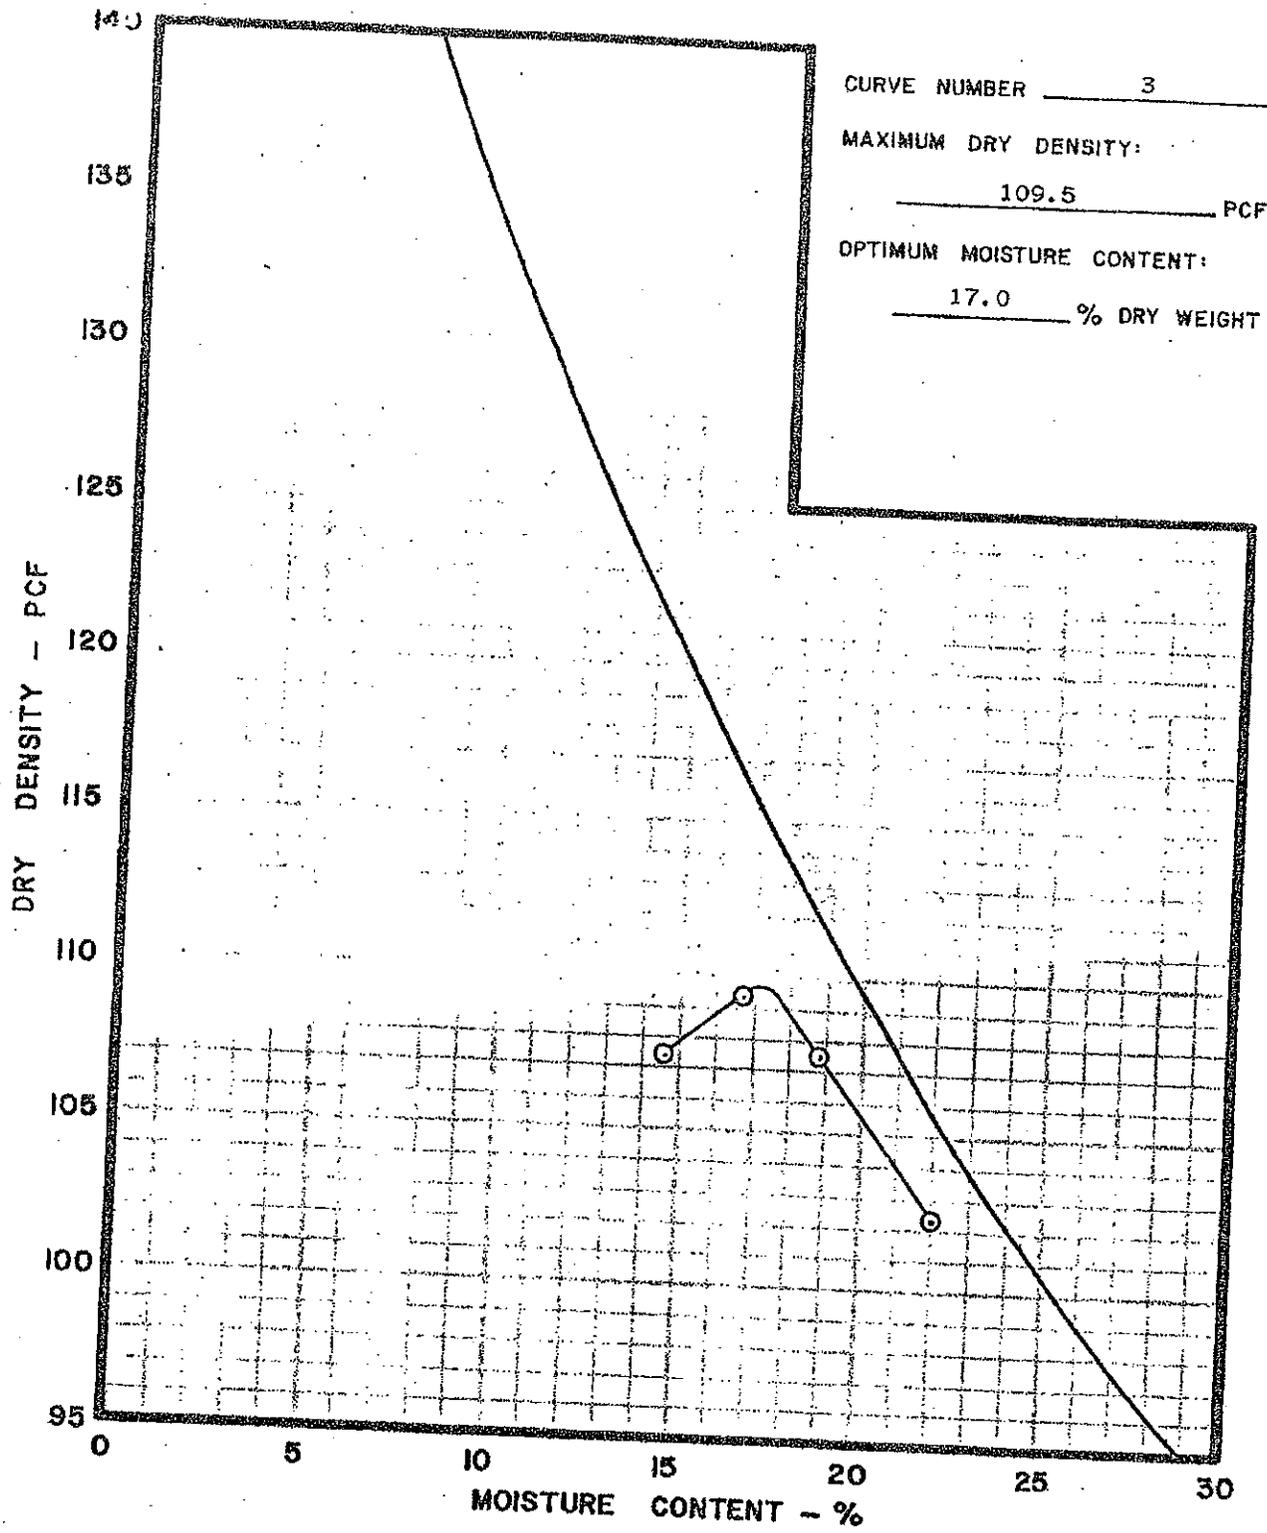
COMPACTION TEST RESULTS

SAMPLE DESCRIPTION CLAY, SANDY, RED-BROWN
 LOCATION ATLANTIC RIM RESERVOIR
 COMPACTION TEST PROCEDURE ASTM D 698-70, METHOD 'A'
 LIQUID LIMIT 25 % PLASTICITY INDEX 20 %
 GRAVEL 0 % SAND 22 % SILT & CLAY 78 %

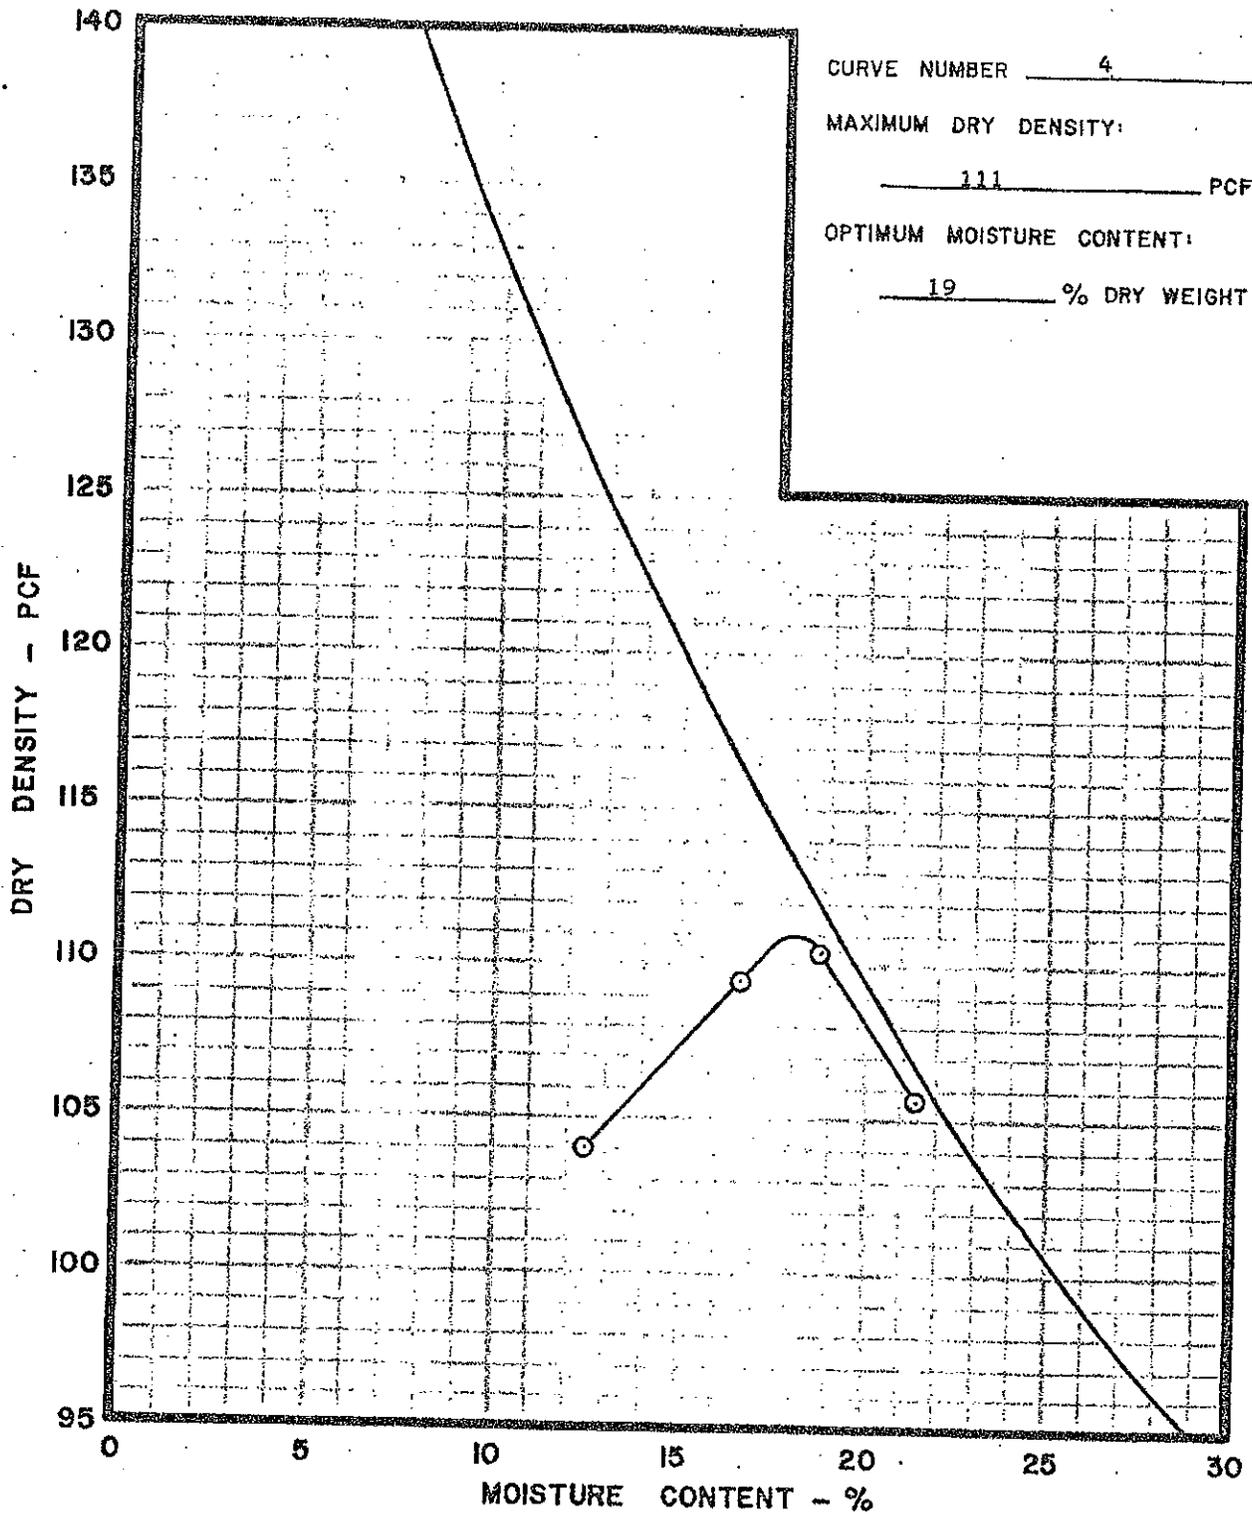
COMPACTION TEST RESULTS

SAMPLE DESCRIPTION CLAY, SANDY, VERY HIGH SULFATE CONTENT, BROWN

LOCATION ATLANTIC RIM RESERVOIR - CORE TRENCH, 4-7 FEET

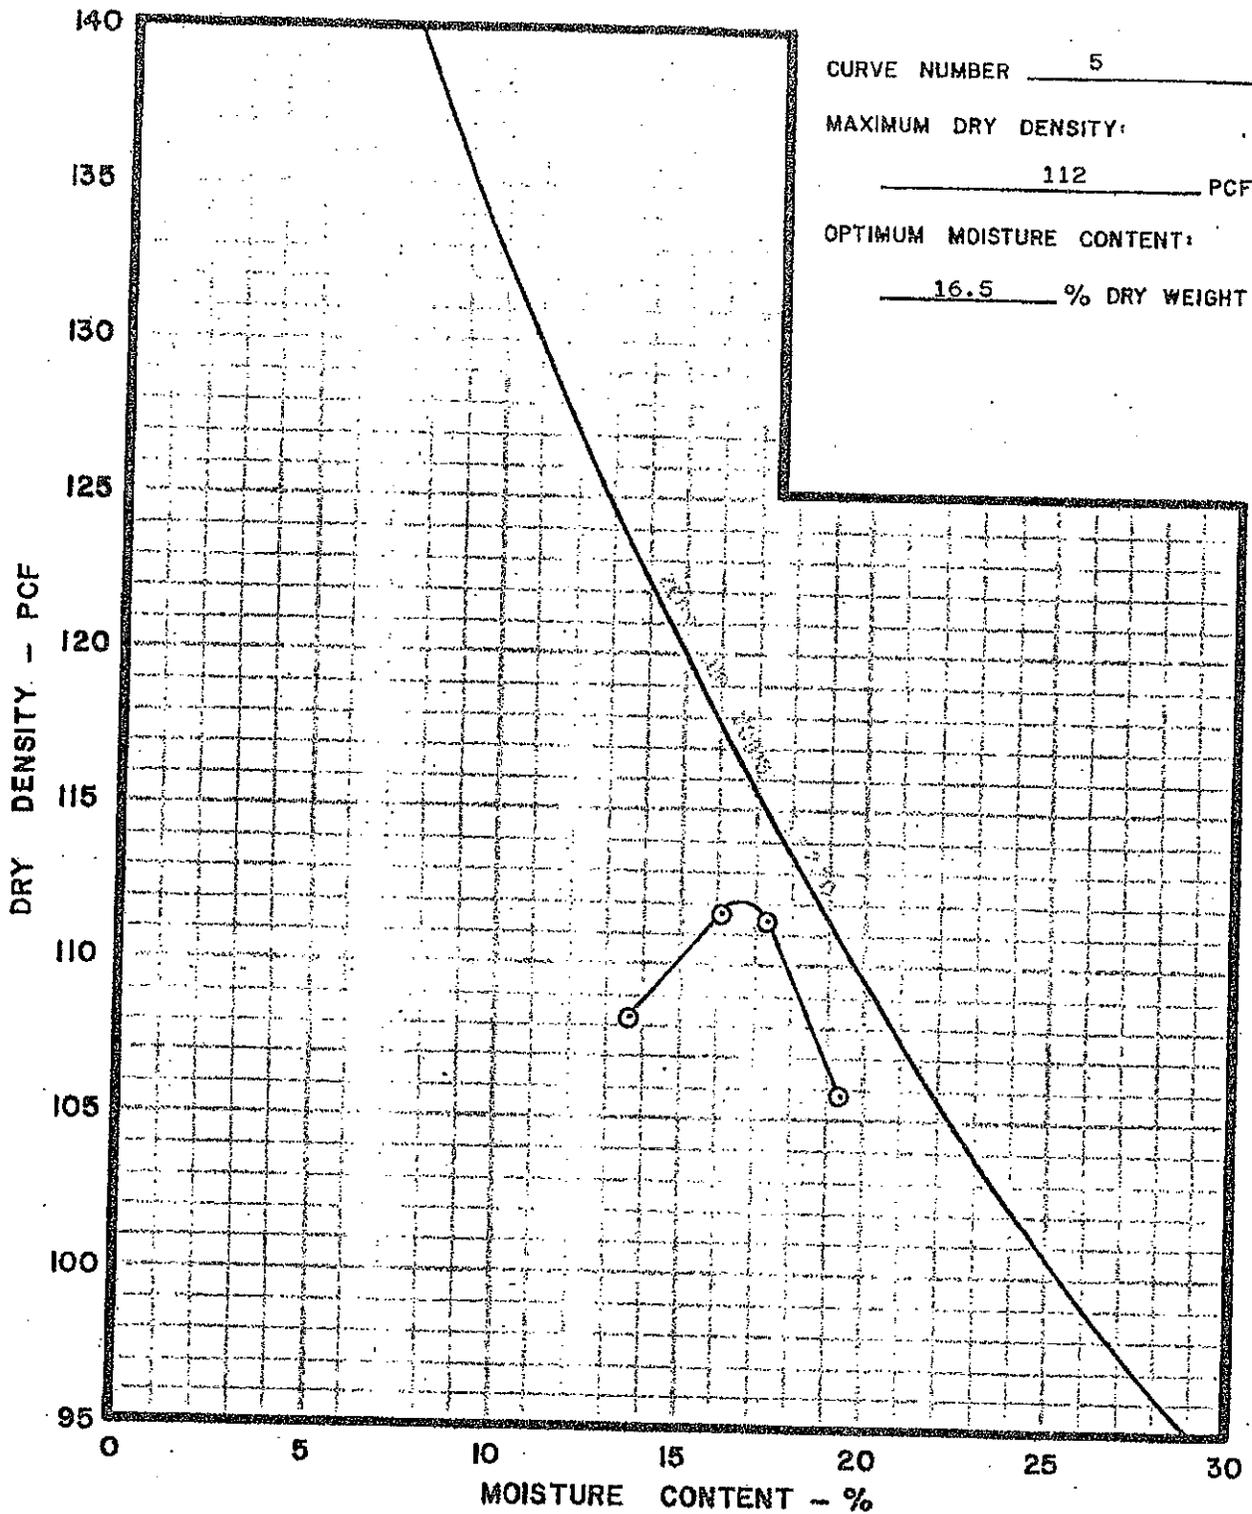
COMPACTION TEST RESULTS

SAMPLE DESCRIPTION CLAY, SANDY, SLIGHTLY GRAVELLY, RED, BROWN

GRAVEL _____ % SAND _____ % SILT & CLAY 61 %

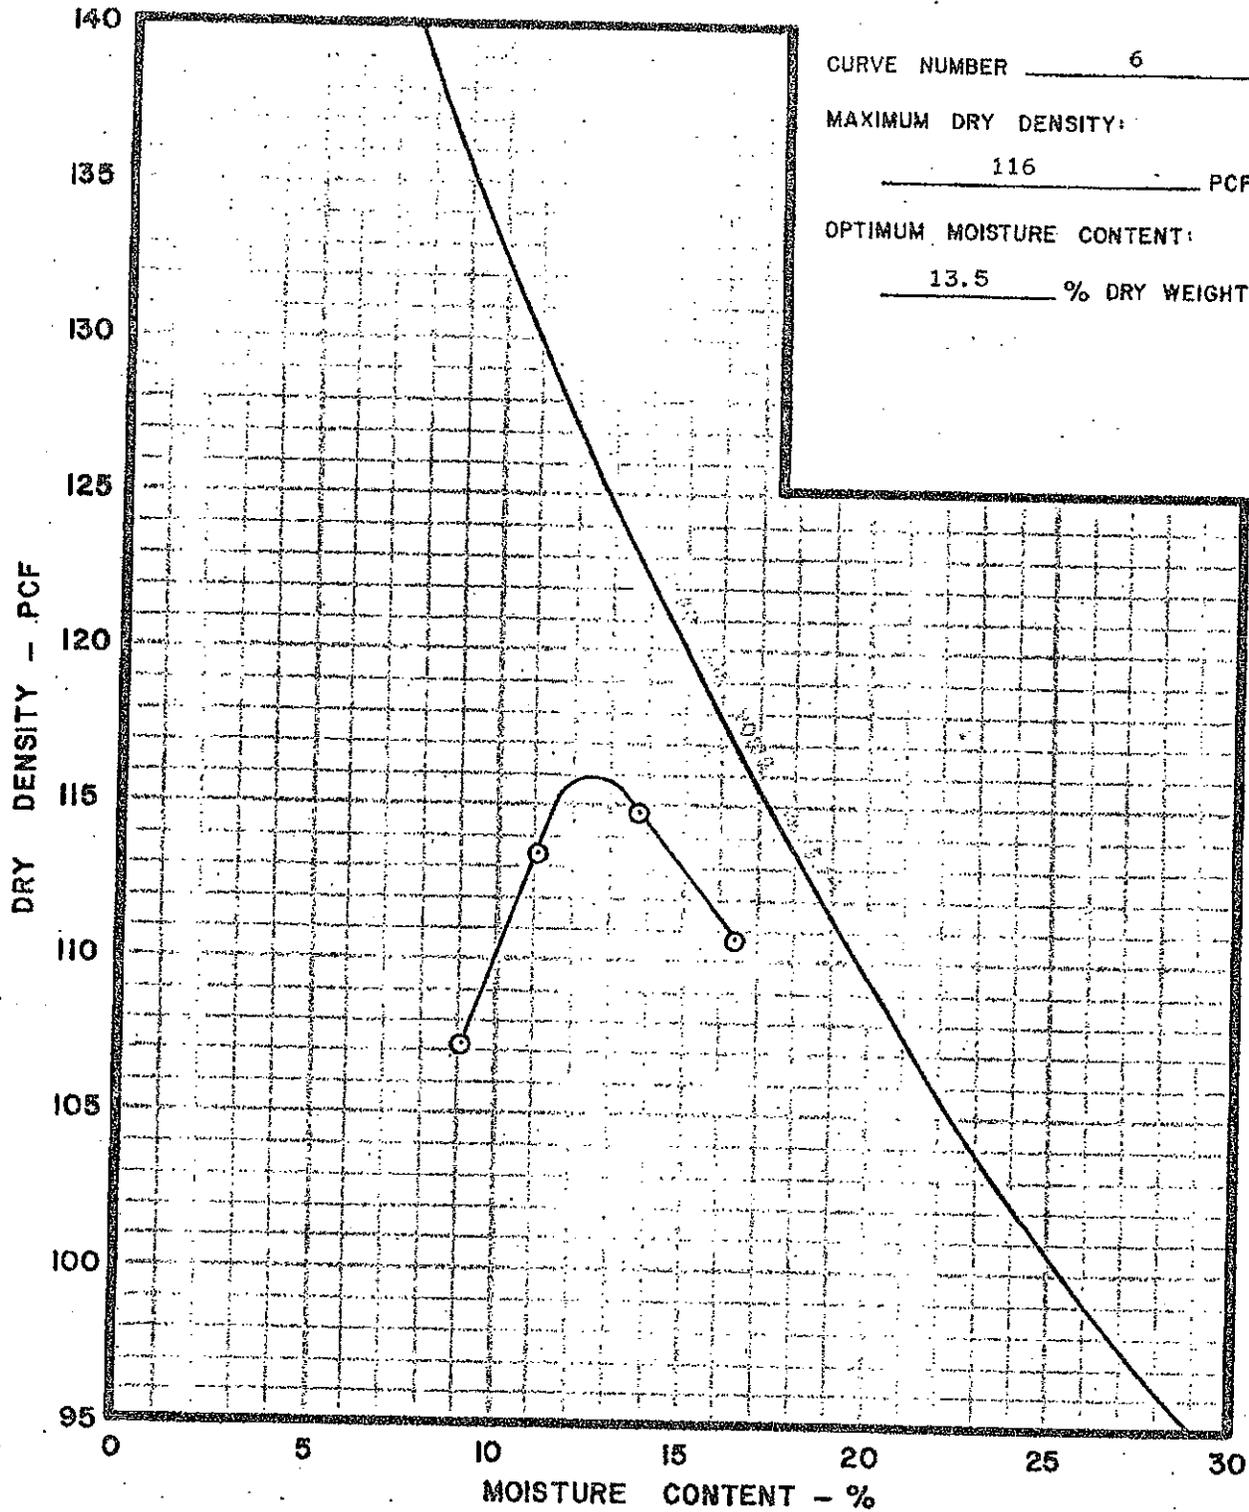
COMPACTION TEST RESULTS

SAMPLE DESCRIPTION CLAY, VERY SILTY, LIGHT BROWN, SLIGHTLY CALCAREOUS

LOCATION ATLANTIC RIM RESERVOIR, RAWLINS, WYOMING

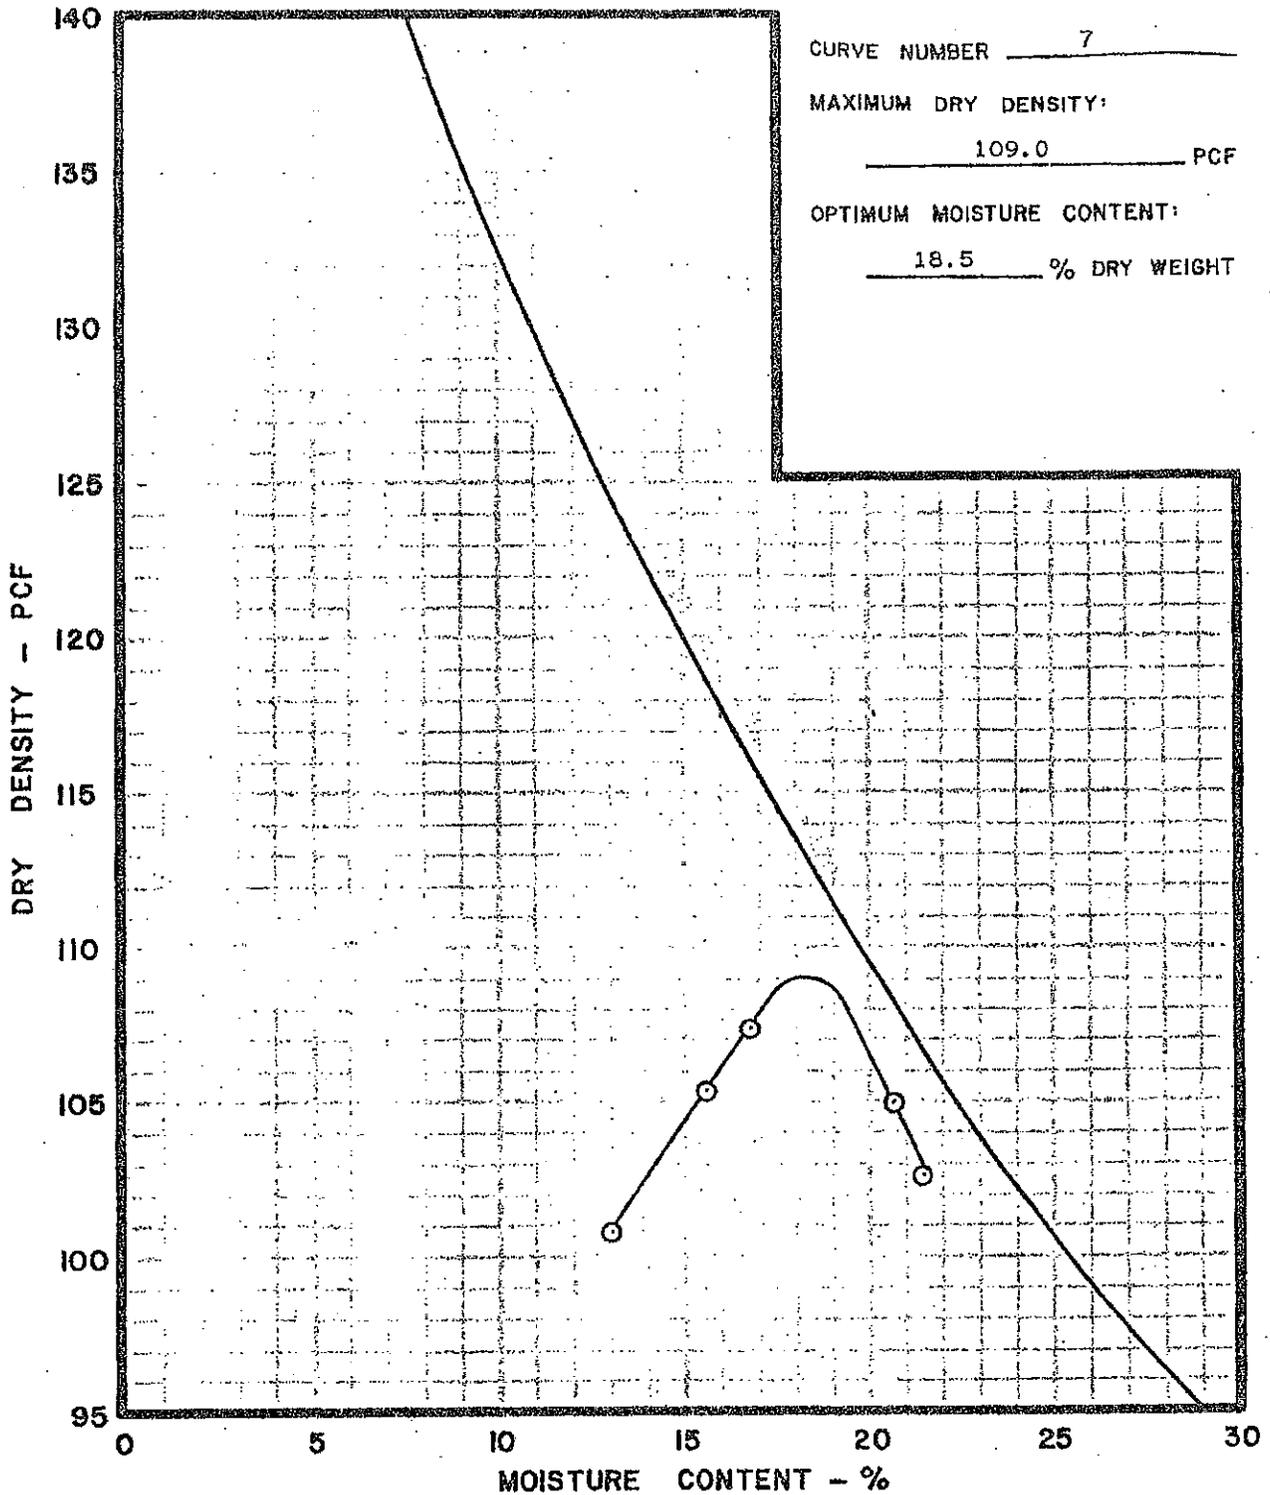
COMPACTION TEST RESULTS

SAMPLE DESCRIPTION CLAYSTONE, SILTSTONE, HIGH SULFATE, DARK, GRAY-GREEN

LOCATION ATLANTIC RIM RESERVOIR

GRAVEL _____ % SAND _____ % SILT & CLAY 95 %

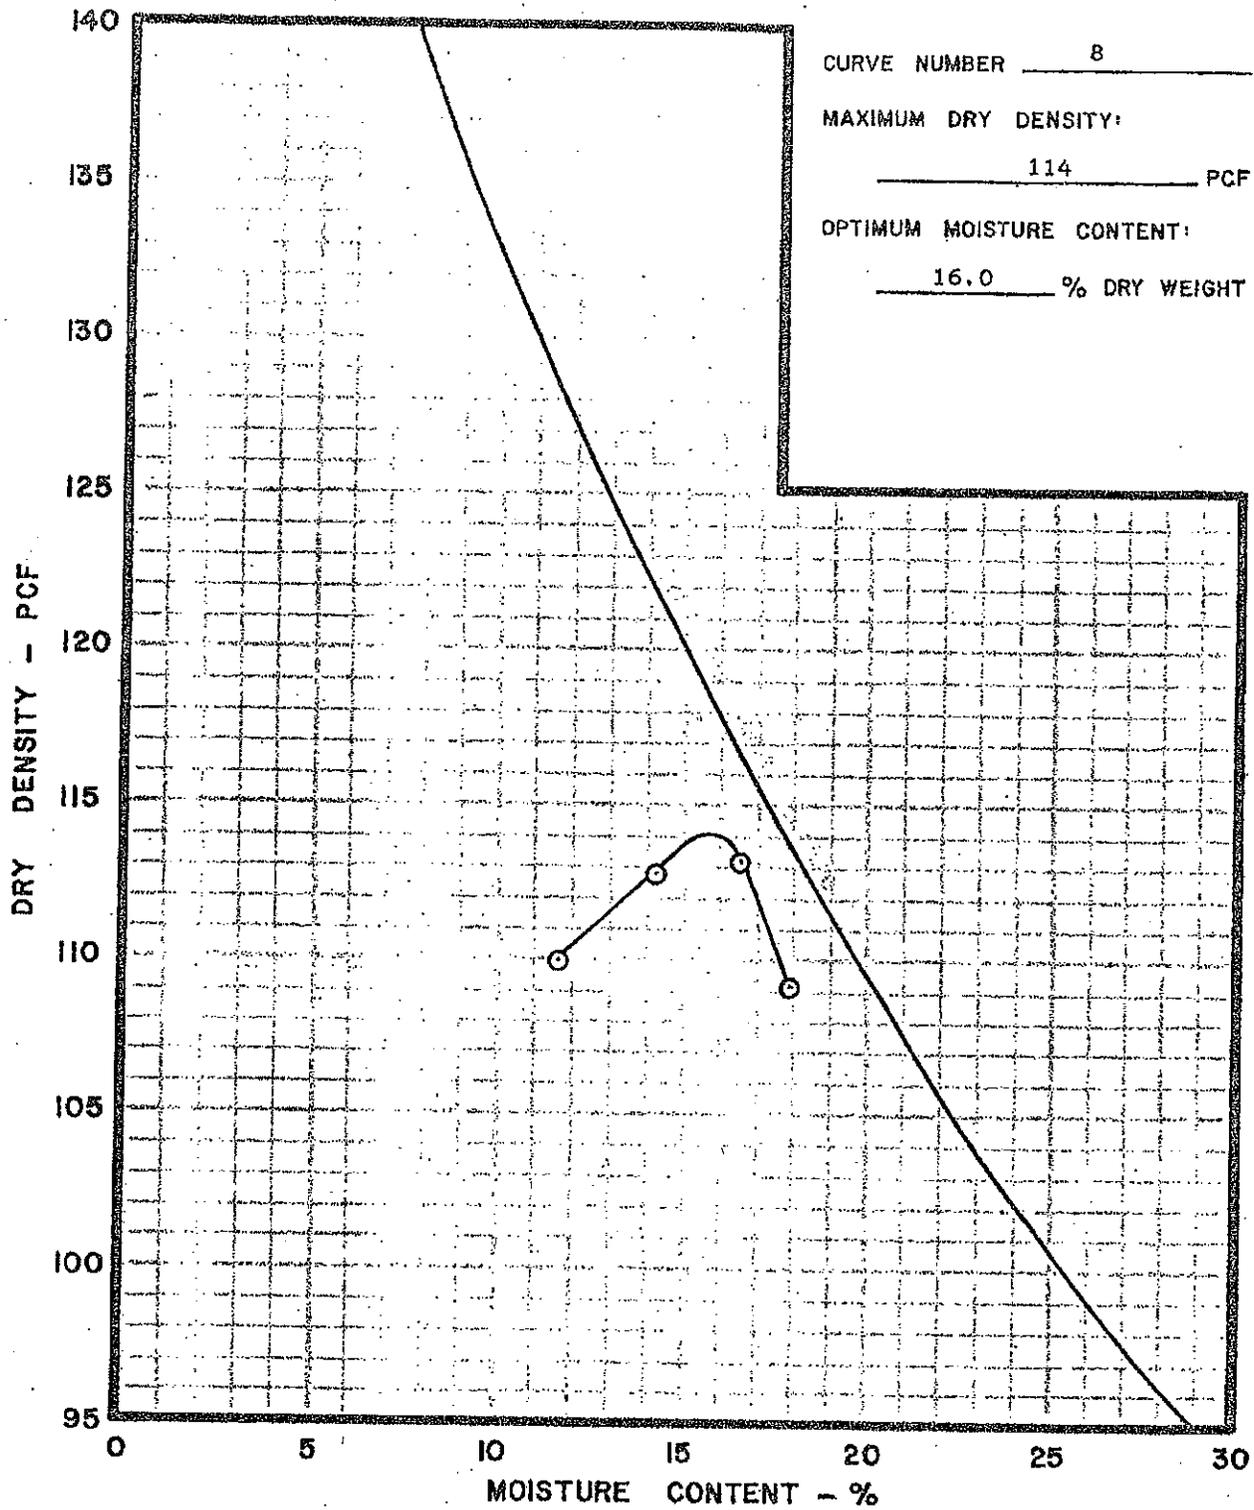
SAMPLE DESCRIPTION CLAY, SANDY, SILTY, SLIGHTLY CALCAREOUS, BROWN

LOCATION ATLANTIC RIM RESERVOIR

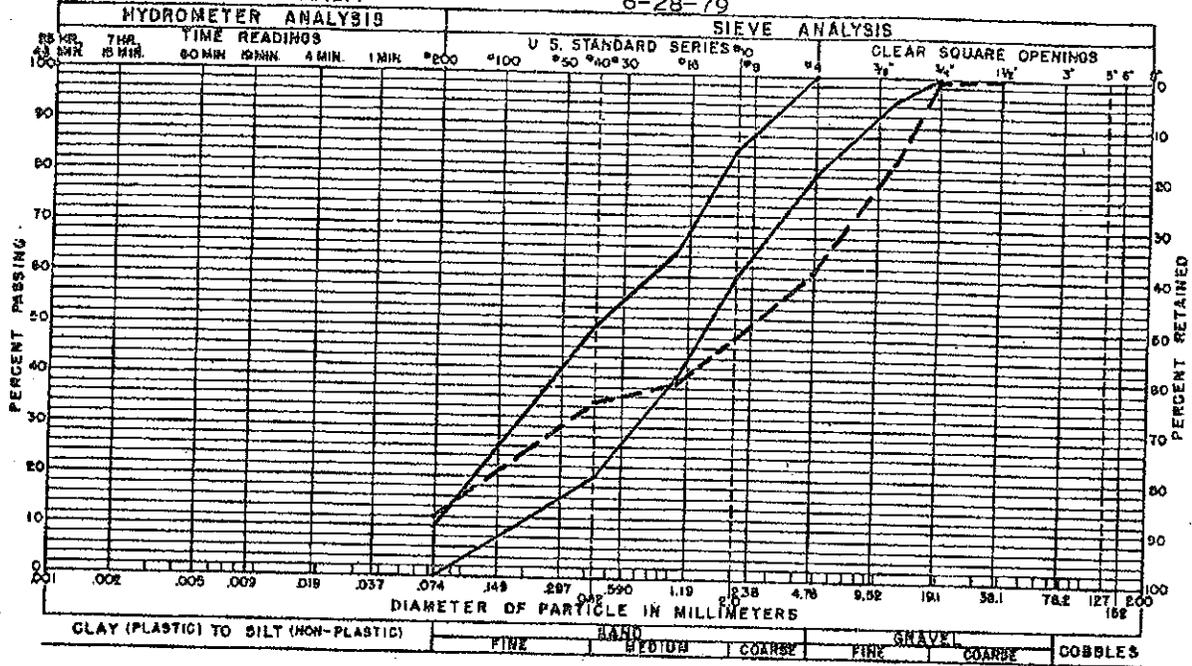
BLANKET DRAIN

GRAVEL 39 % SAND 49 % SILT AND CLAY 12 %
 LIQUID LIMIT % PLASTICITY INDEX %

SAMPLE OF SAND, GRAVELLY

FROM STATE GRAVEL PIT, NORTHWEST OF RAWLINS (REJECT MATERIAL)

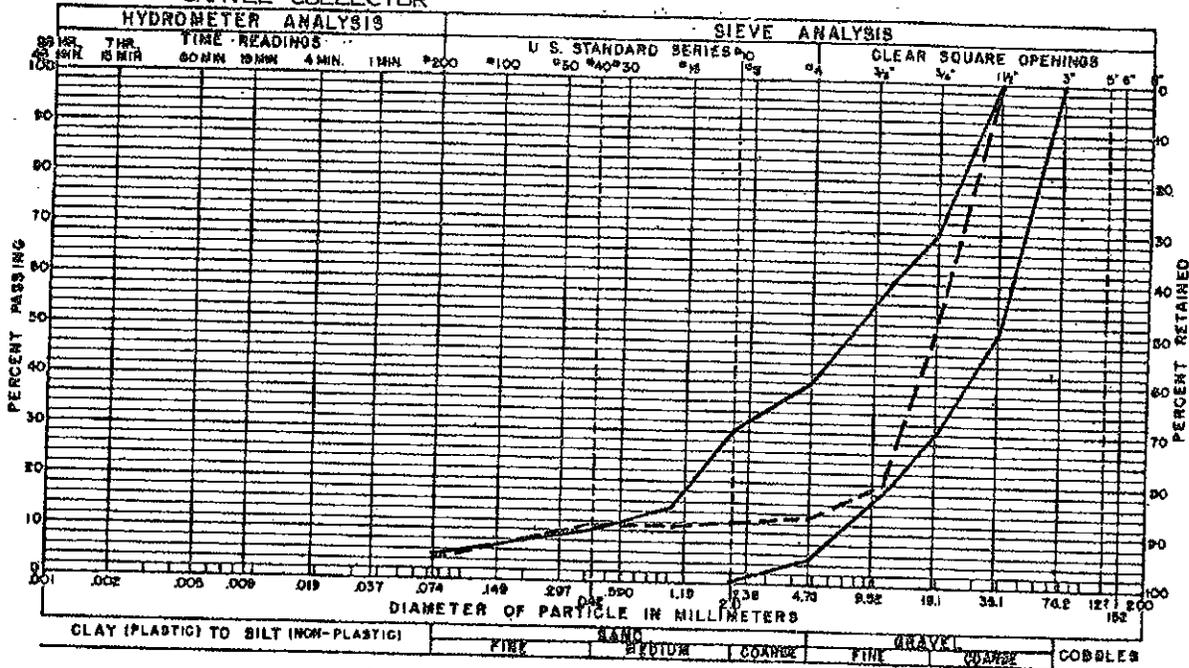
GRAVEL COLLECTOR

GRAVEL 87 % SAND 9 % SILT AND CLAY 4 %
 LIQUID LIMIT % PLASTICITY INDEX %

SAMPLE OF GRAVEL, SLIGHTLY SANDY FROM RAWLINS SAND AND GRAVEL

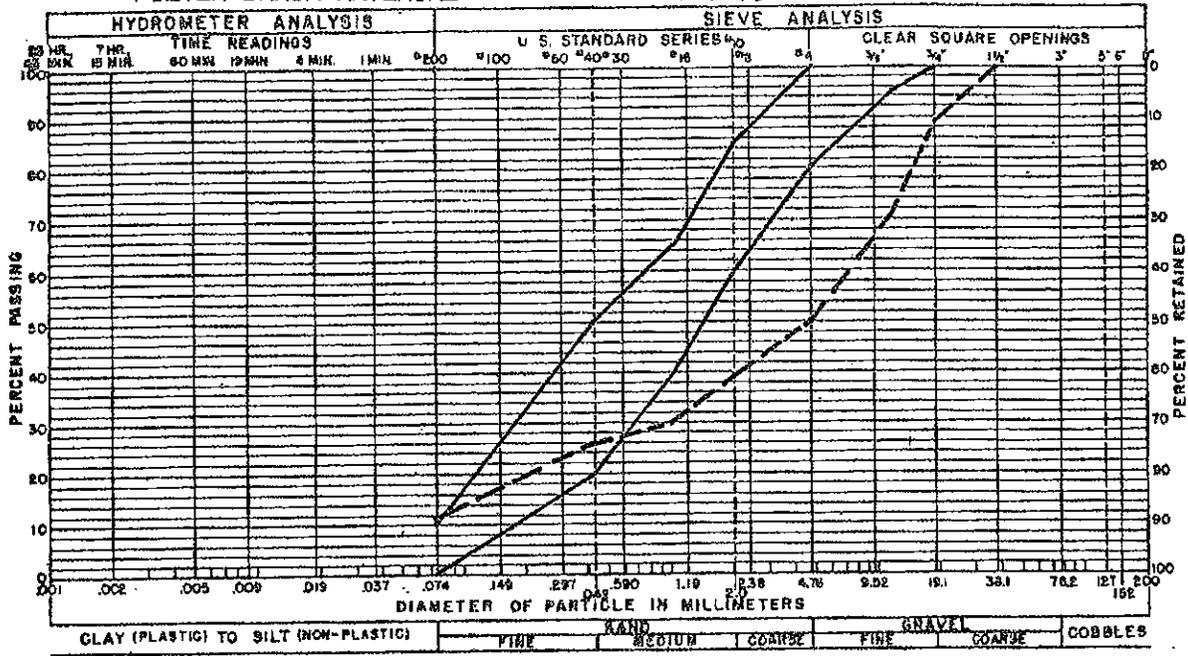
FILTER DRAIN MATERIAL

GRAVEL 50 % SAND 39 % SILT AND CLAY 11 %
 LIQUID LIMIT % PLASTICITY INDEX %
 SAMPLE OF GRAVEL, SANDY FROM RAWLINS AND AND GRAVEL

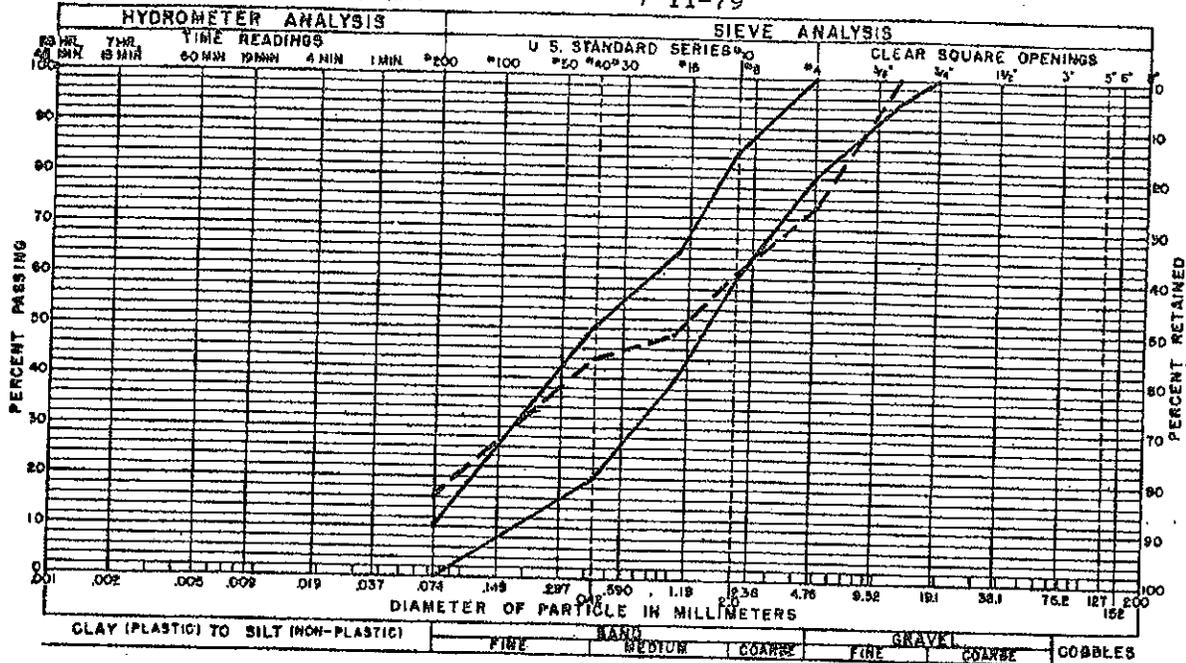
BLANKET DRAIN

GRAVEL 25 % SAND 59 % SILT AND CLAY 16 %
 LIQUID LIMIT % PLASTICITY INDEX %

SAMPLE OF SAND, GRAVELLY

FROM RAWLINS GRAVEL PIT, SOUTH WEST OF RAWLINS

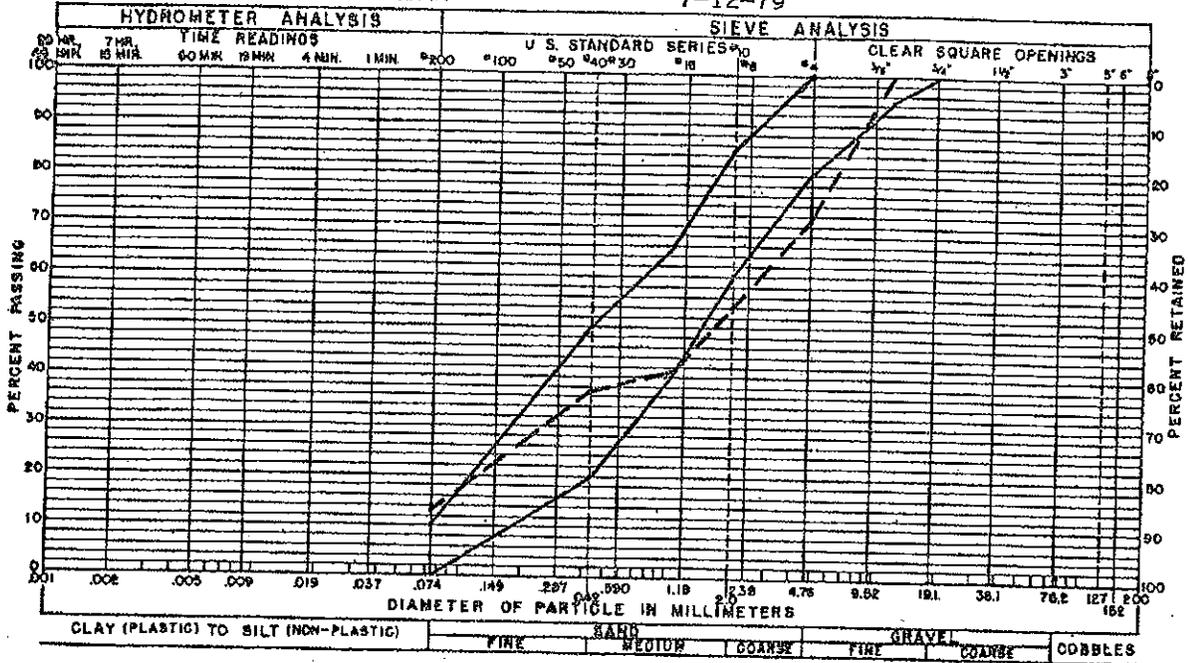
BLANKET DRAIN MATERIAL

GRAVEL 29 % SAND 58 % SILT AND CLAY 13 %
 LIQUID LIMIT % PLASTICITY INDEX %
 SAMPLE OF SAND, GRAVELLY FROM RAWLINS GRAVEL PIT, SOUTH-WEST OF RAWLINS

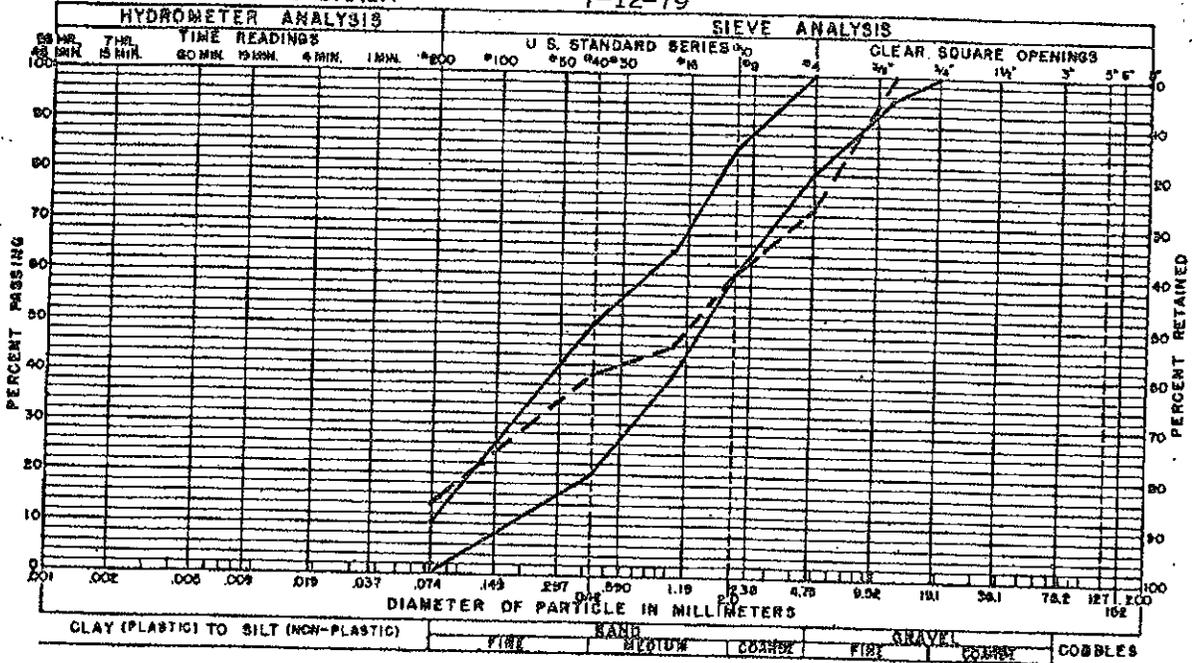
BLANKET DRAIN

GRAVEL 27 % SAND 59 % SILT AND CLAY 14 %
 LIQUID LIMIT % PLASTICITY INDEX %
 SAMPLE OF SAND, GRAVELLY FROM RAWLINS GRAVEL PIT, SOUTH-WEST OF RAWLINS

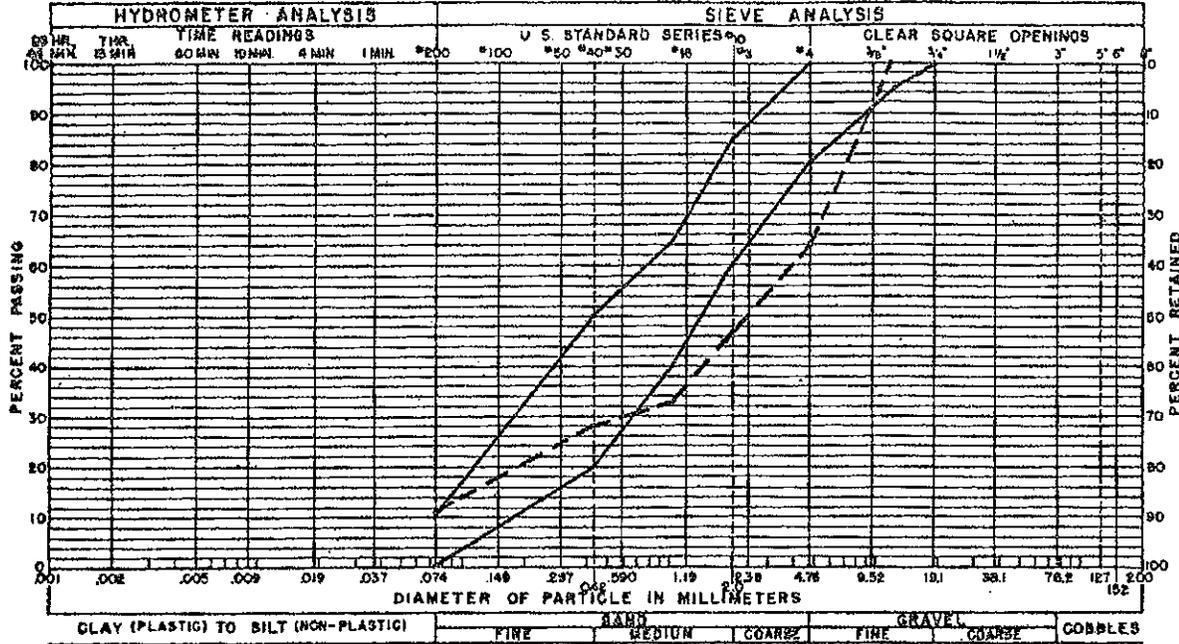
BLANKET DRAIN

GRAVEL 35 % SAND 54 % SILT AND CLAY 11 %
 LIQUID LIMIT % PLASTICITY INDEX %

SAMPLE OF SAND, GRAVELLY FROM RAWLINS GRAVEL PIT, SOUTH-WEST OF RAWLINS
