Submitted by
RJH Consultants, Inc.
9800 Mt. Pyramid Court, Suite 330
Englewood, Colorado 80112
303-225-4611
www.rjh-consultants.com

April 2010
Project 09121

ATLANTIC RIM
RESERVOIR

SITE VICINITY MAP

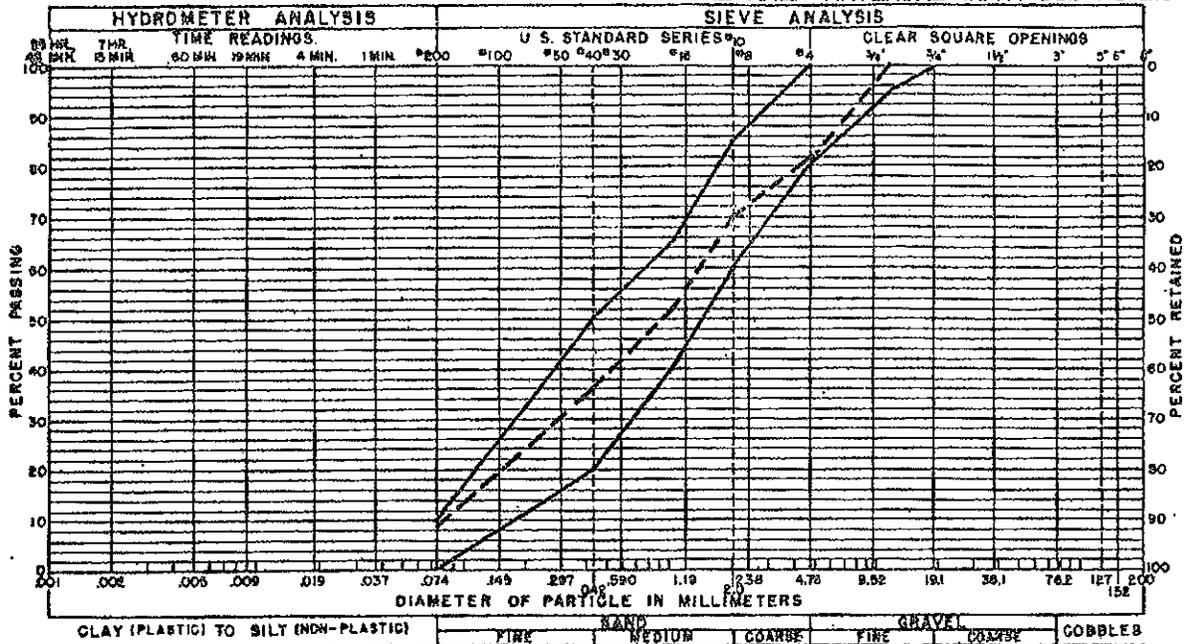
BLANKET DRAIN 7-25-79 (CLEAN SAND) ONE-HALF MATERIAL WITH 11% FINES
 ONE-HALF RAWLINS SAND AND GRAVEL

GRAVEL 19.4 % SAND 72 % SILT AND CLAY 8.6 %

SAMPLE OF SAND, SLIGHTLY GRAVELLY FROM 1/2 RAWLINS GRAVEL PIT; 1/2 CLEAN SAND FROM RAWLINS SAND AND GRAVEL

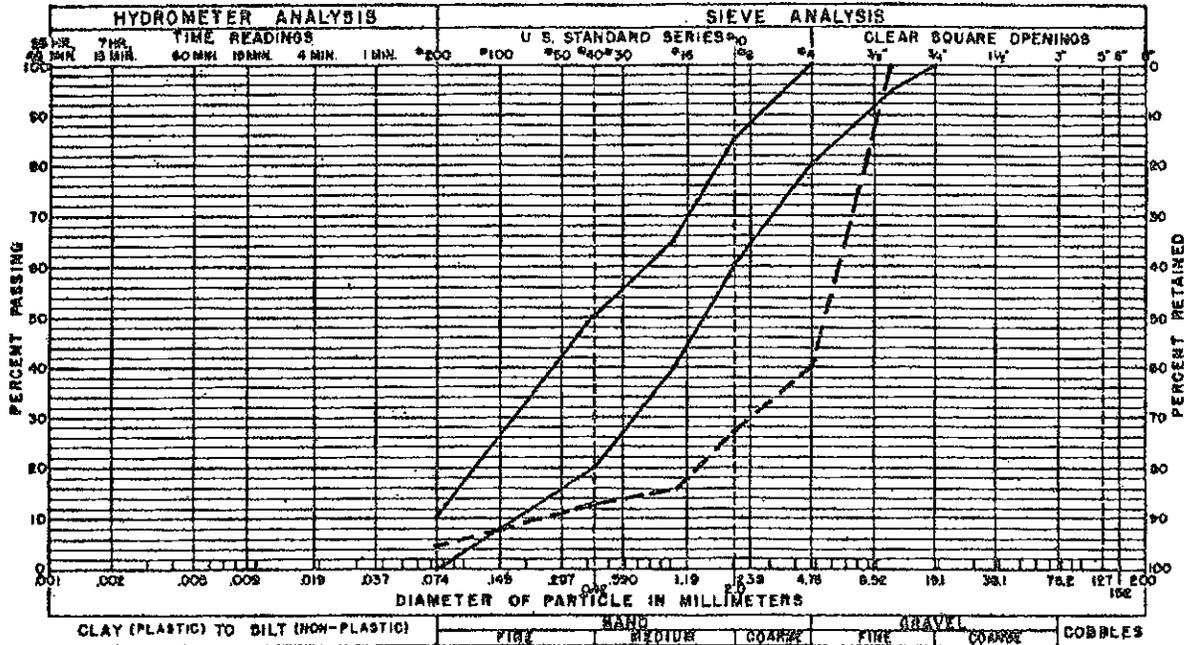
BLANKET DRAIN 7-25-79 CHIPS ADDED

GRAVEL 59.6 % SAND 35.9 % SILT AND CLAY 4.5 %

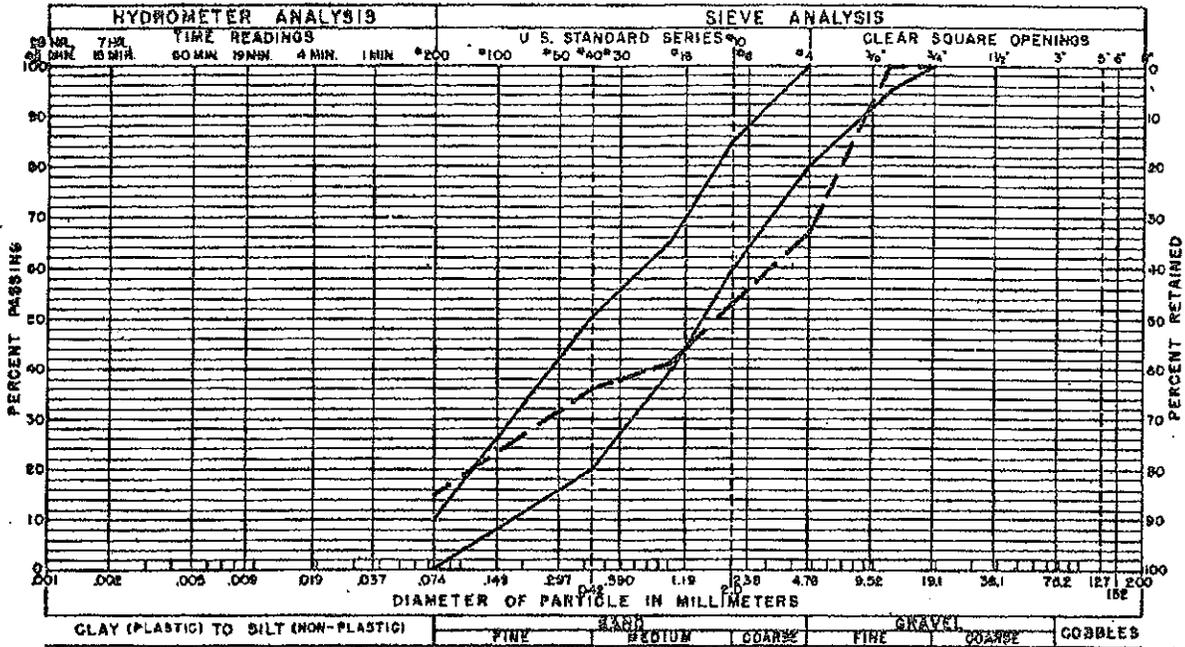
CHIPS AND MORE FINES (REJECTED)

GRAVEL 32.9 % SAND 52.3 % SILT AND CLAY 14.8 %

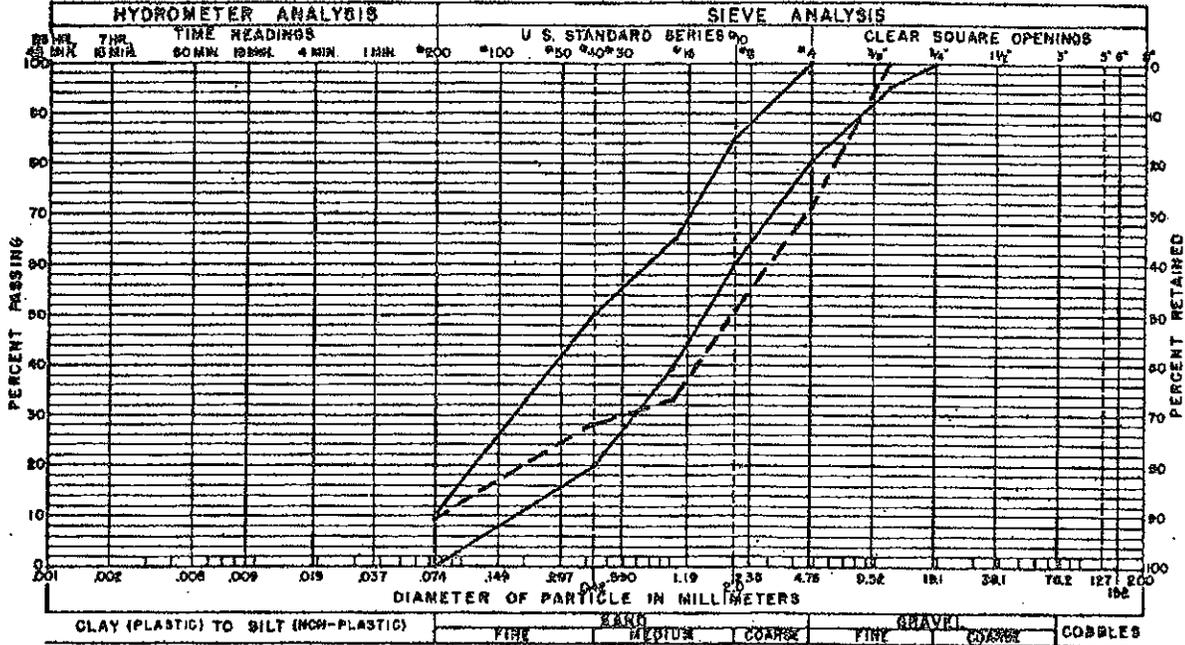
ACCEPTED FOR TOP FOOT OF BLANKET DRAIN

GRAVEL 28.9 % SAND 61.6 % SILT AND CLAY 9.5 %

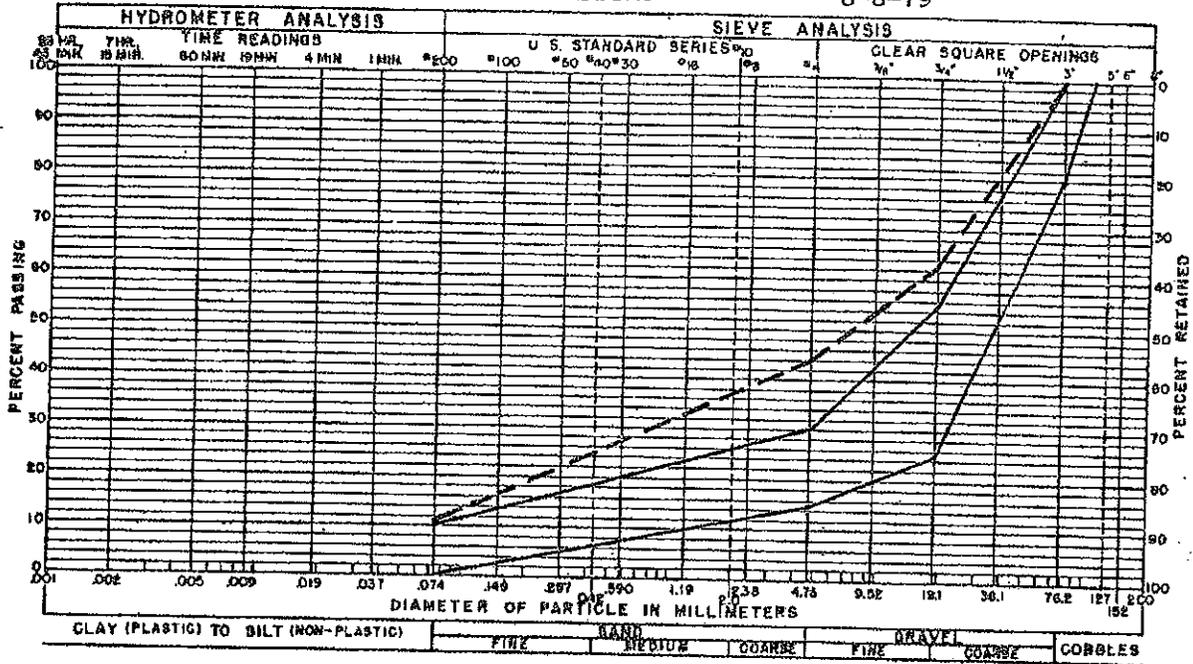
RIPRAP BEDDING

GRAVEL 56 % SAND 32.9% SILT AND CLAY 11.1 %
 LIQUID LIMIT % PLASTICITY INDEX %

SAMPLE OF GRAVEL, SANDY FROM RAWLINS GRAVEL PIT
 SOUTHWEST OF RAWLINS

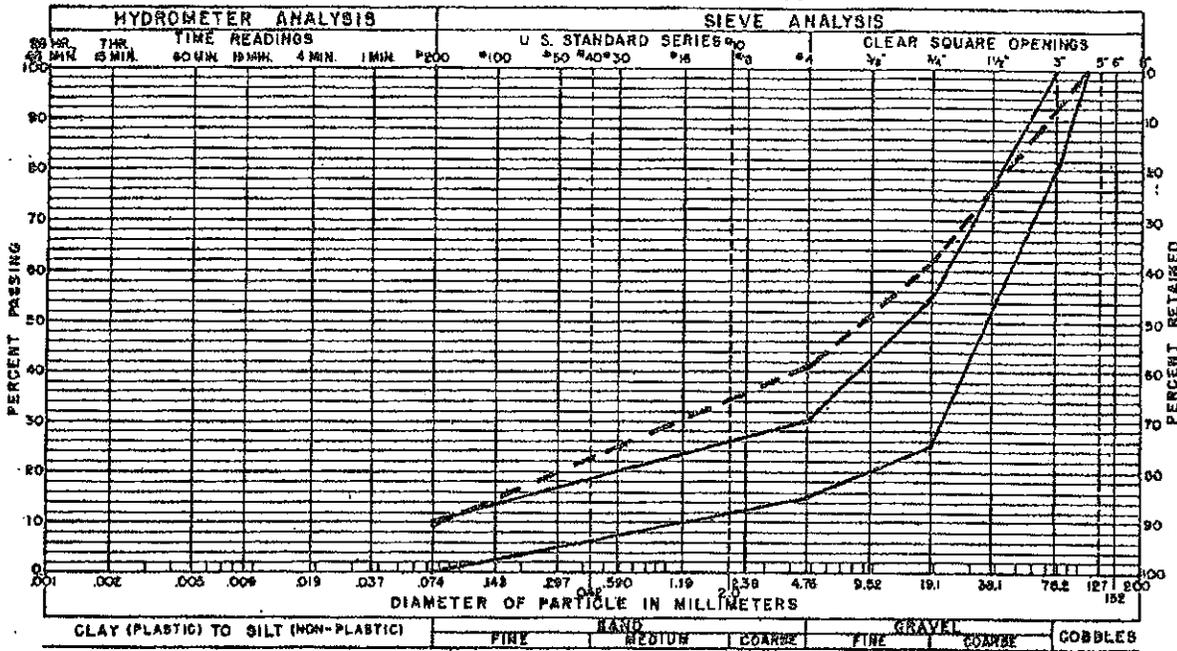
RIPRAP BEDDING

GRAVEL 59 % SAND 31.4 % SILT AND CLAY 9.6 %

SAMPLE OF GRAVEL, SANDY

FROM RAWLINS GRAVEL PIT SOUTHWEST OF RAWLINS

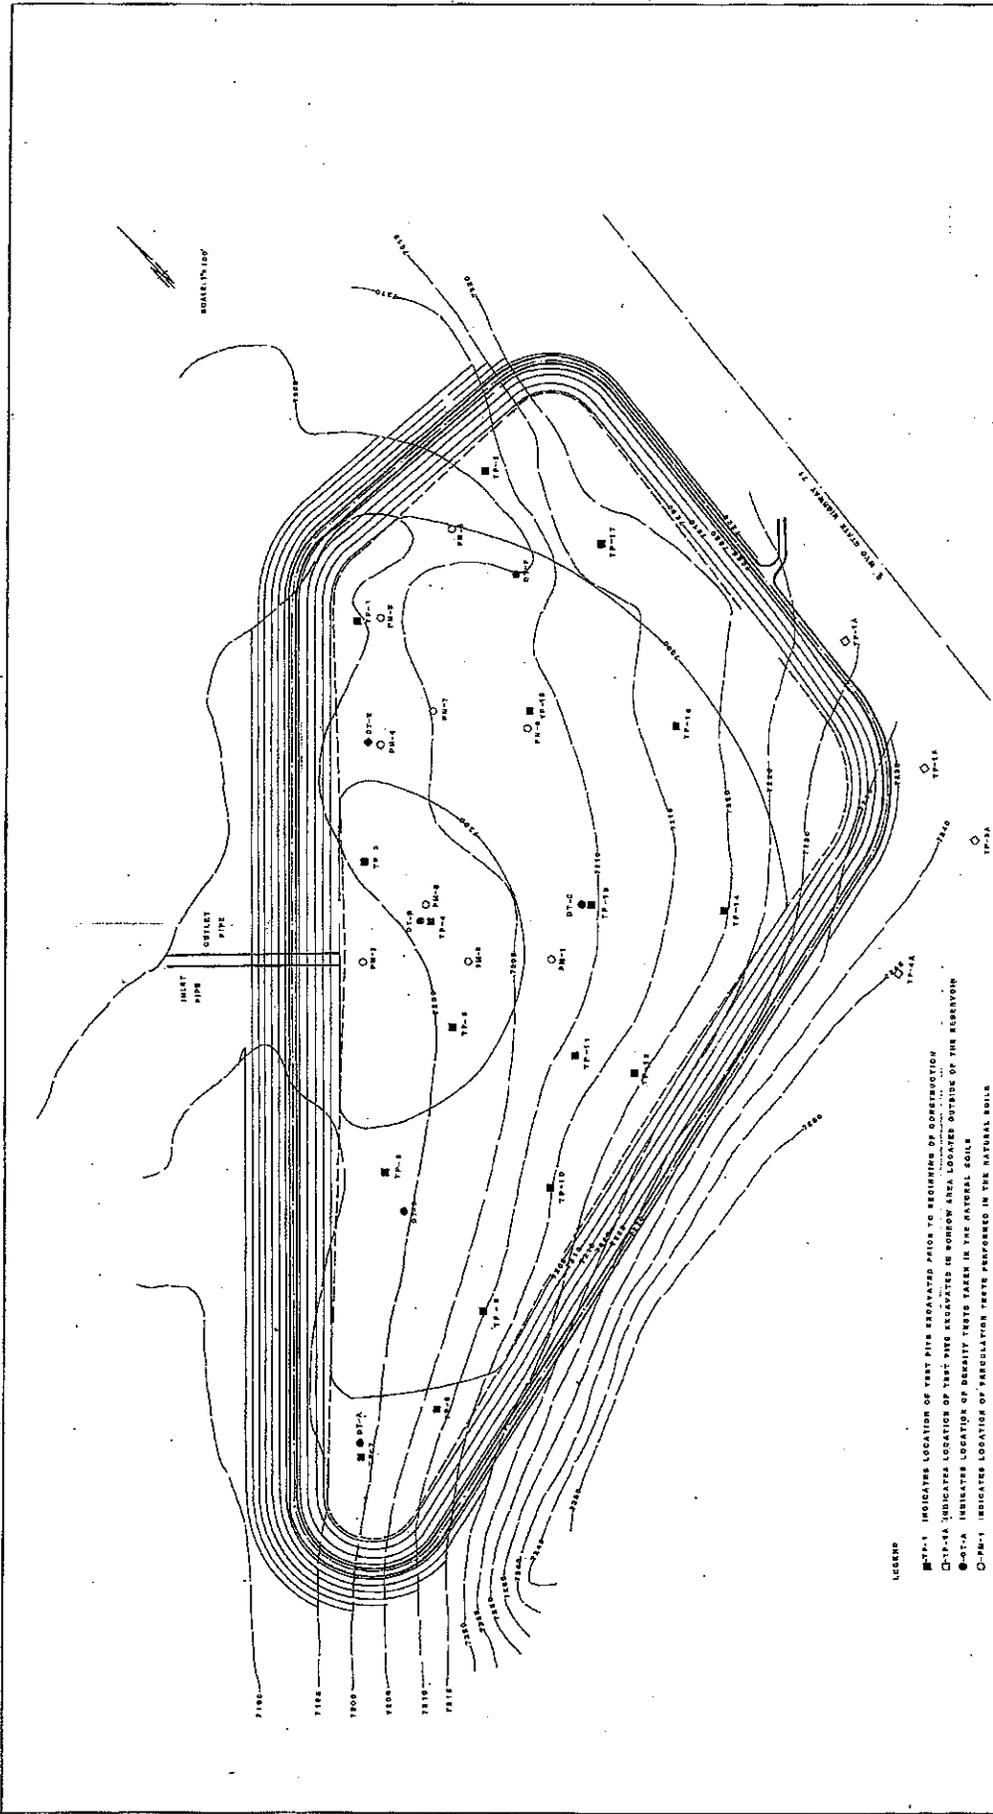
- TP-1 INDICATES LOCATION OF TEST PIT EXAMINED PRIOR TO BEGINNING OF CONSTRUCTION
- TP-101 INDICATES LOCATION OF TEST PIT EXAMINED IN BOMBED AREA LOCATED OUTSIDE OF THE RESERVOIR
- TP-102 INDICATES LOCATION OF DENSITY TESTS TAKEN IN THE NATURAL SOIL
- TP-103 INDICATES LOCATION OF PERCUSSION TESTS PERFORMED IN THE NATURAL SOIL

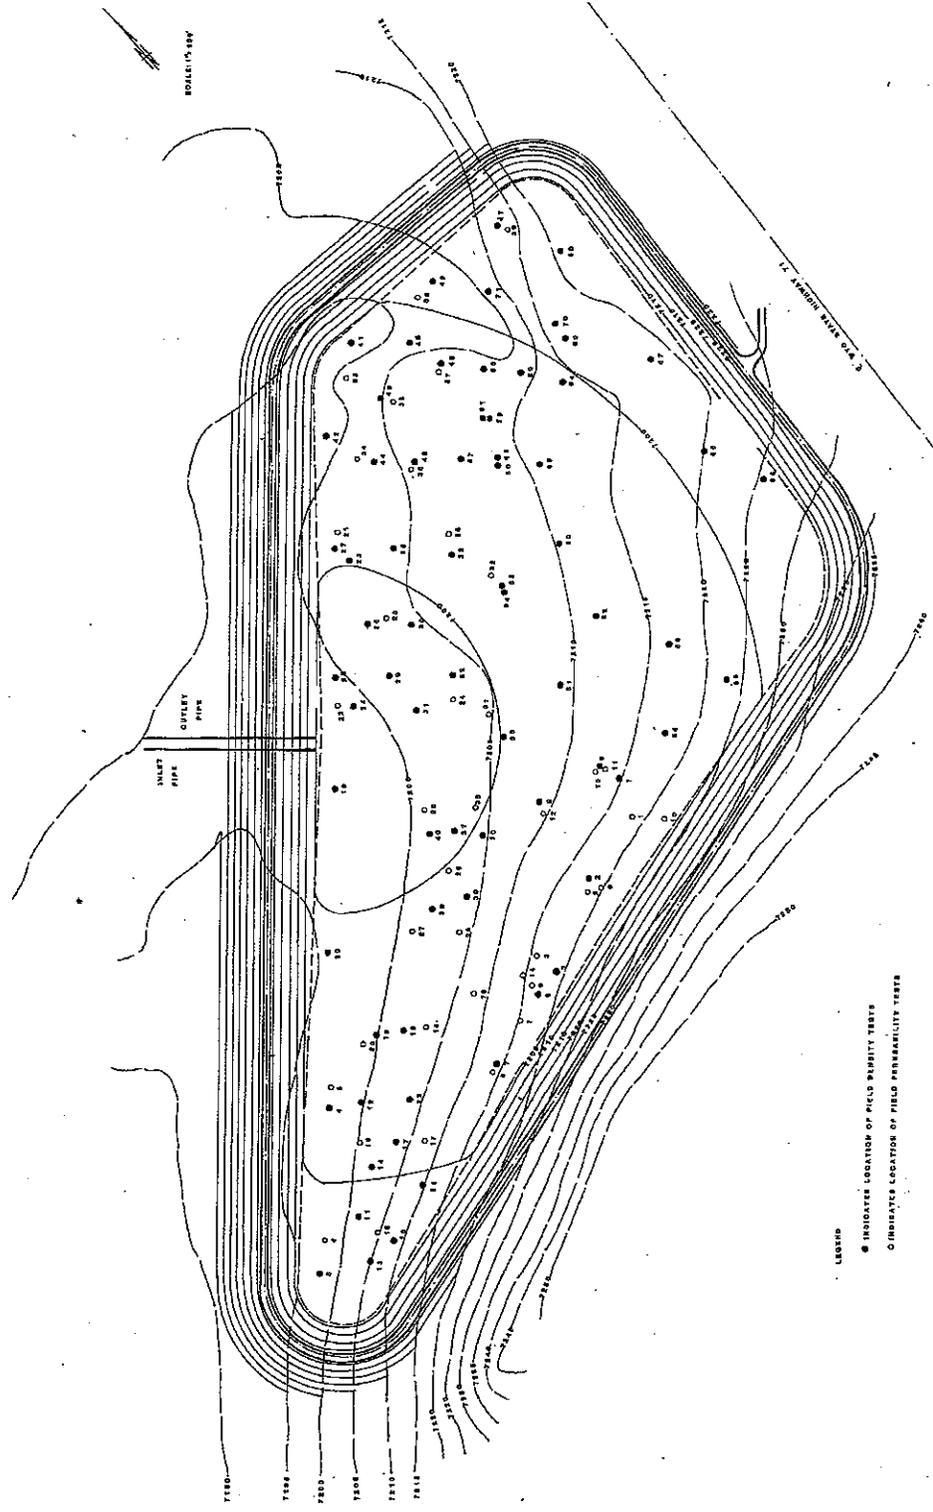
LEGEND
 ● INDICATES LOCATION OF FIELD DENSITY TESTS
 ○ INDICATES LOCATION OF FIELD PERMEABILITY TESTS

ATLANTIC RIM RESERVOIR
 RAWLINS, WYOMING

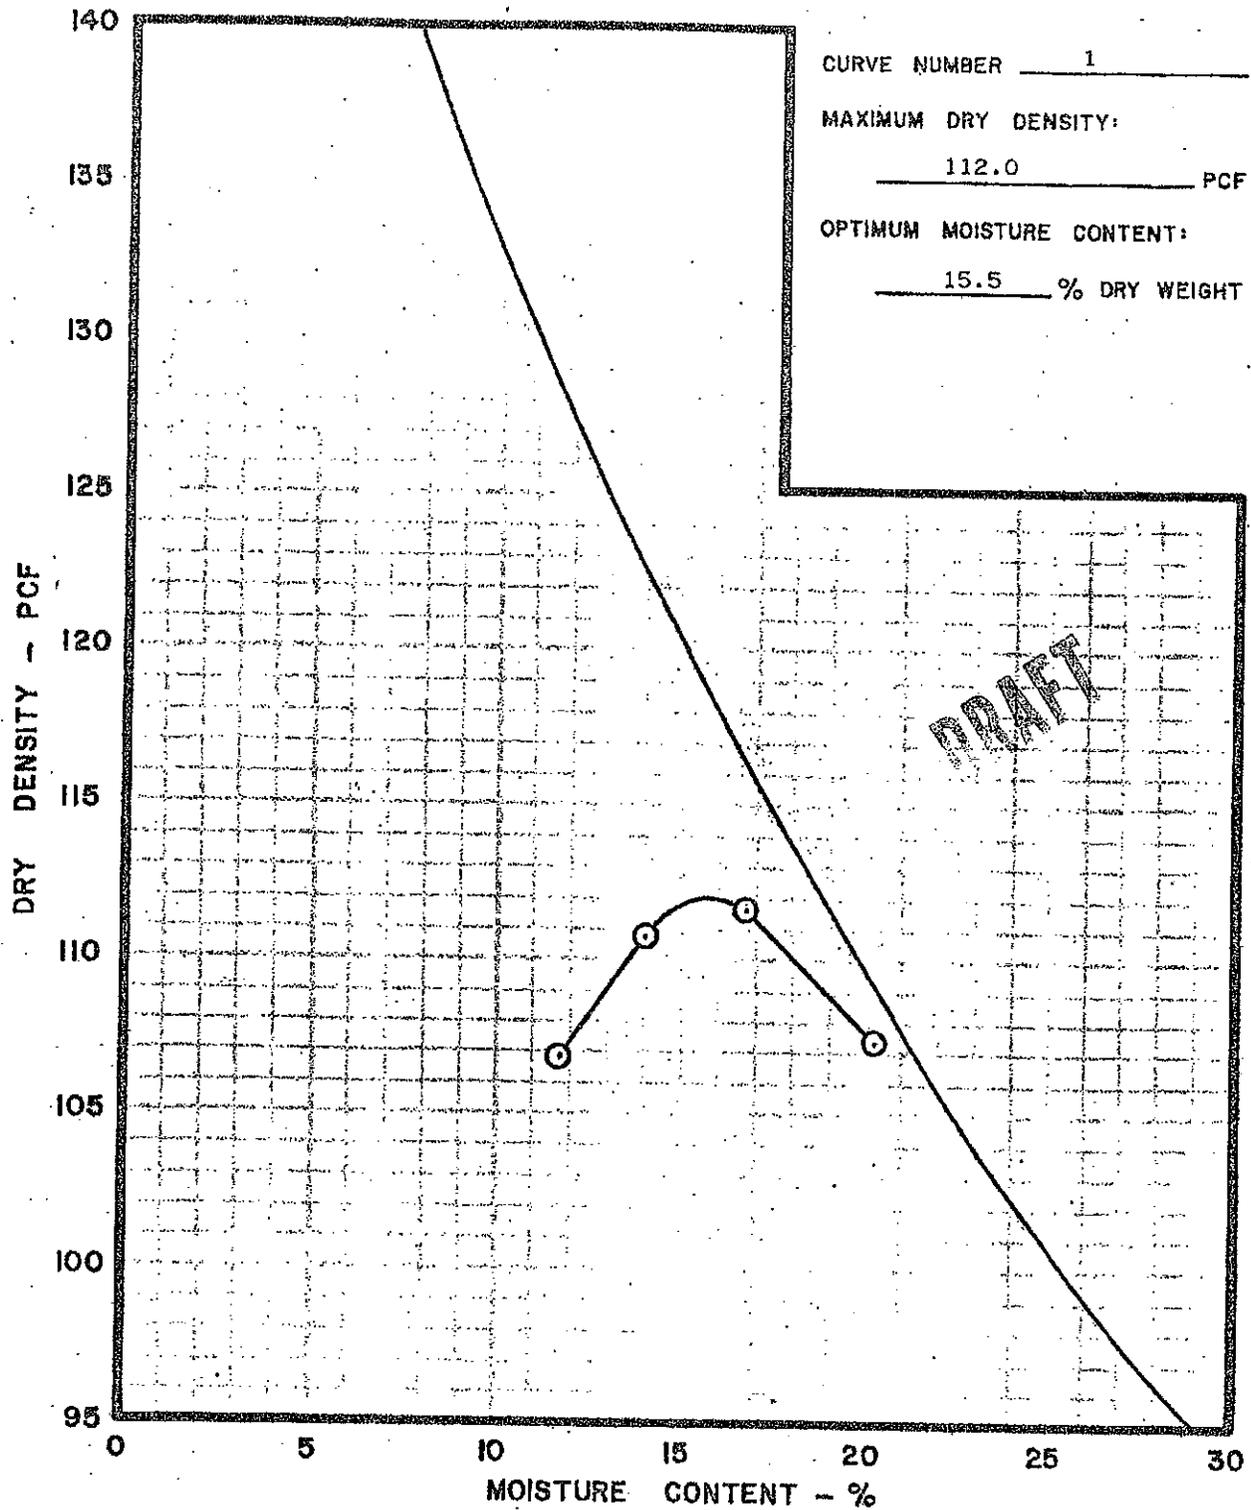
COMPACTION TEST RESULTS

SAMPLE DESCRIPTION CLAY, SANDY, SILTY, BROWN

LOCATION TEST PIT NO. 8

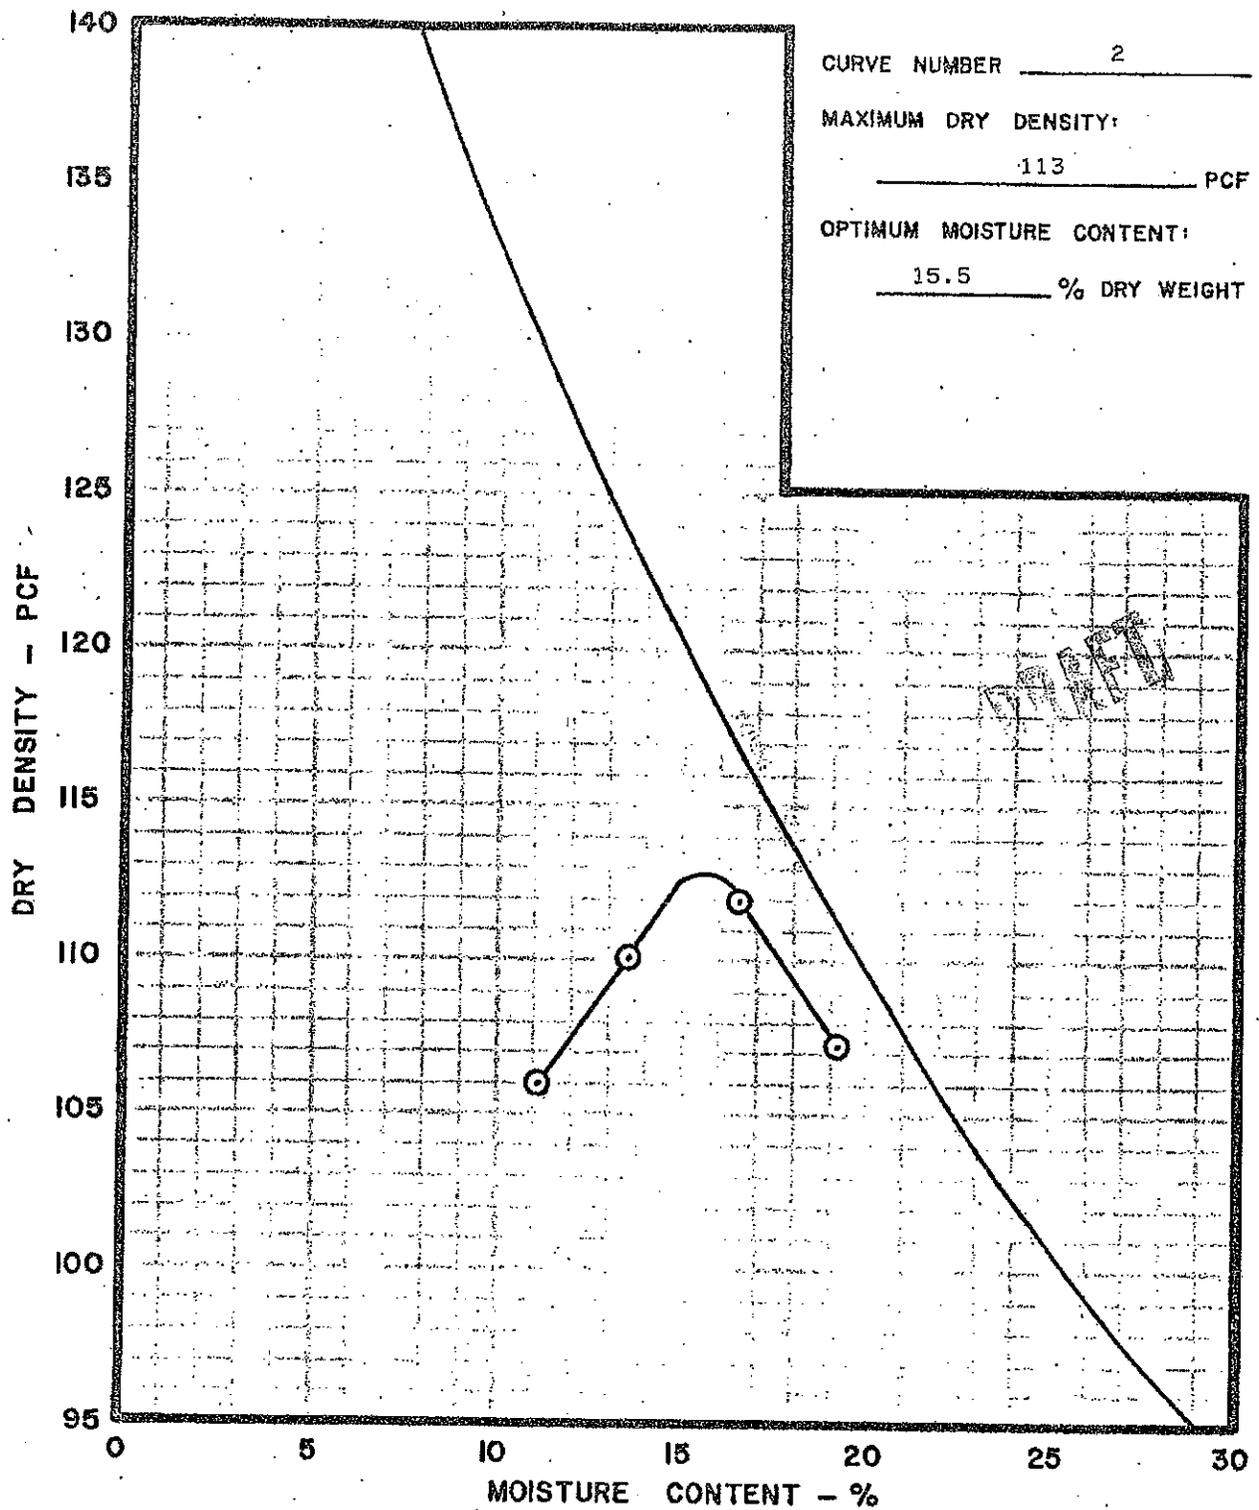
COMPACTION TEST RESULTS

SAMPLE DESCRIPTION CLAY, VERY SILTY, VERY SANDY, BROWN, LIGHT BROWN

LOCATION STOCKPILE FROM FIRST CUT TO BEGIN PLACEMENT OF RESERVOIR LINING

GRAVEL % SAND 41 % SILT & CLAY 59 %

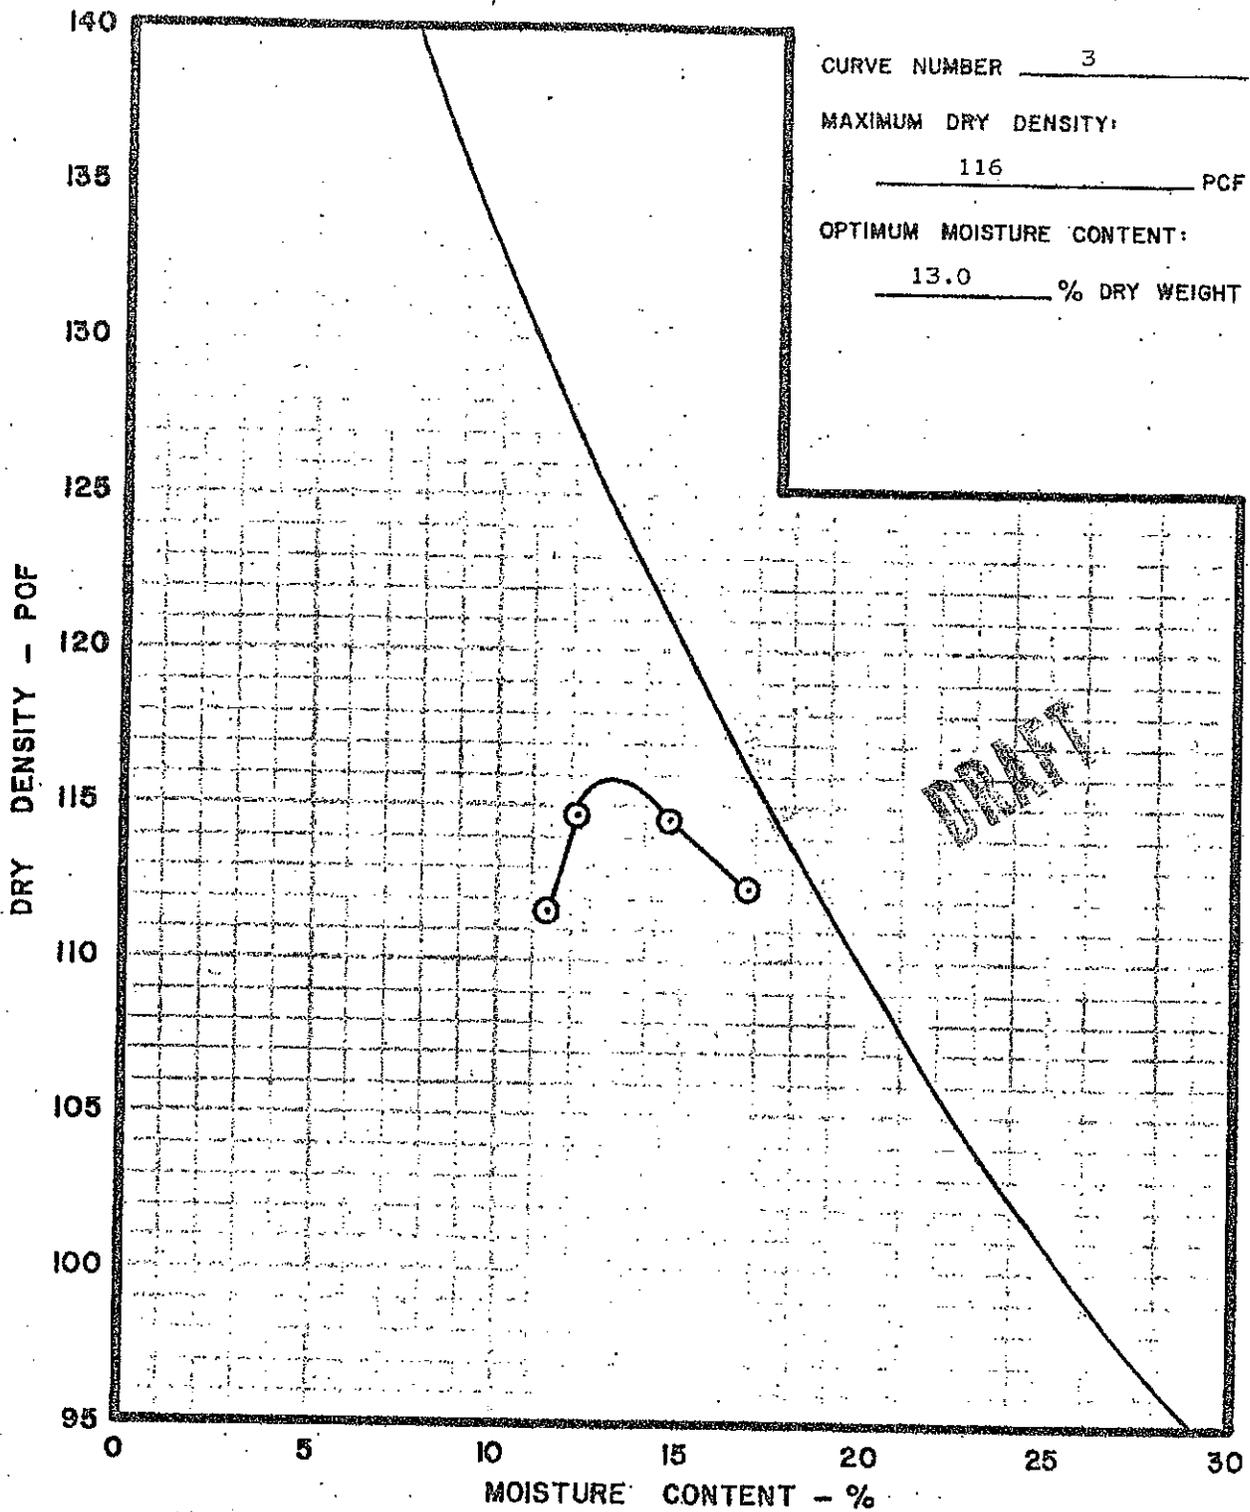
COMPACTION TEST RESULTS

SAMPLE DESCRIPTION CLAY, SILTY, SANDY, BROWN

LOCATION STOCKPILE FROM FIRST CUT

GRAVEL 0 % SAND 36 % SILT & CLAY 64 %

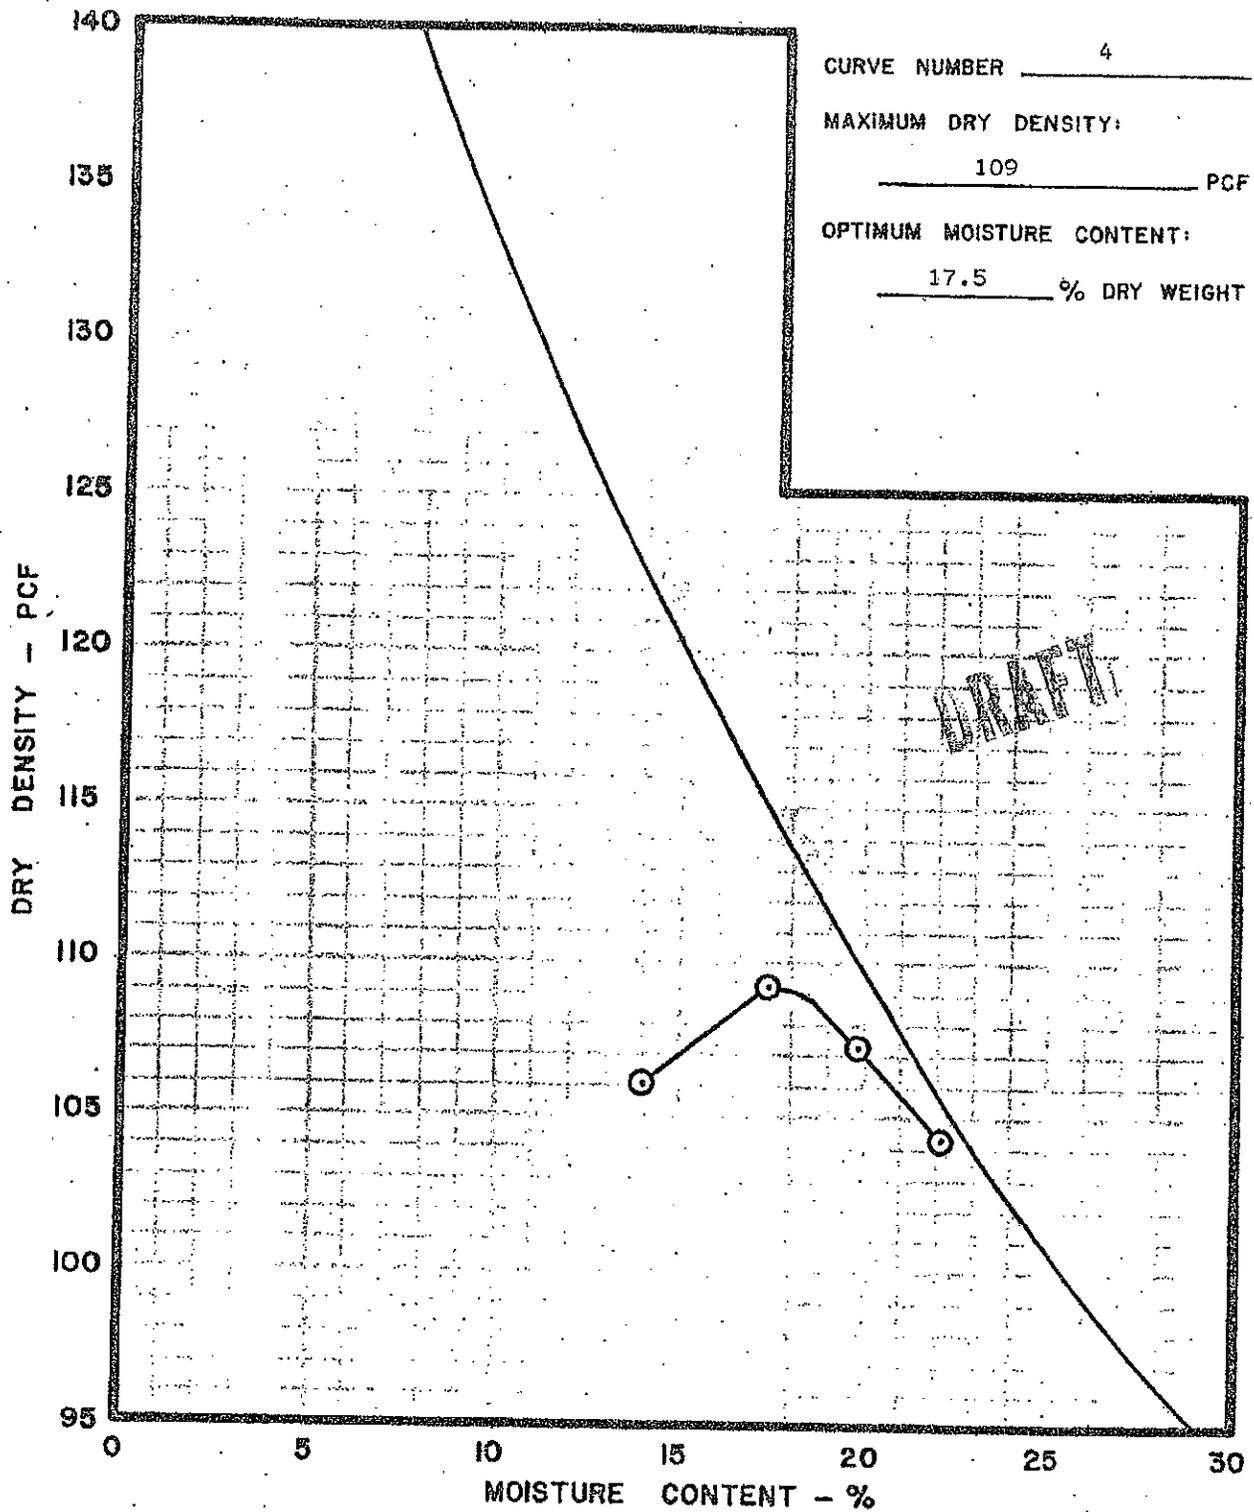
COMPACTION TEST RESULTS

SAMPLE DESCRIPTION CLAY, SLIGHTLY SILTY, SLIGHTLY SANDY, SULFATES, BROWN

LOCATION WEST HALF OF PONDING AREA FOR ATLANTIC RIM RESERVOIR

SILT & CLAY 89 %

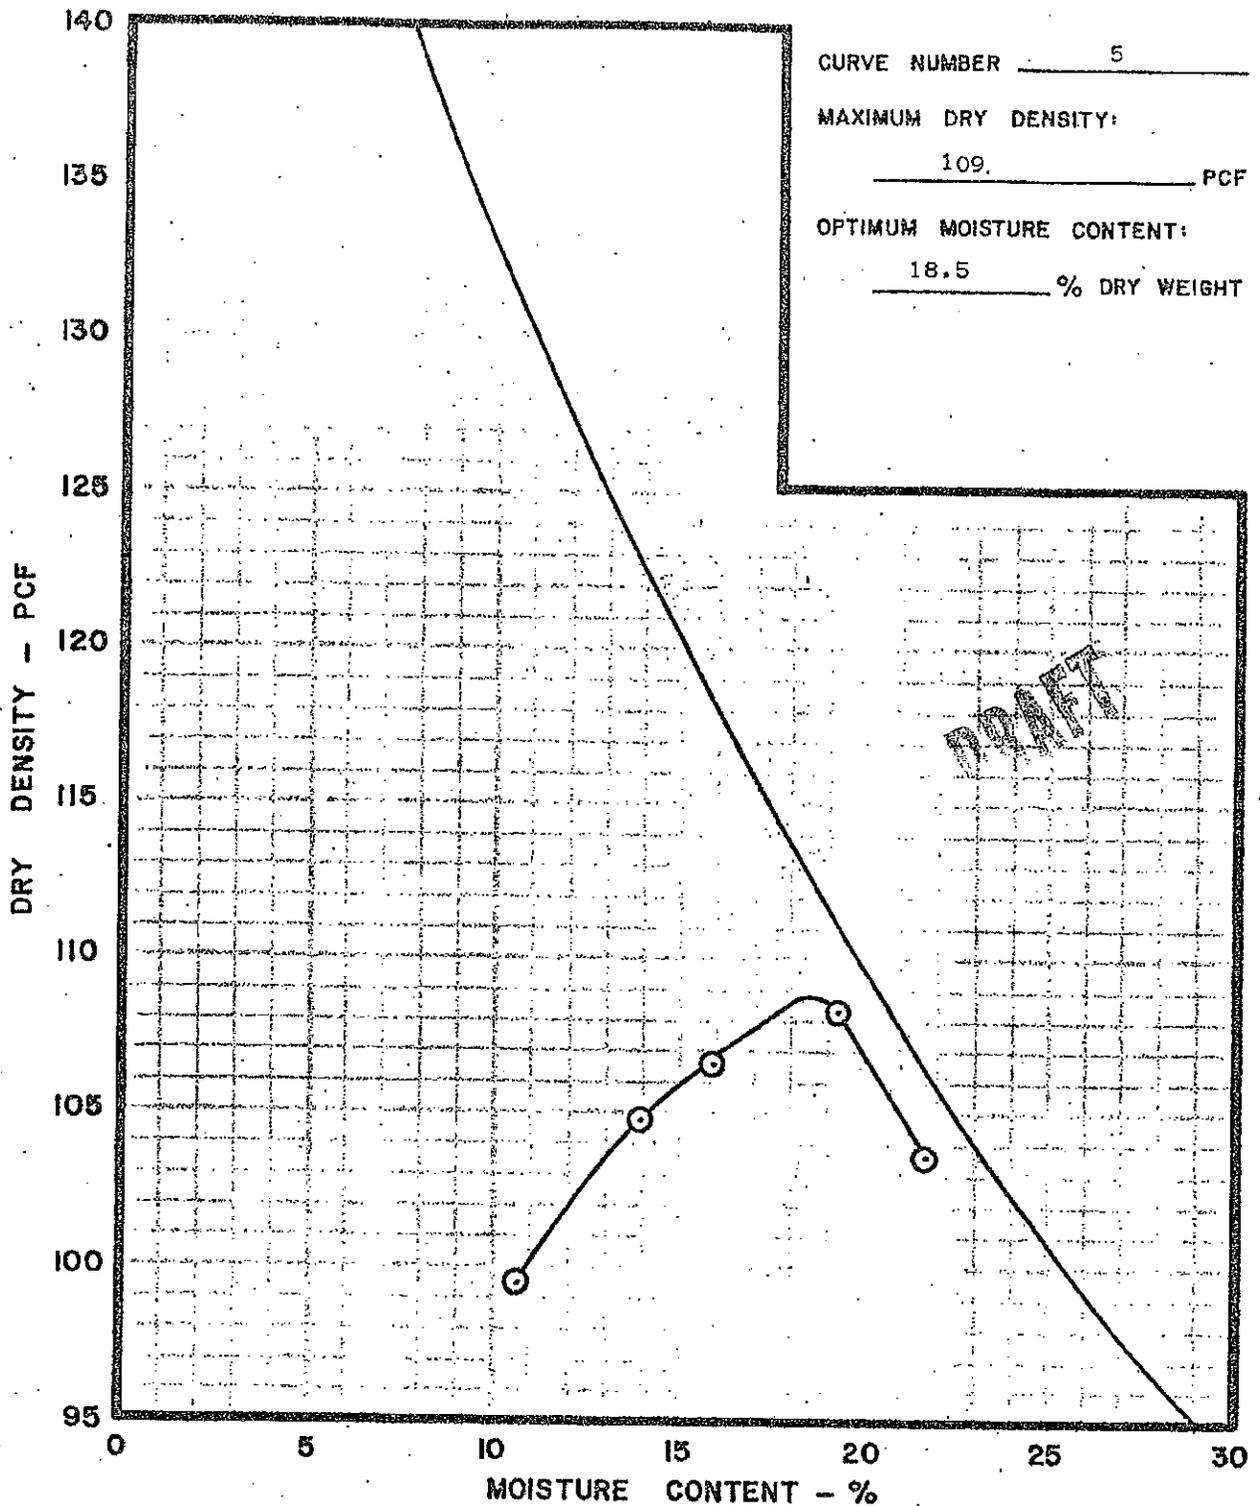
SAMPLE DESCRIPTION CLAY, SANDY, SLIGHTLY SILTY, RED BROWN, BROWN

LOCATION INSIDE TOE BETWEEN STA 38+00 AND 40+00

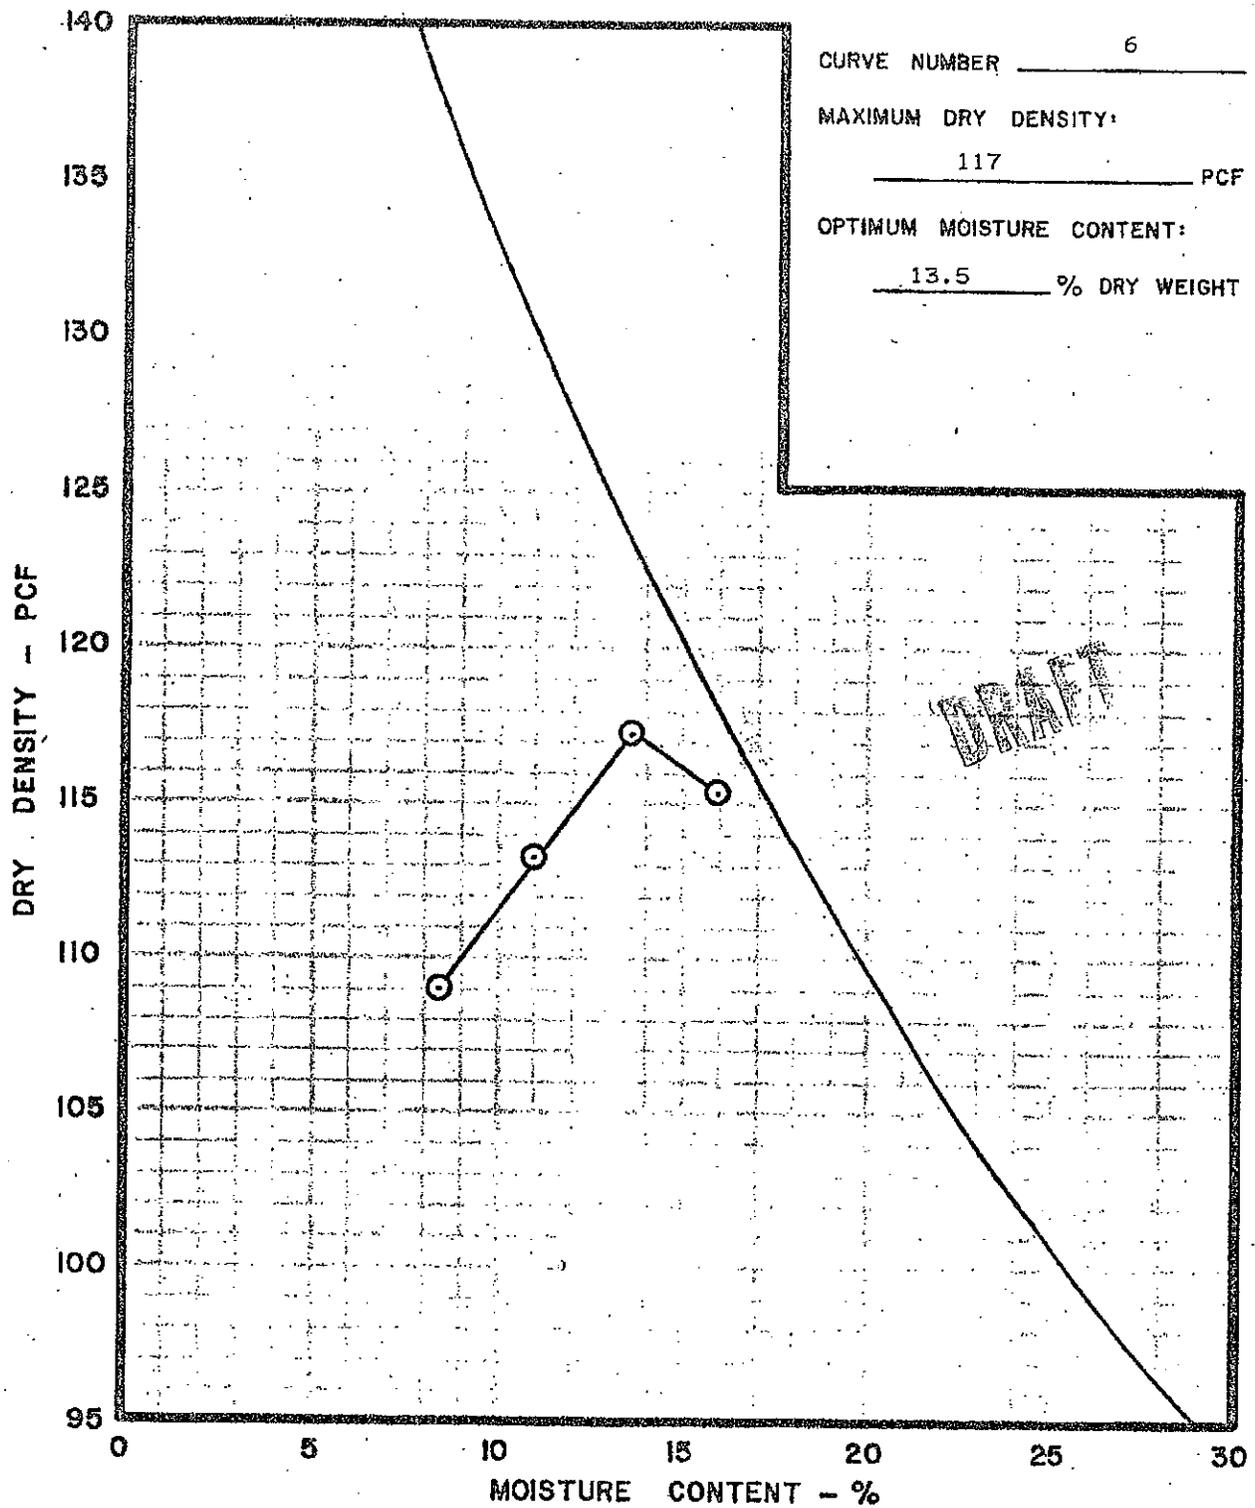
LOCATION TP-3

COMPACTION TEST RESULTS

SAMPLE DESCRIPTION CLAY, VERY SANDY, SILTY, BROWN (CL)

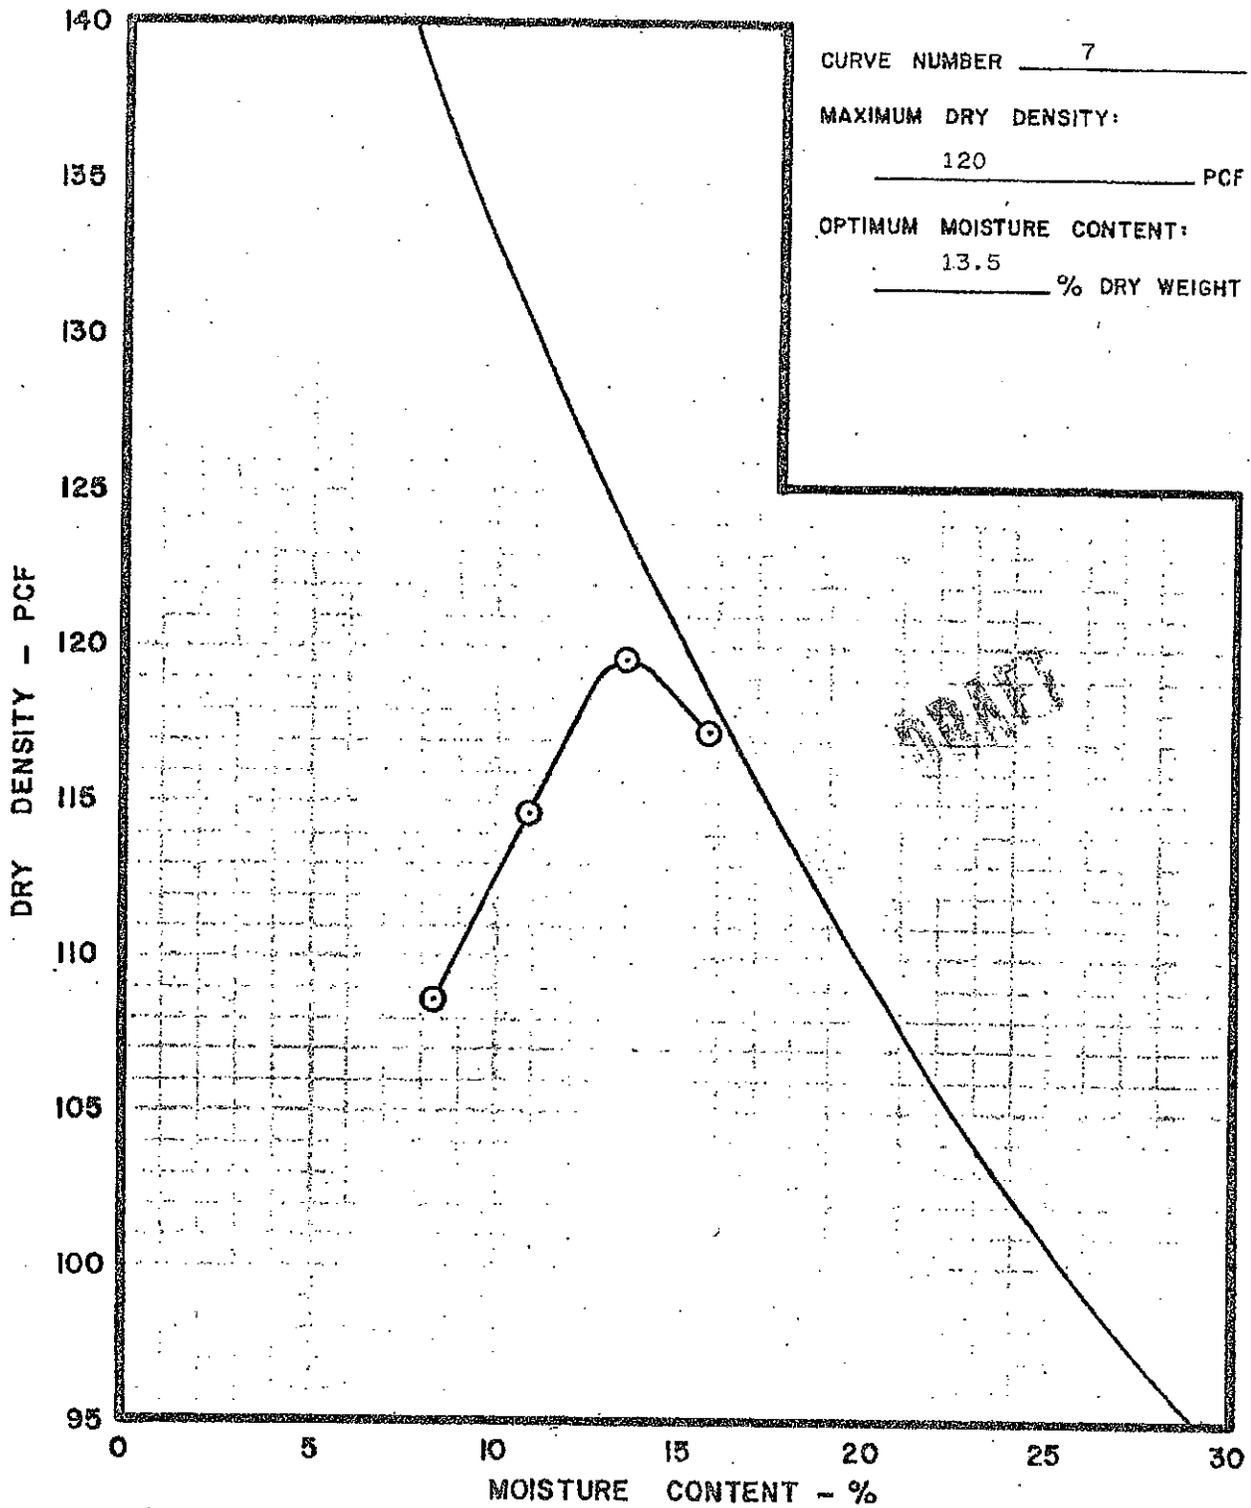
LOCATION TP-1

COMPACTION TEST RESULTS

SAMPLE DESCRIPTION CLAY, VERY SANDY, SILTY, SULFATES, BROWN (CL)
