Submitted by
RJH Consultants, Inc.
9800 Mt. Pyramid Court, Suite 330
Englewood, Colorado 80112
303-225-4611
www.rjh-consultants.com

April 2010
Project 09121

ATLANTIC RIM
RESERVOIR

SITE VICINITY MAP

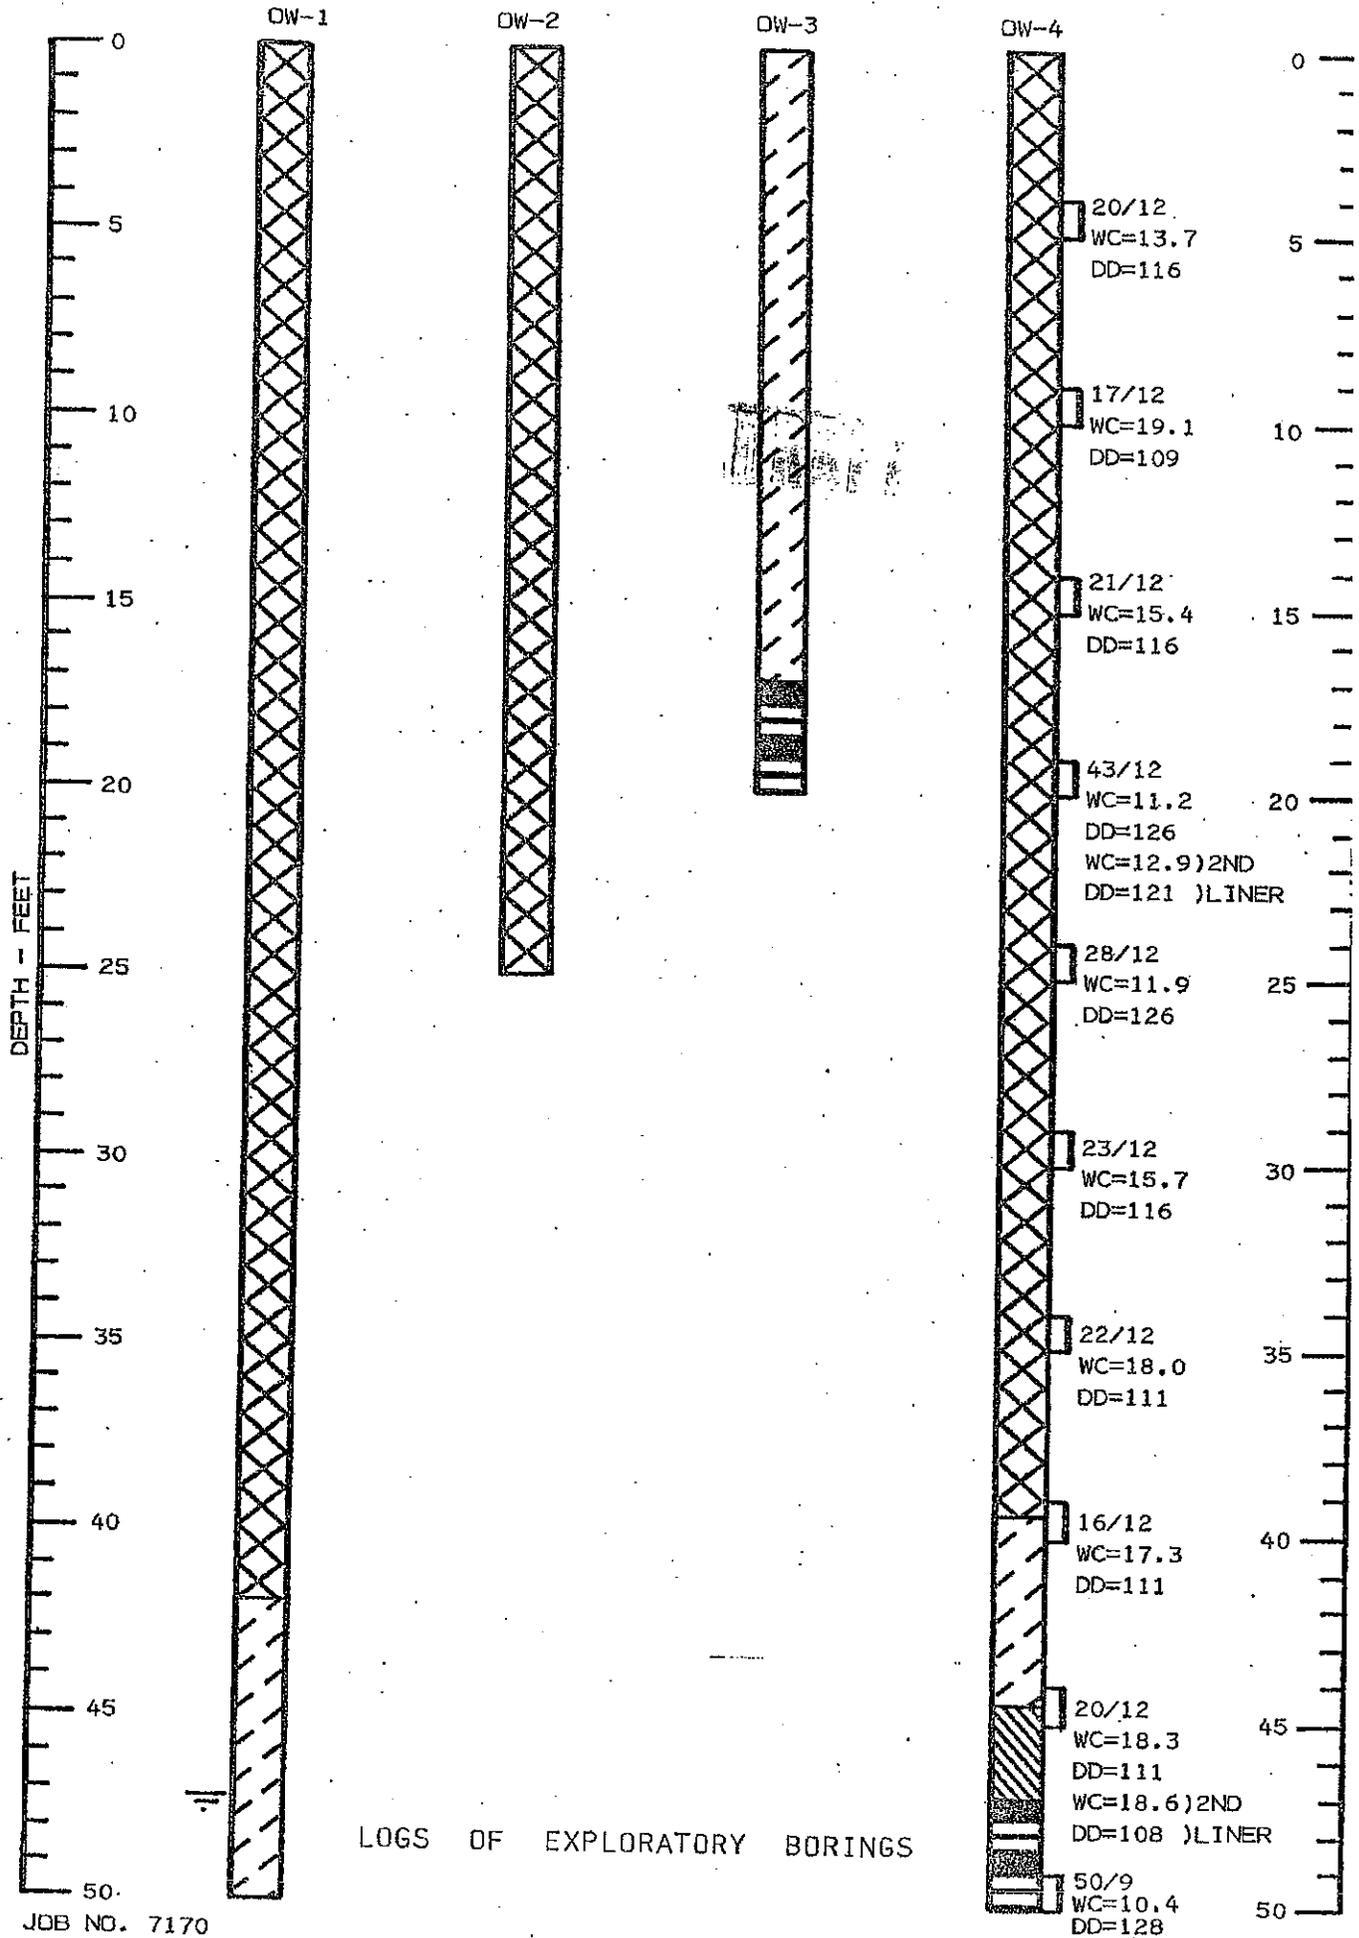
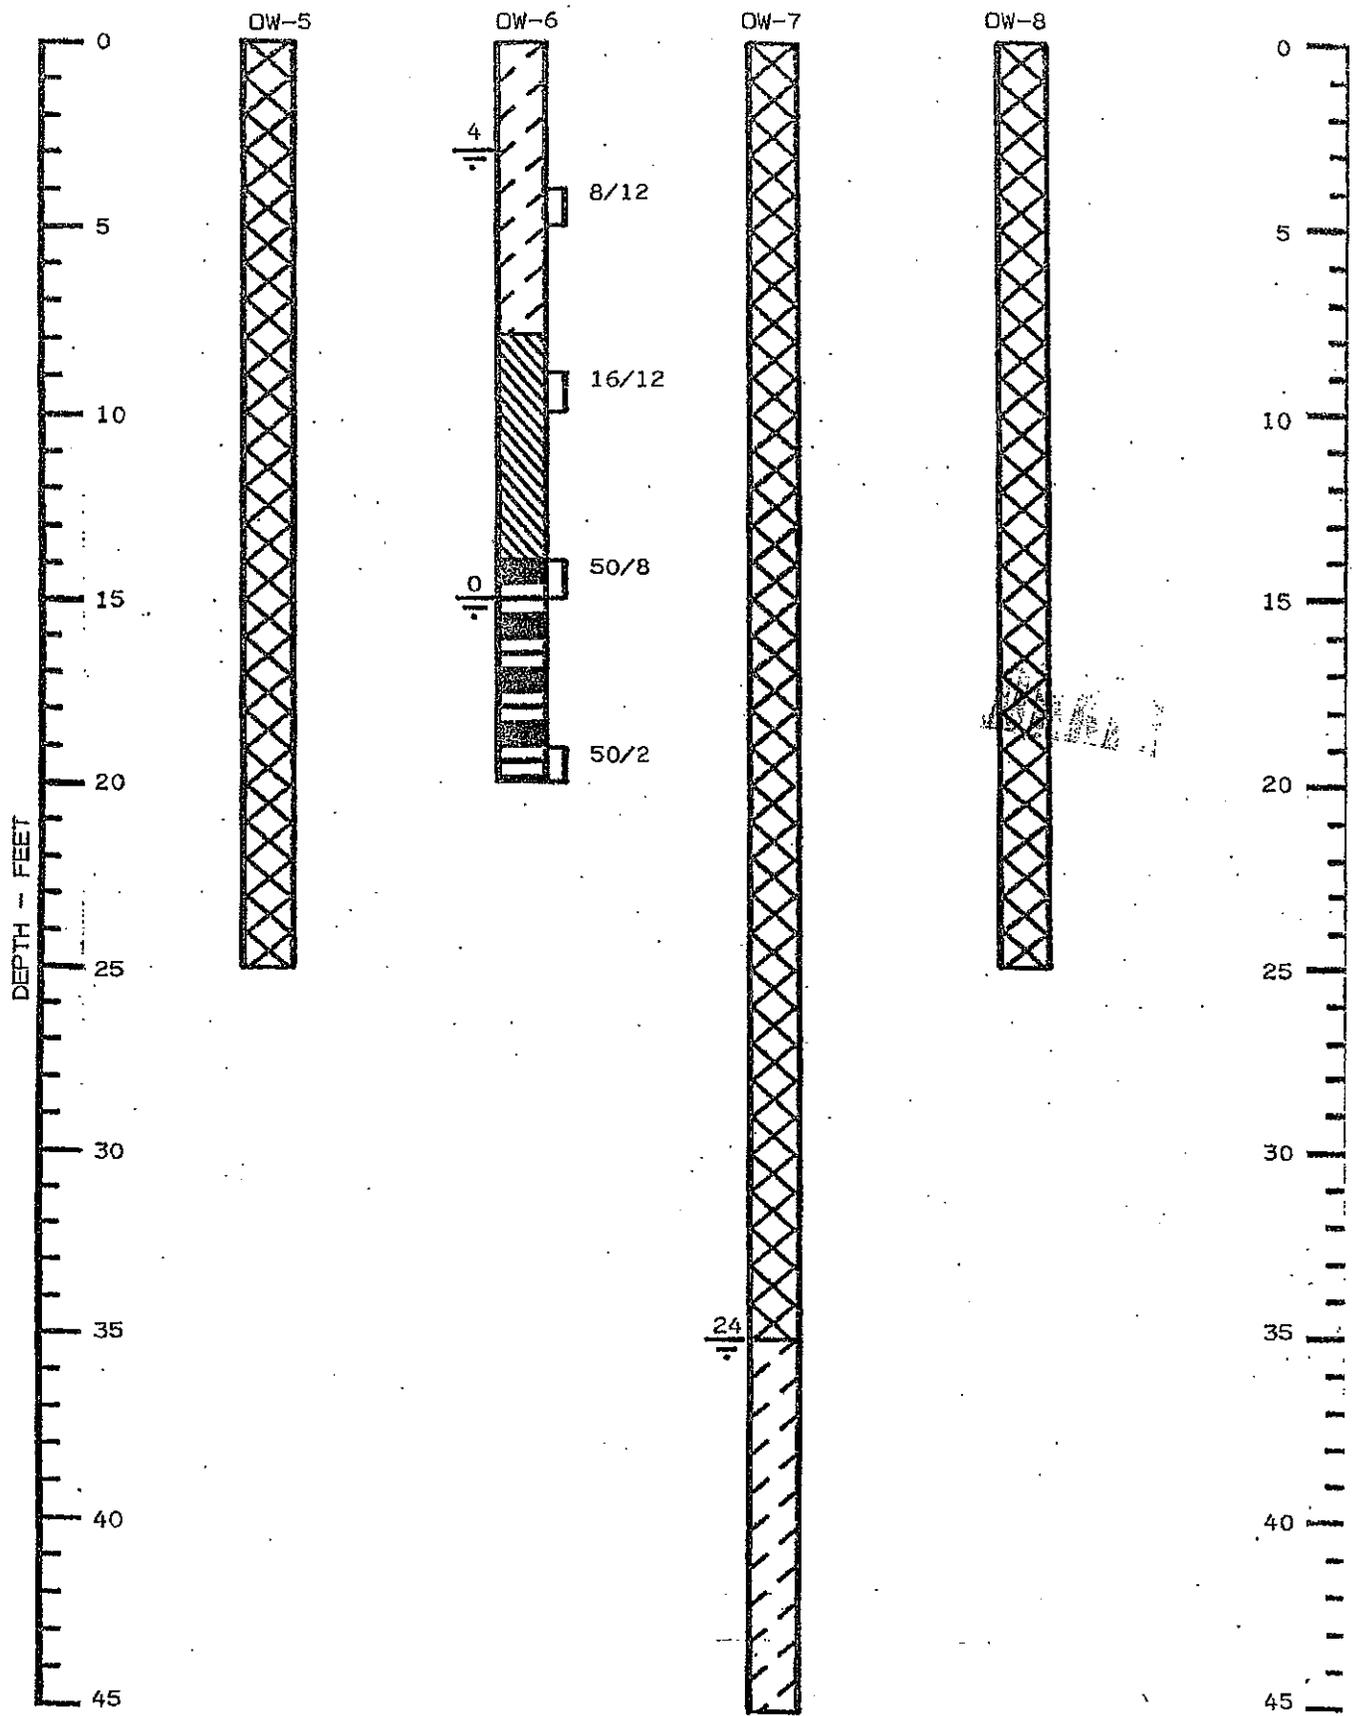
LOGS OF EXPLORATORY BORINGS

1. EXPLORATORY BORINGS WERE DRILLED AUG. 5&6, 1980; 5/5,7,8,9 & 6/17, 1981 USING A 4-INCH DIAMETER CONTINUOUS FLIGHT POWER AUGER. EXPLORATORY BORINGS WERE DRILLED MAY 19, 20, AND 21, 1981 USING A POST-HOLE AUGER.
2. THESE LOGS ARE SUBJECT TO THE EXPLANATIONS, LIMITATIONS AND CONCLUSIONS AS CONTAINED IN THIS REPORT.
3. ELEVATIONS OF BORINGS OBTAINED BY SURVEYING FROM KNOWN PHYSICAL FEATURES ON DAM
4. WC INDICATES NATURAL MOISTURE CONTENT (%)
DD INDICATES DRY DENSITY (PCF)
-200 INDICATES PERCENT PASSING THE NO. 200 SIEVE
PI INDICATES PLASTICITY INDEX (%)
LL INDICATES LIQUID LIMIT (%)
UC INDICATES UNCONFINED COMPRESSIVE STRENGTH (PSF)
SS INDICATES SOLUBLE SULFATES (PPM)

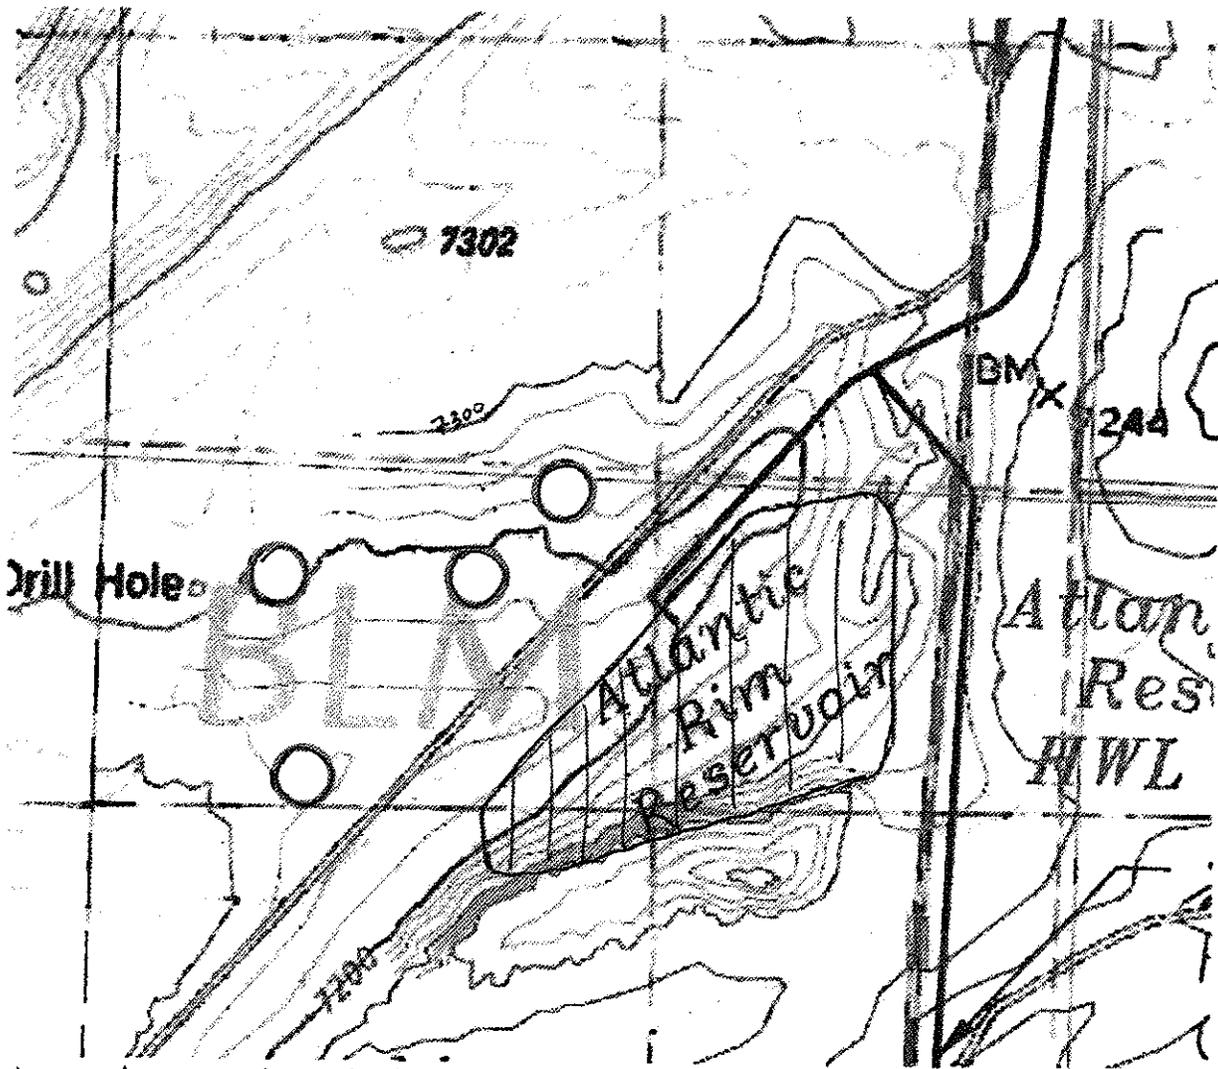
GANNETT FLEMING TEST PIT LOGS - 2006

○ Proposed Test Pit Locations

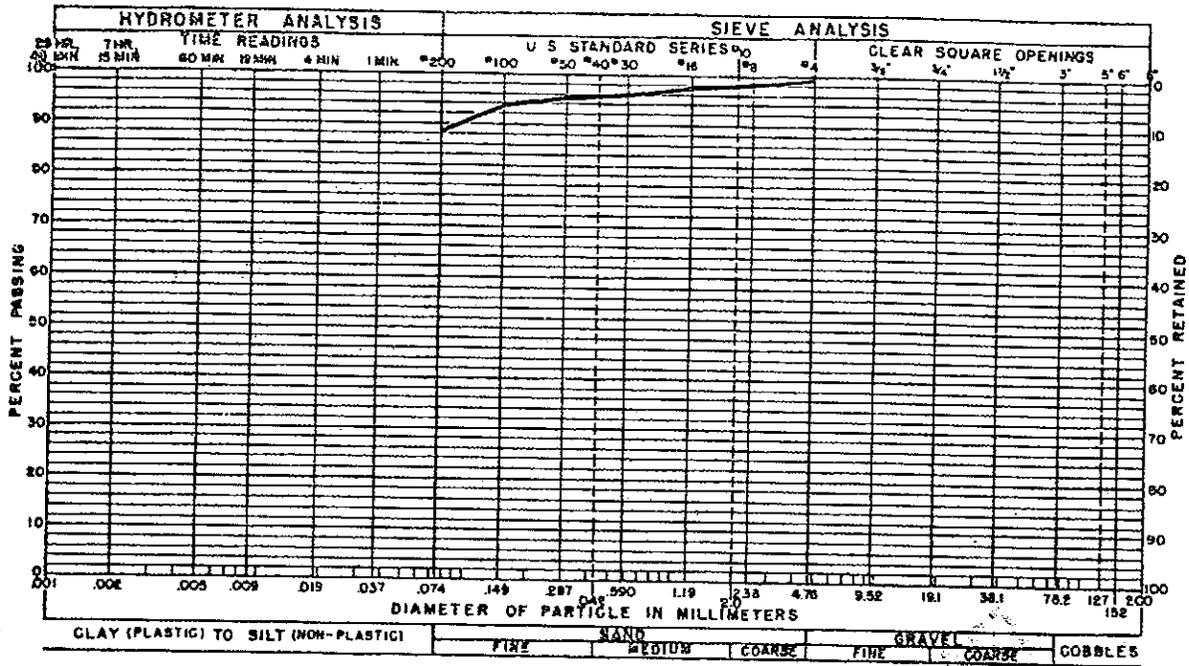
GRAVEL 1 % SAND 11 % SILT AND CLAY 88 %
 LIQUID LIMIT 26 % PLASTICITY INDEX 10 %
 SAMPLE OF CLAY (CL) FROM DW-18 AT 49.5 FEET

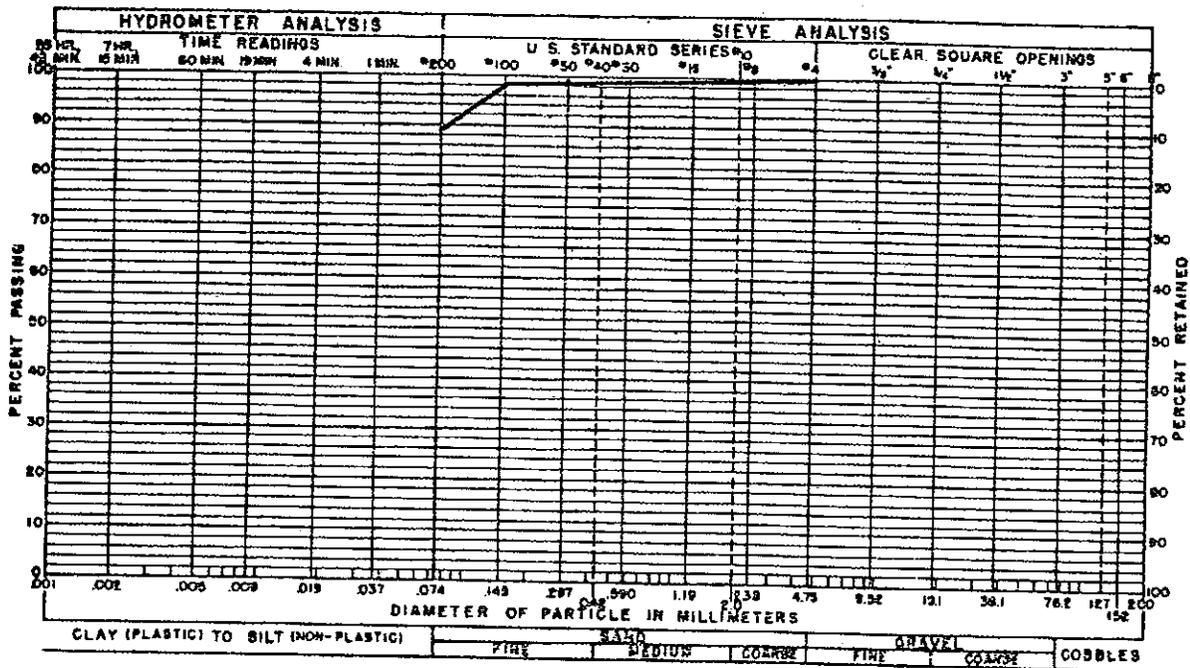
GRAVEL 0 % SAND 11 % SILT AND CLAY 89 %
 LIQUID LIMIT 27 % PLASTICITY INDEX 13 %
 SAMPLE OF CLAY (CL) FROM DW-19 AT 49 FEET

GRADATION TEST RESULTS

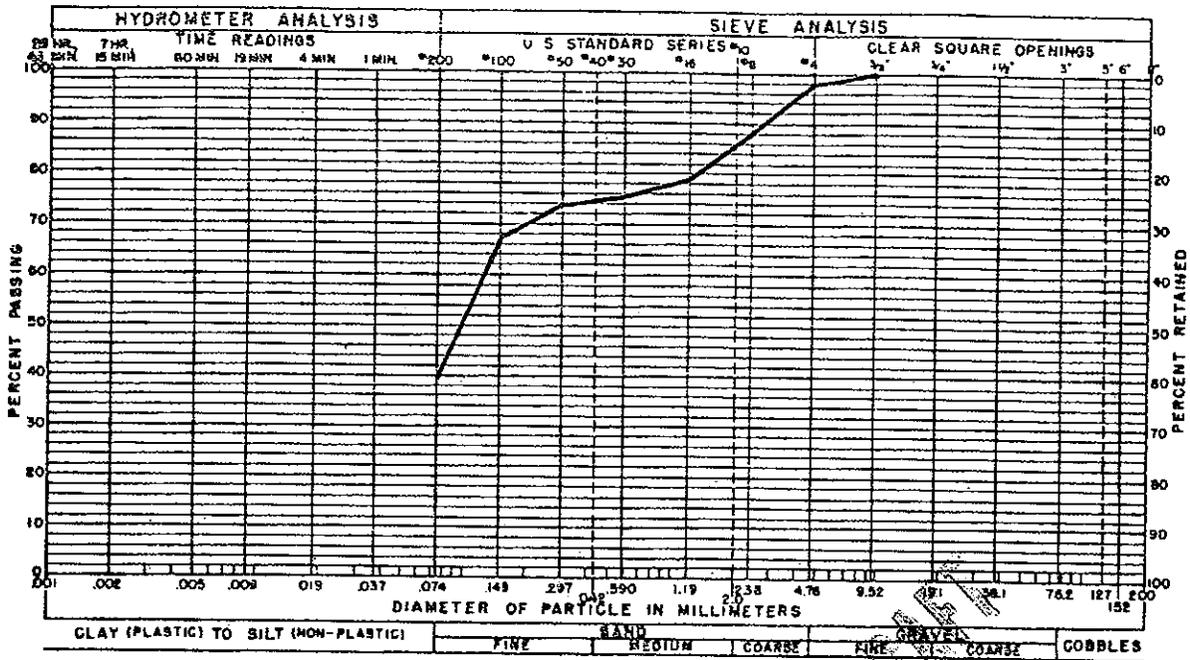
GRAVEL 2 % SAND 49 % SILT AND CLAY 49 %

SAMPLE OF SAND, CLAYEY (SC) FROM OW-20 AT 39 FEET

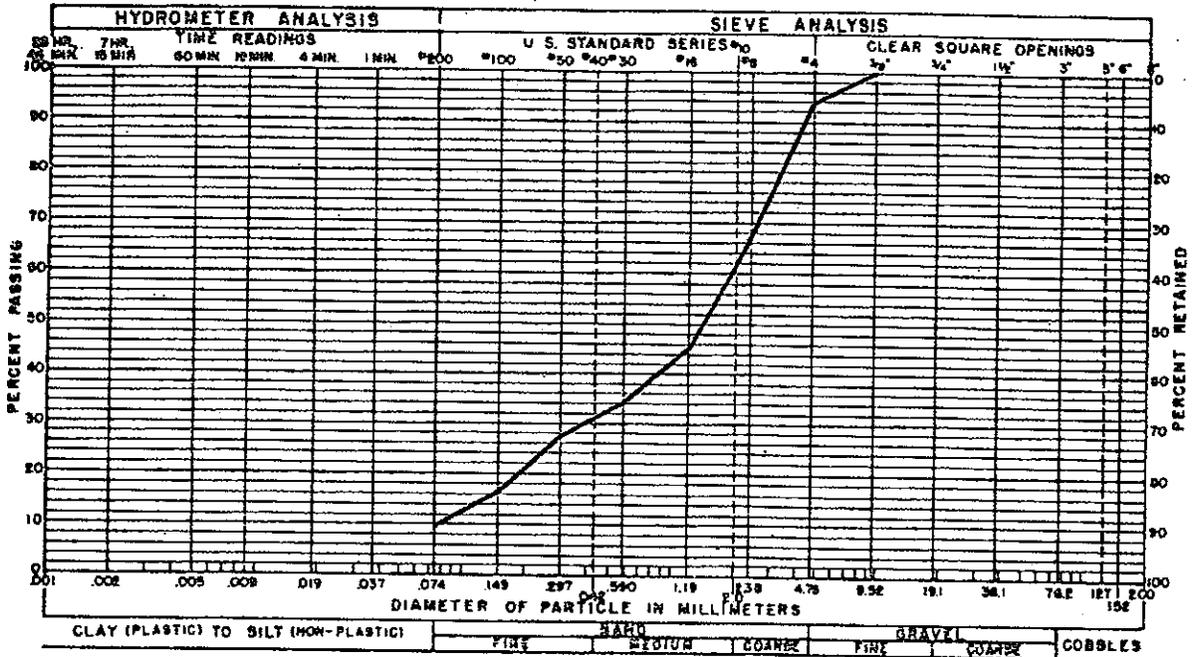
GRAVEL 6 % SAND 84 % SILT AND CLAY 10 %

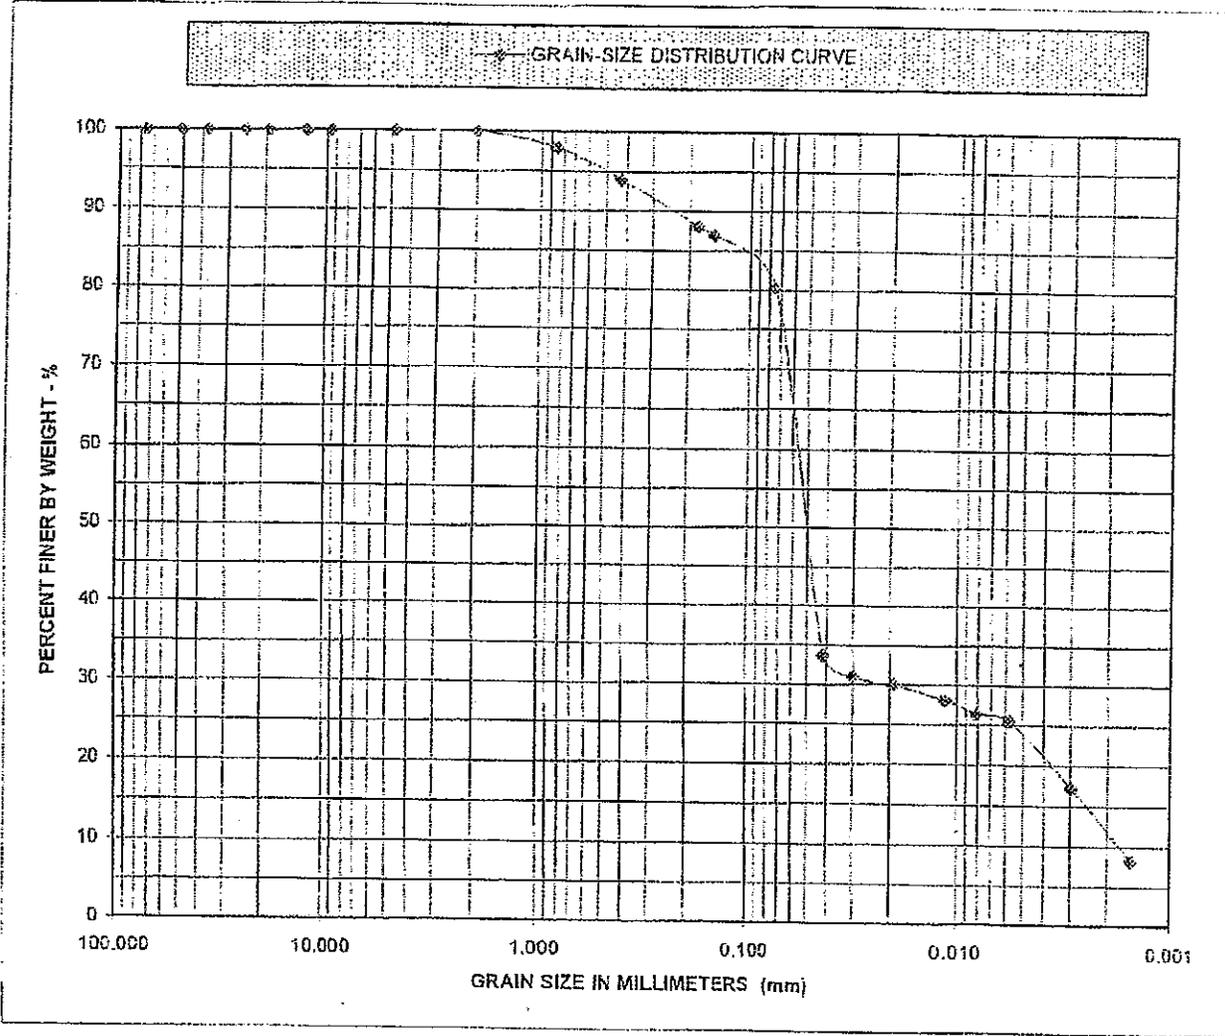
CLIENT: WWC Engineering
PROJECT: Atlantic Rim & Peaking 2 Test Fill Samples
PROJECT LOCATION: Rawlins, Wyoming
SAMPLE LOCATION: TF-3 @ 1-2'

SAMPLE LOCATION	SOIL CLASSIFICATION	MC%	LL	PI	Cc	Cu
TP-3 @ 1-2'	Sandy Lean Clay (CL)	10.2	34	18	3.41	33.27

SAMPLE LOCATION	D100	D60	D30	D10	% GRAVEL	% SAND	% SILT	% CLAY
TP-3 @ 1-2'	2.000	0.060	0.019	0.002	0.0	19.8	56.9	23.3

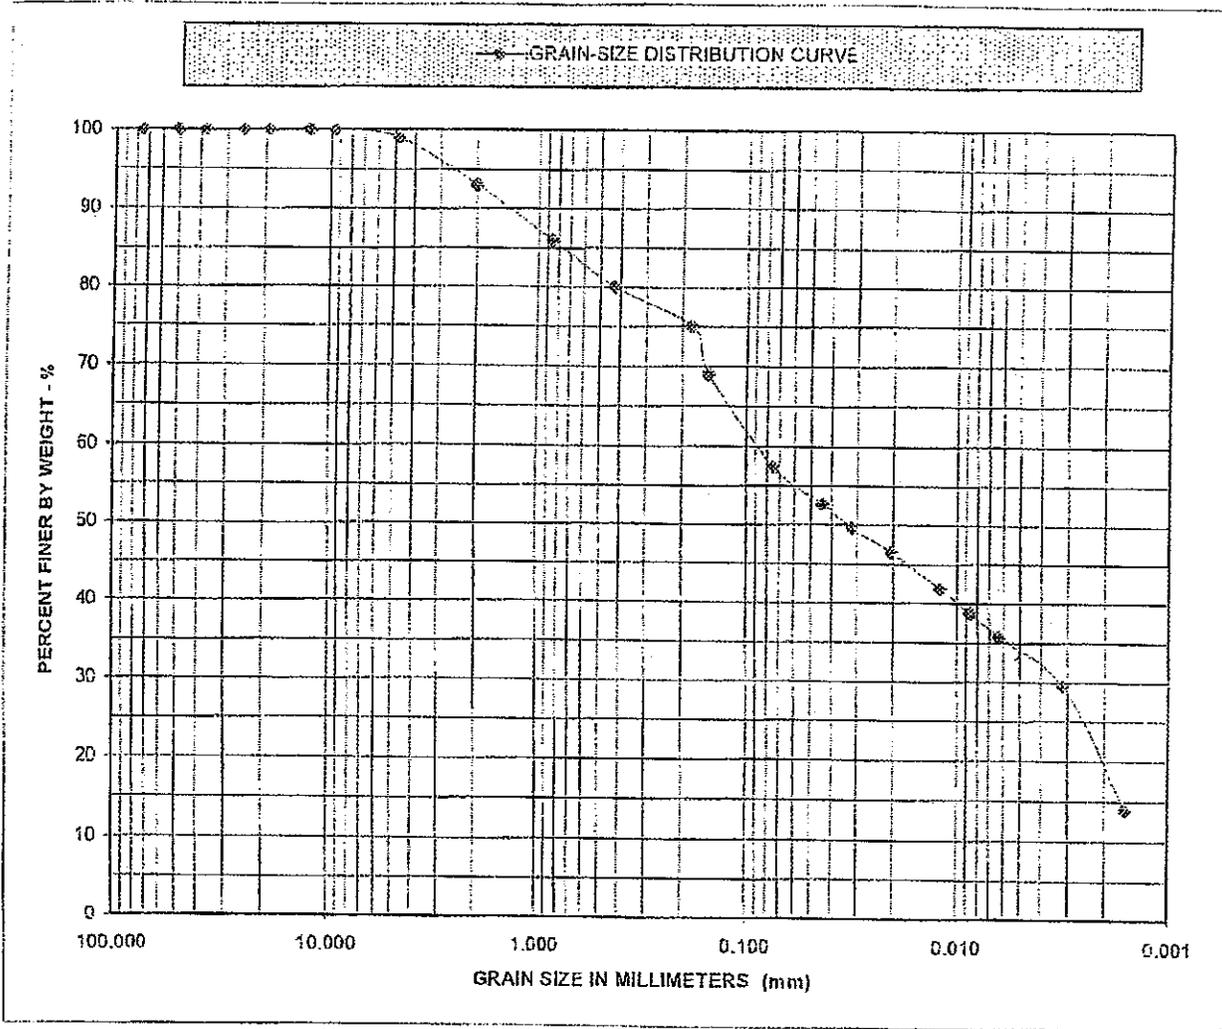
CLIENT: WWC Engineering
 PROJECT: Atlantic Rim & Peaking 2 Test Pit Samples
 PROJECT LOCATION: Rawlins, Wyoming
 SAMPLE LOCATION: TP-4 @ 6-8'

SAMPLE LOCATION	SOIL CLASSIFICATION	MC%	LL	PI	Cc	Cu
TP-4 @ 6-8'	Sandy Silty Clay (CL-ML)	10.9	24	6

SAMPLE LOCATION	D100	D60	D30	D10	% GRAVEL	% SAND	% SILT	% CLAY
TP-4 @ 6-8'	9.500	0.092	0.003		1.0	41.6	24.2	33.2

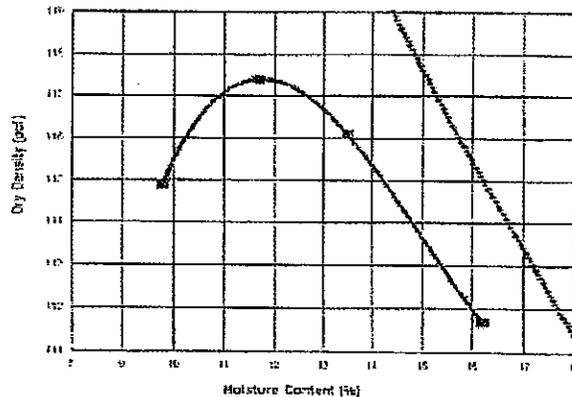
Result	Specifications
Test Procedure:	ASTM D698-91	Liquid Limit:	24
Test Method:	Method A	Plastic Limit:	18
Sample Preparation:	Wet Preparation	Plasticity Index:	6
Rammer Type:	Mech. Rammer	% Passing #200:	57.4
Maximum Dry Unit Weight, pcf:	117.5	% Passing #40:	80.0
Optimum Water Content, %:	12.0

Moisture Density Relations
 Zero Air Voids Curve for assumed specific gravity 2.63

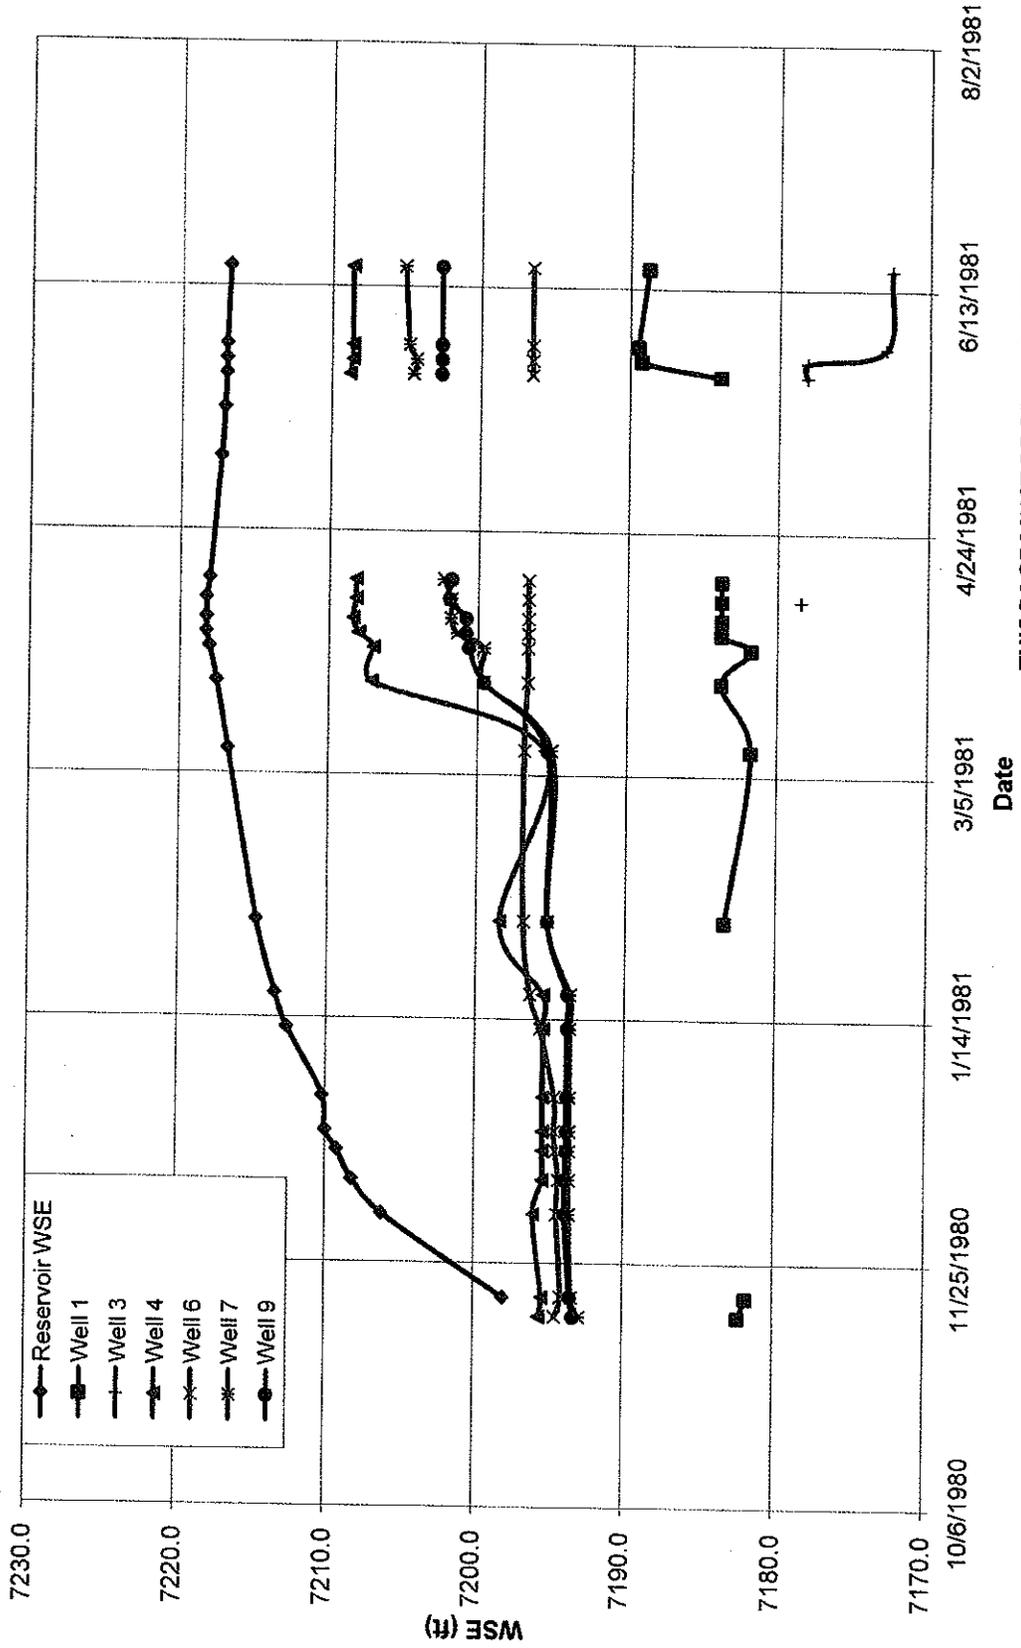
Atlantic Rim Reservoir WSE and Observation Well Levels

DATE	11/14	11/17	11/18	12/5	12/12	12/18	12/22	12/29
WATER SURFACE ELEVATION	RES-ERVOIR EMPTY	FILLING BEGAN	7198.0	7206.2	7208.2	7209.2	7210.0	7210.2
OBSERVATION WELL NUMBER AND ELEVATION OF WATER IN WELL	1	7182.3		7181.8	DRY	DRY	DRY	DRY
	2	DRY		DRY	DRY	DRY	DRY	DRY
	3	DRY		DRY	DRY	DRY	DRY	DRY
	4	7195.6		7195.4	7196.0	7195.4	7195.4	7195.4
	5	DRY		DRY	DRY	DRY	DRY	DRY
	6	7194.5		7194.1	7194.4	7194.3	7194.5	7194.6
	7	7192.9		7193.4	7193.6	7193.6	7193.6	7193.6
	8	DRY		DRY	DRY	DRY	DRY	DRY
	9	7193.3		7193.5	7193.9	7193.9	7193.8	7193.8
	10							
	11							
	12							
	13							
	14							
	15							
	16							
	17							
	18							
	19							
	20							
	21							
	22							
	23							
	24							
	25							
	26

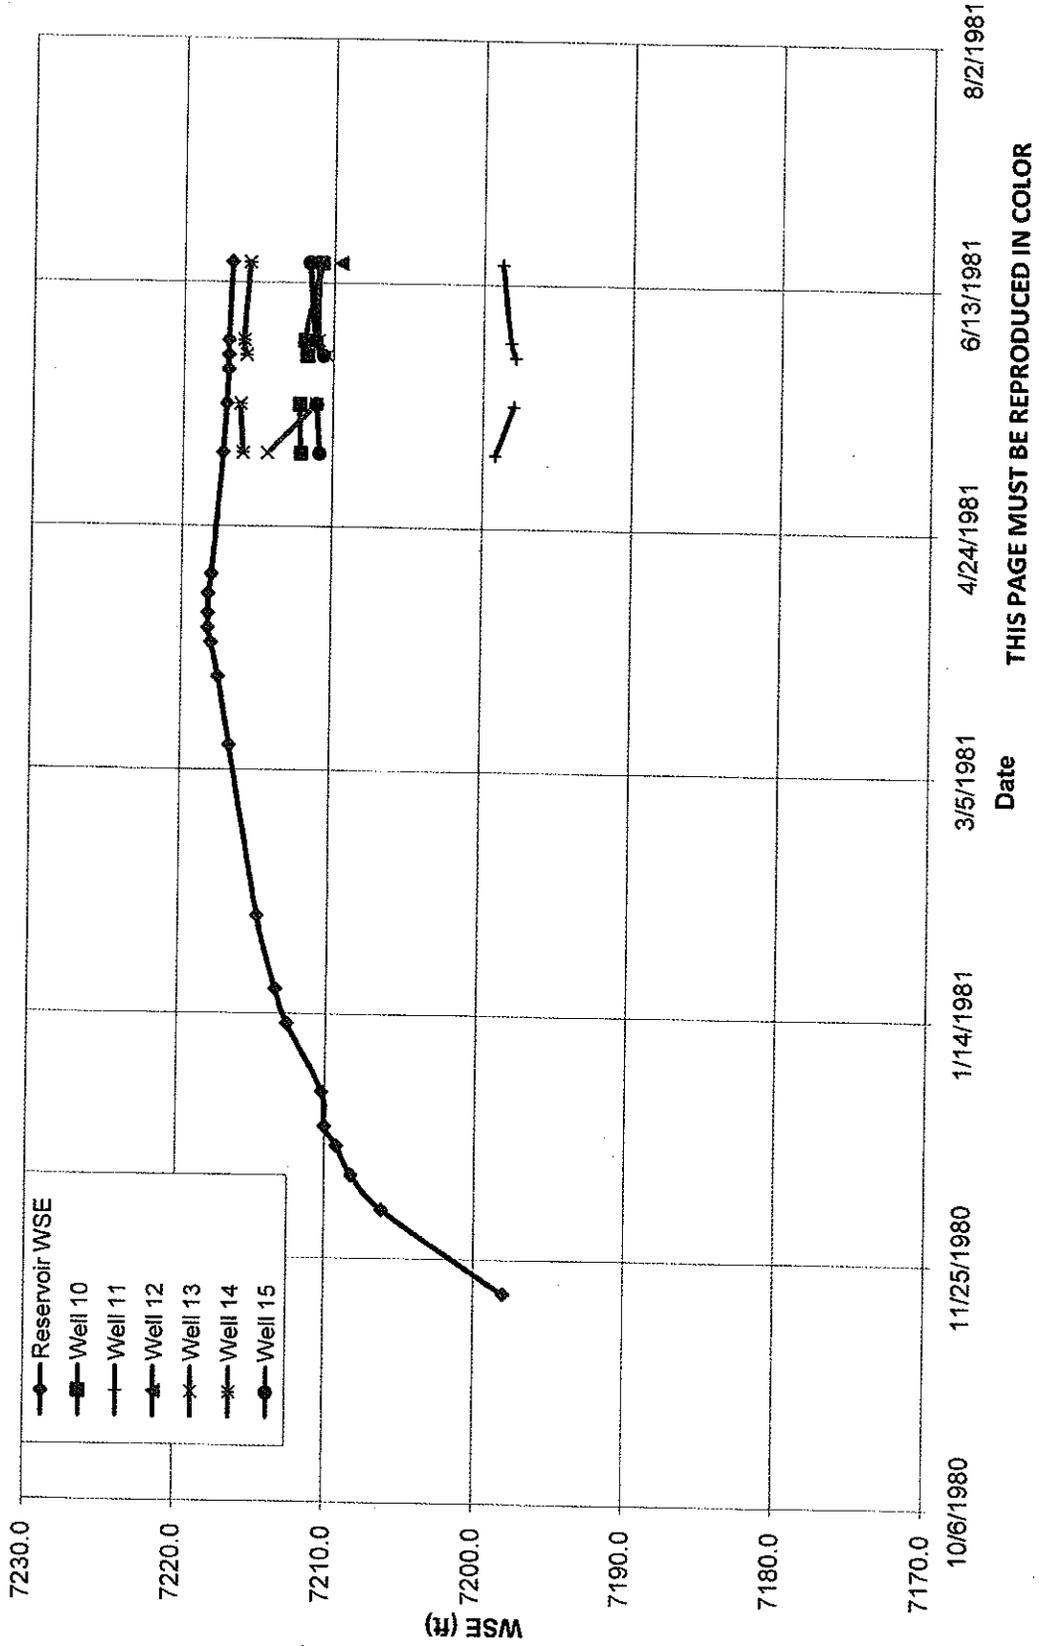
Atlantic Rim Reservoir WSE and Observation Well Levels

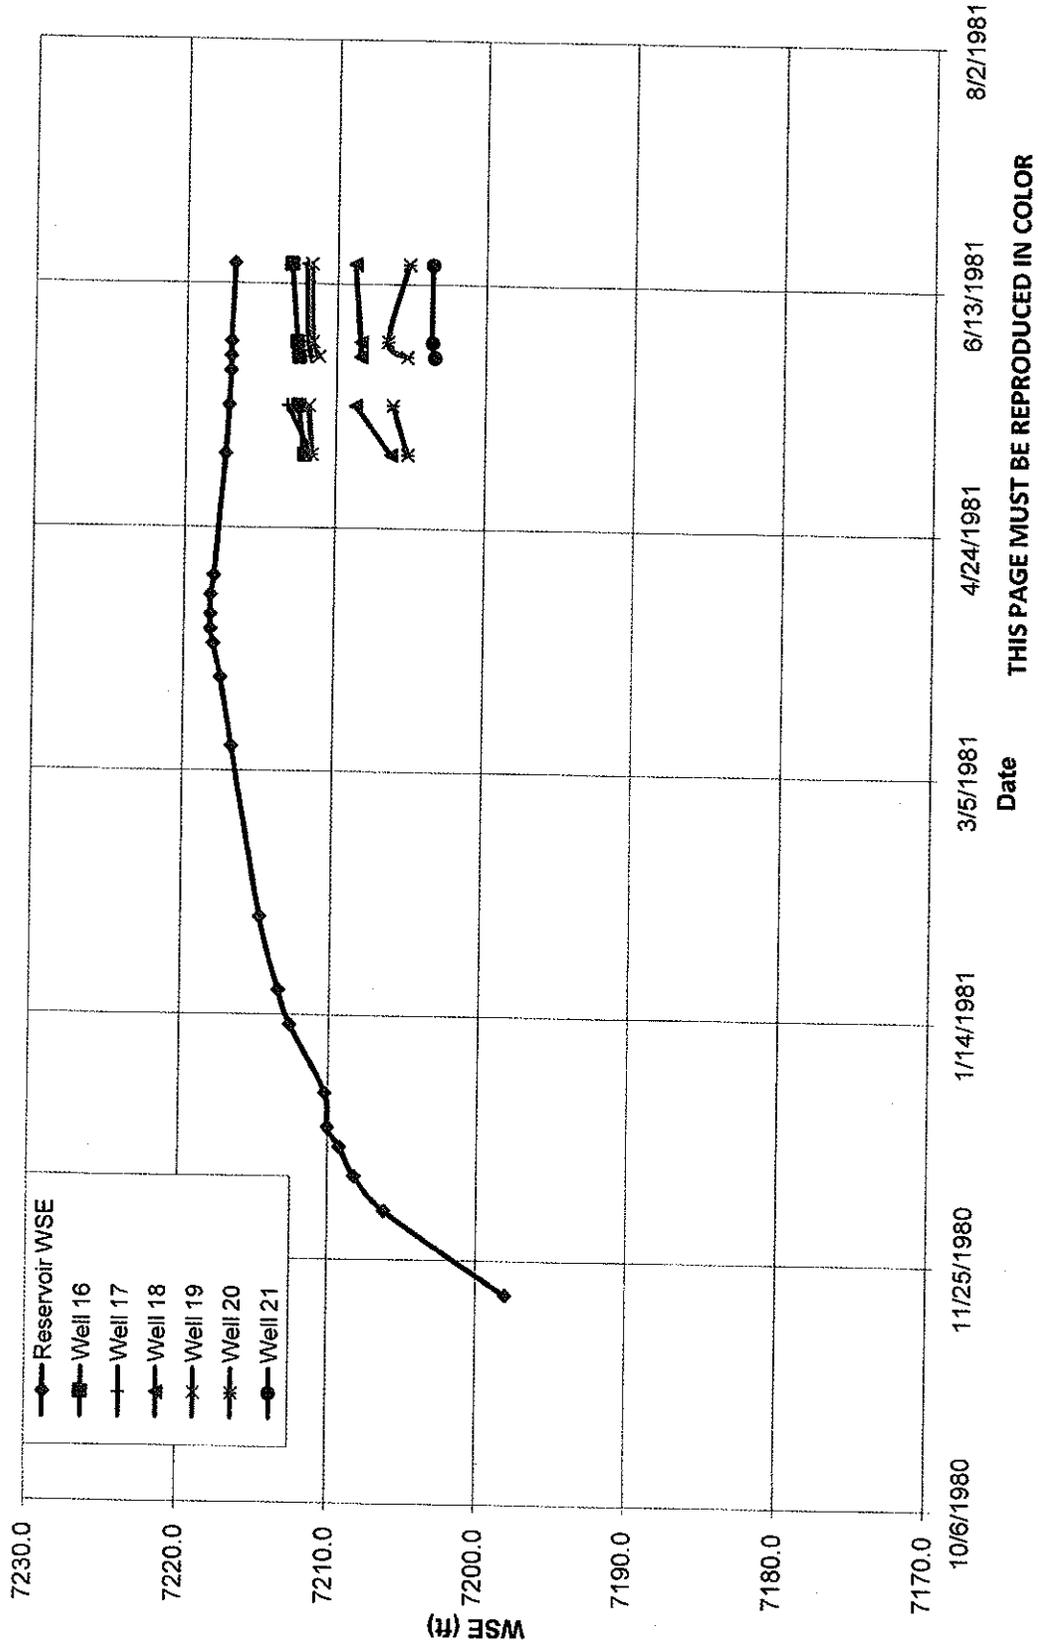
Atlantic Rim Reservoir WSE and Observation Well Levels

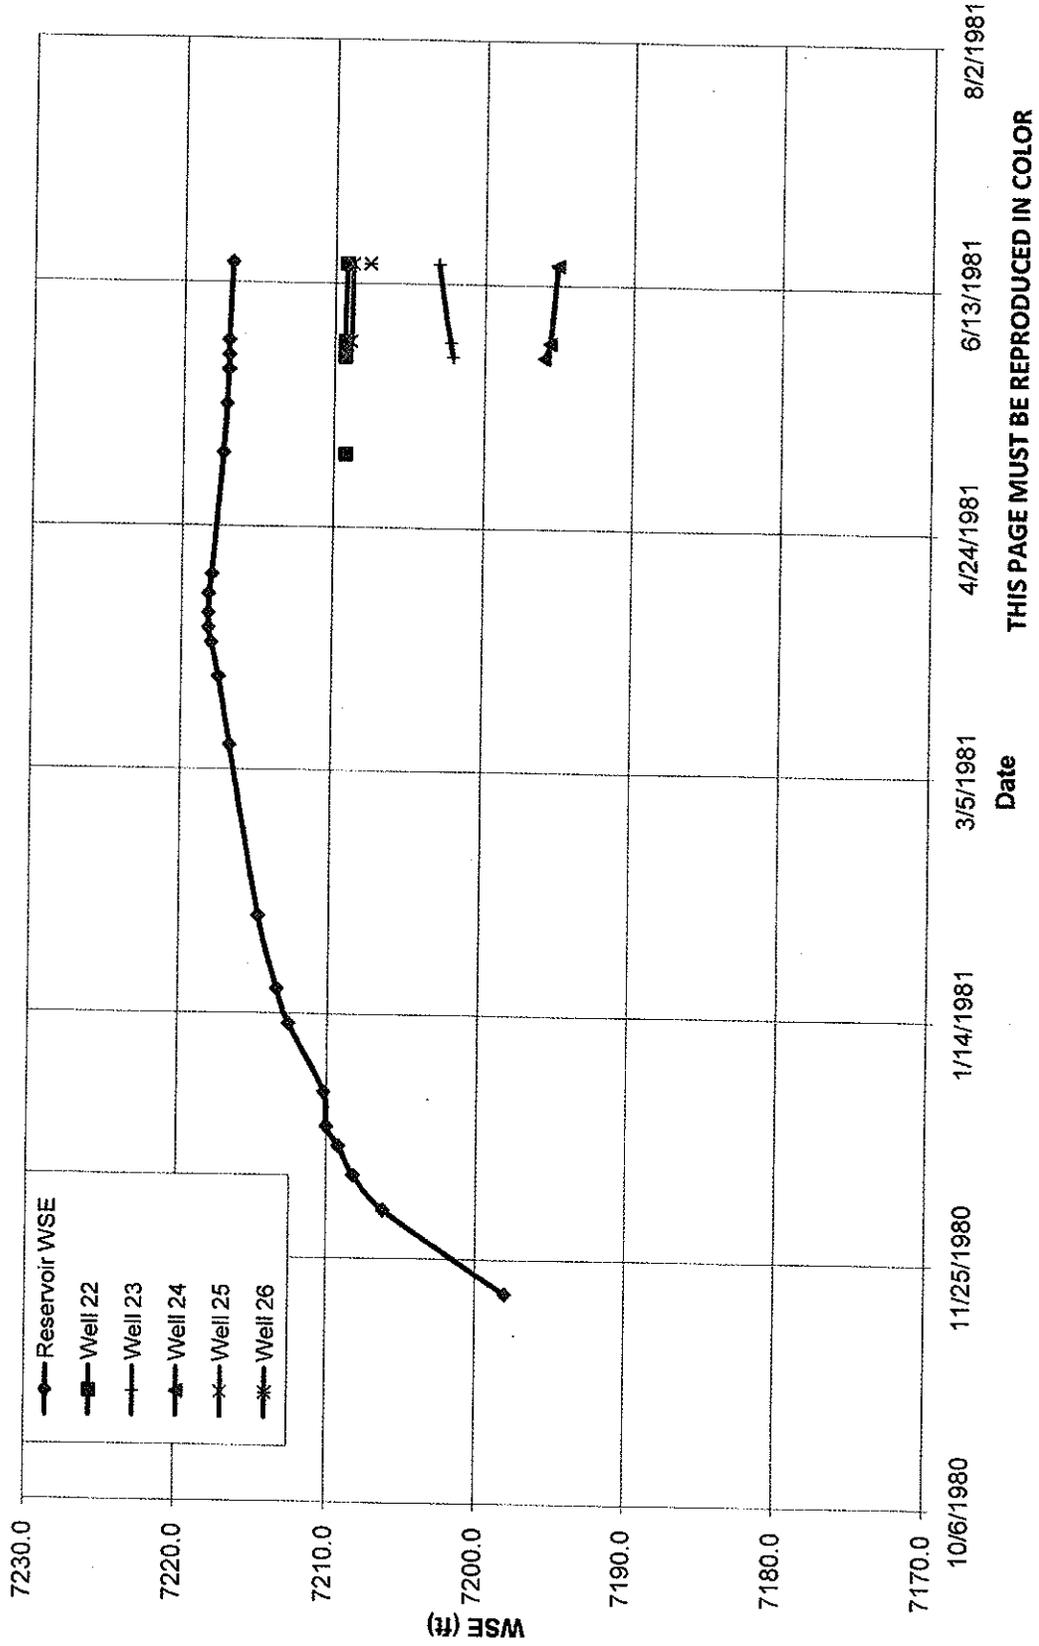
Atlantic Rim Reservoir WSE and Observation Well Levels

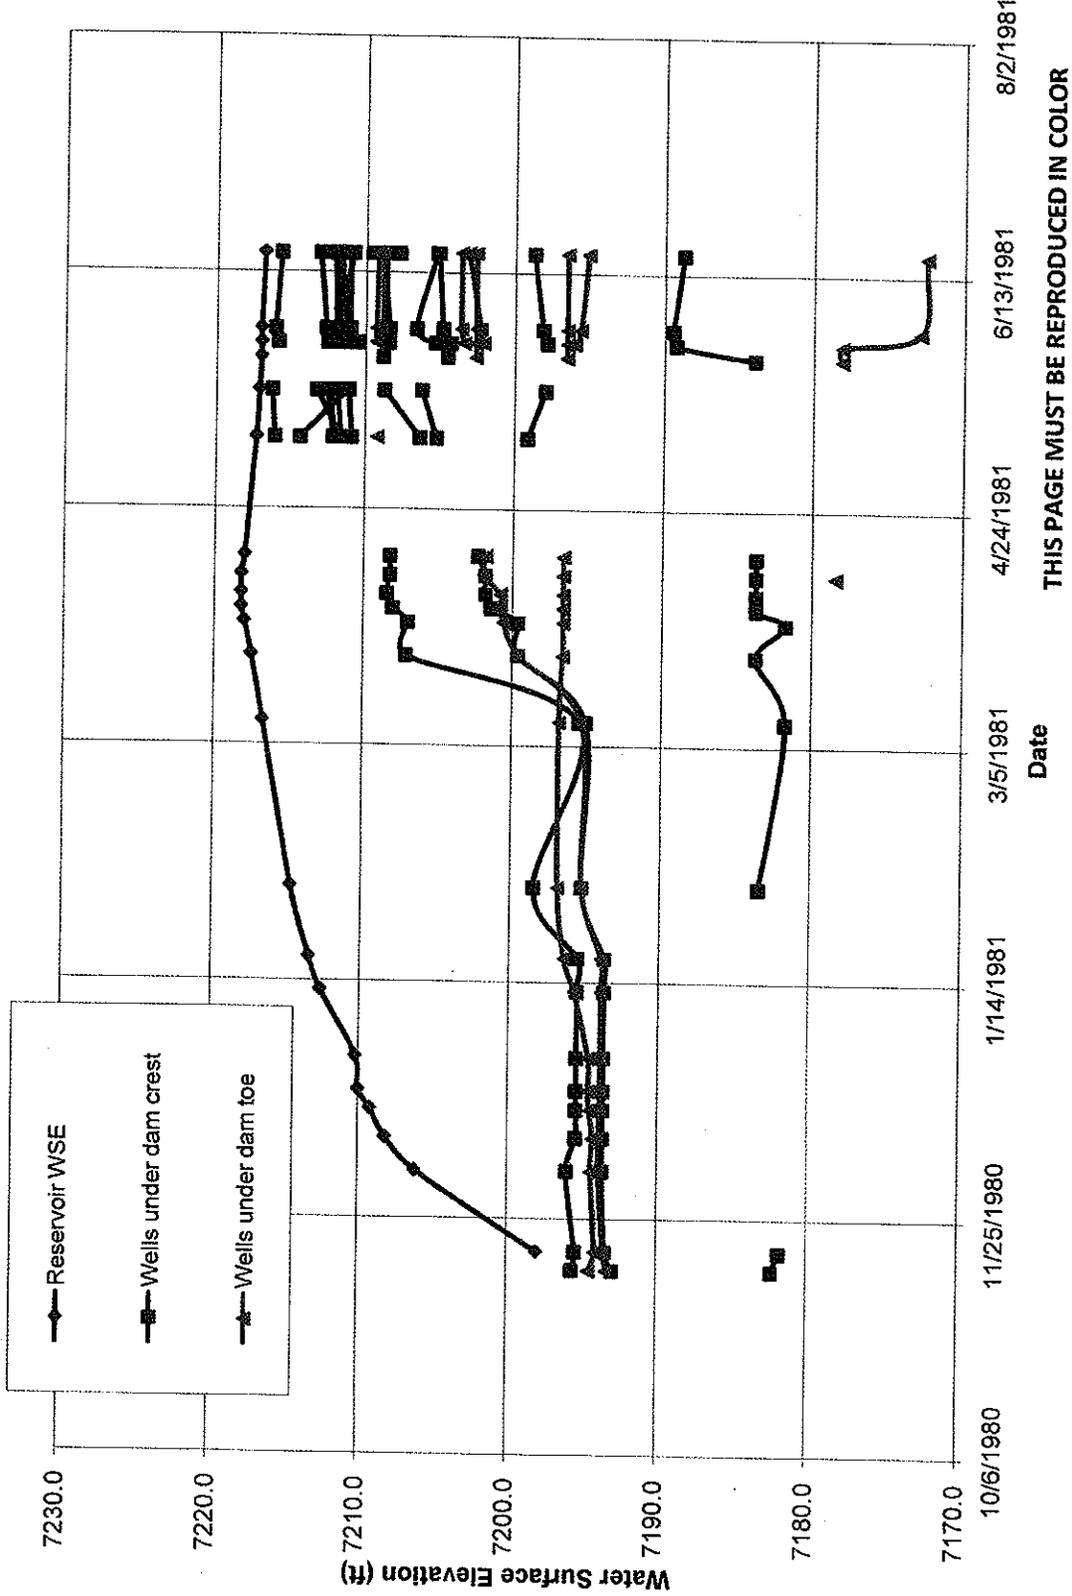
Atlantic Rim Reservoir WSE and Observation Well Levels by Location

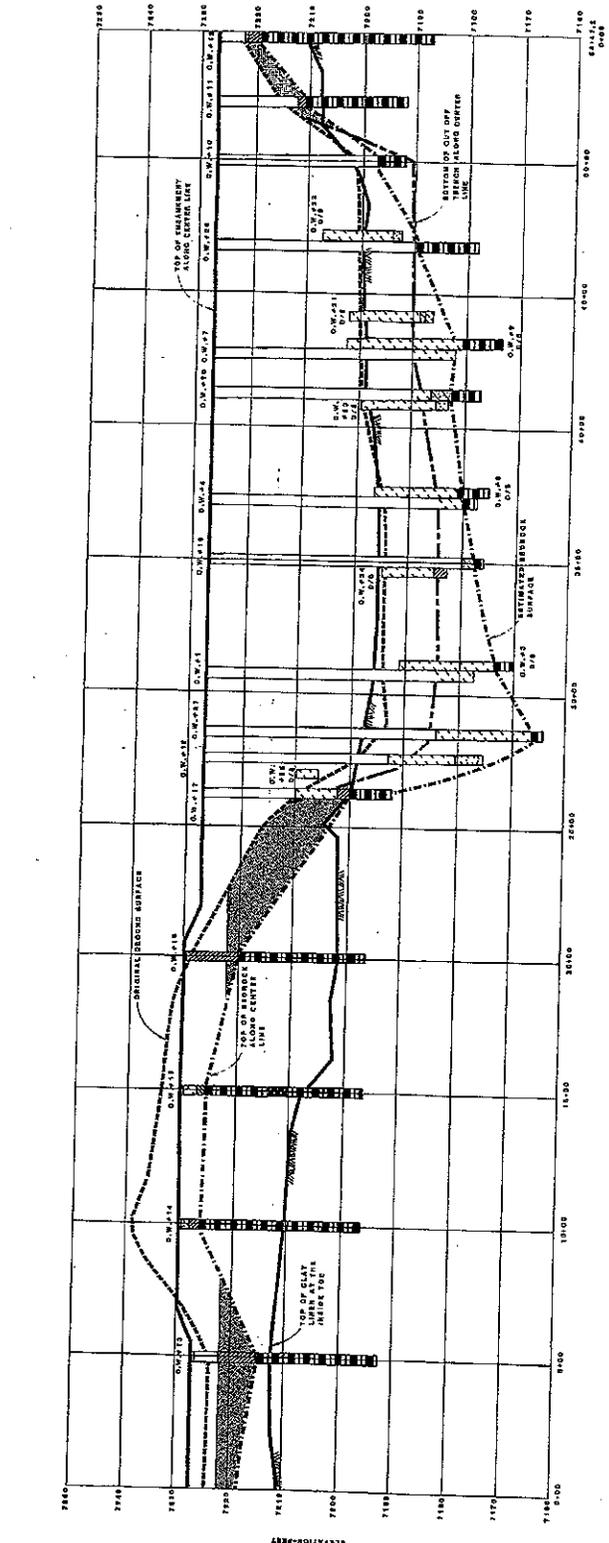
LEGEND:
 POTENTIAL SEEPAGE AREAS

PROFILE AT C. OF EMBANKMENT SCALE: HORIZ. 1"=50' VERT. 1"=10'

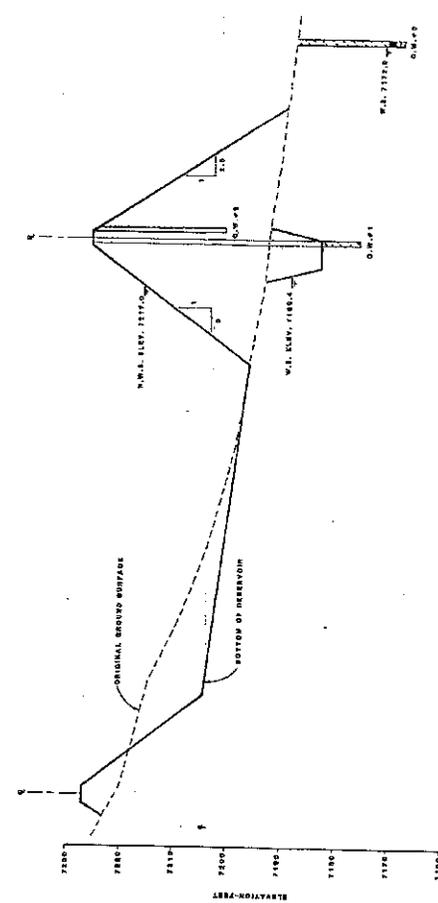
CROSS SECTION A-A' AT STATION 31400 SCALE: HORIZ. 1"=50' VERT. 1"=10'
