Submitted by
RJH Consultants, Inc.
9800 Mt. Pyramid Court, Suite 330
Englewood, Colorado 80112
303-225-4611
www.rjh-consultants.com

April 2010
Project 09121

ATLANTIC RIM
RESERVOIR

SITE VICINITY MAP

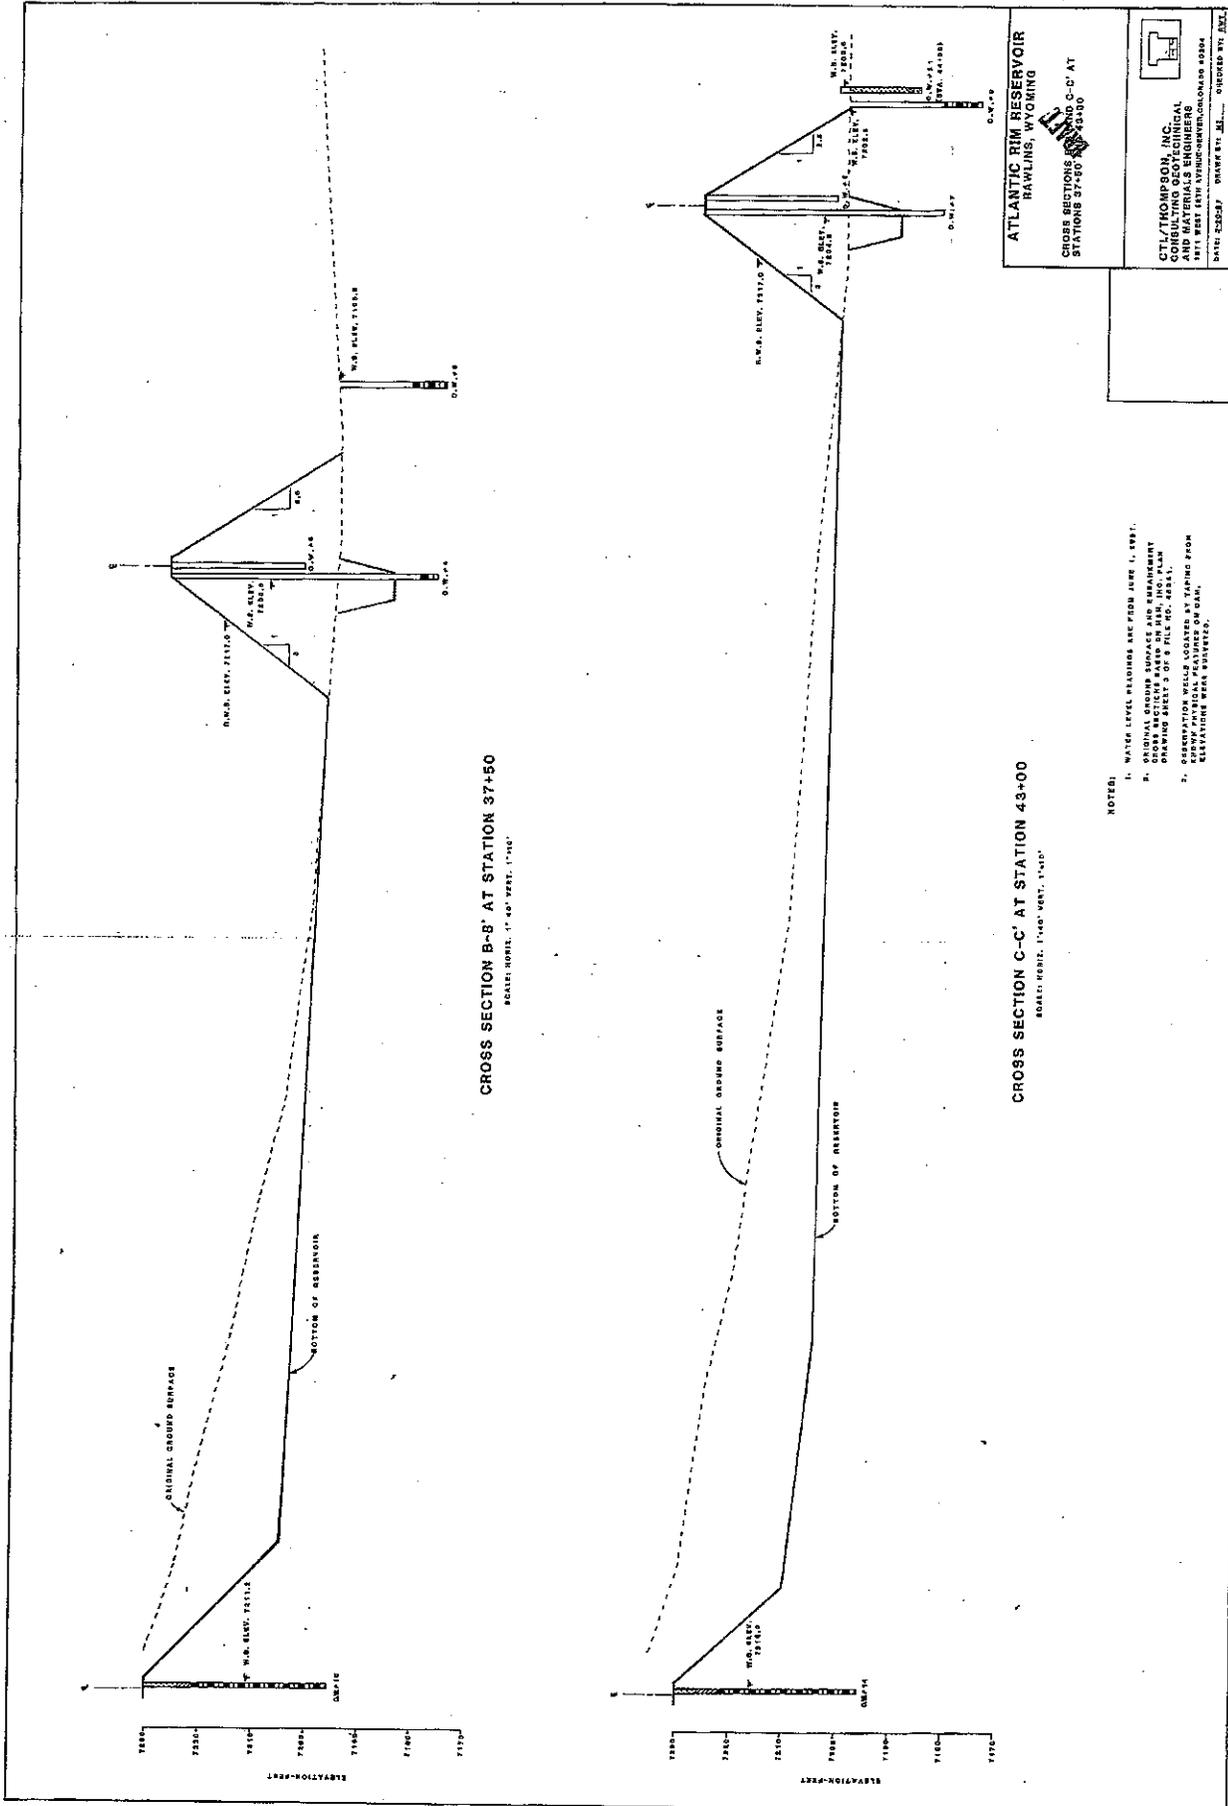
CROSS SECTION B-B' AT STATION 37+50
SCALE: HORIZ. 1" = 40' VERT. 1" = 10'

CROSS SECTION C-C' AT STATION 43+00
SCALE: HORIZ. 1" = 40' VERT. 1" = 10'

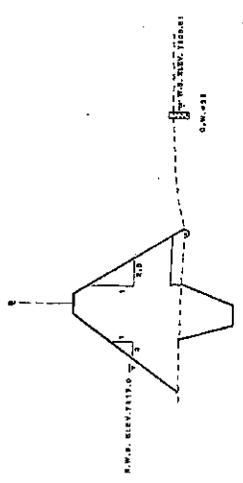
CROSS SECTION D-D' AT STATION 26+70
SCALE: HORIZ. 1"=40' VERT. 1"=4'

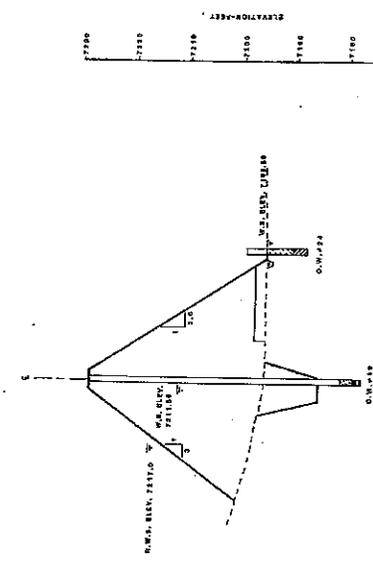
CROSS SECTION E-E' AT STATION 35+00
SCALE: HORIZ. 1"=40' VERT. 1"=4'

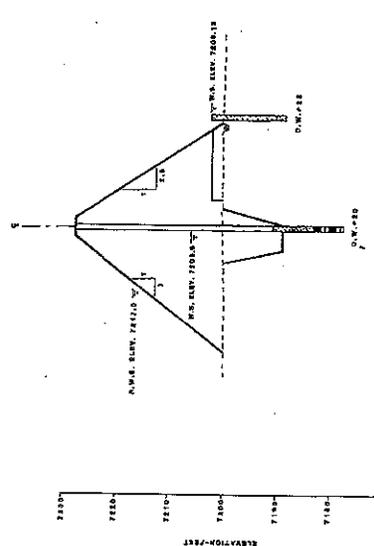
CROSS SECTION F-F' AT STATION 41+00
SCALE: HORIZ. 1"=40' VERT. 1"=4'

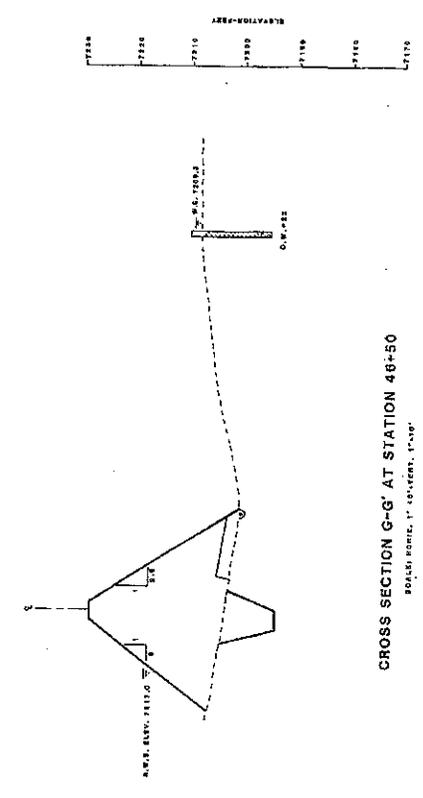
CROSS SECTION G-G' AT STATION 48+50
SCALE: HORIZ. 1"=40' VERT. 1"=4'
